THE KASHMIR, PAKISTAN
EARTHQUAKE OF 8 OCTOBER 2005
A FIELD REPORT BY EEFIT

A FIELD REPORT BY EEFIT

Dr Navin Peiris
Dr Tiziana Rossetto
Dr Paul Burton
Mr Suqlain Mahmood

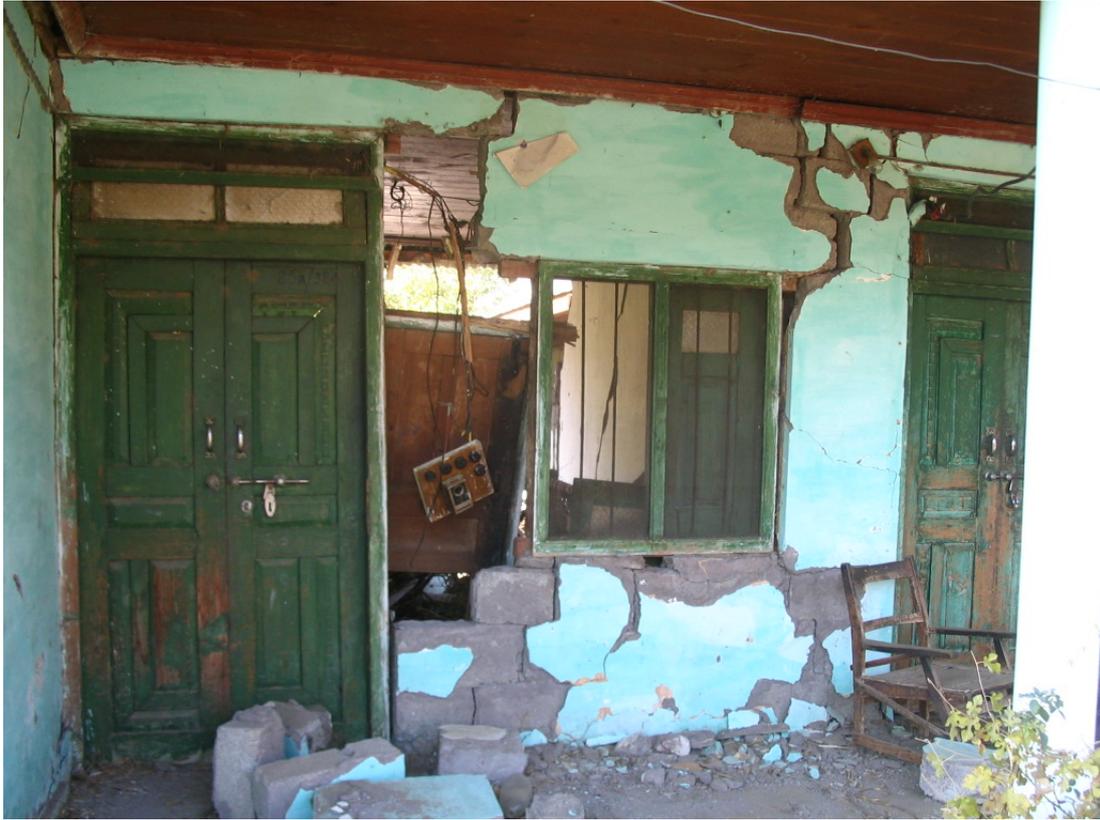
Figure 3.3: Damaged unreinforced concrete block masonry office building south of Balakot

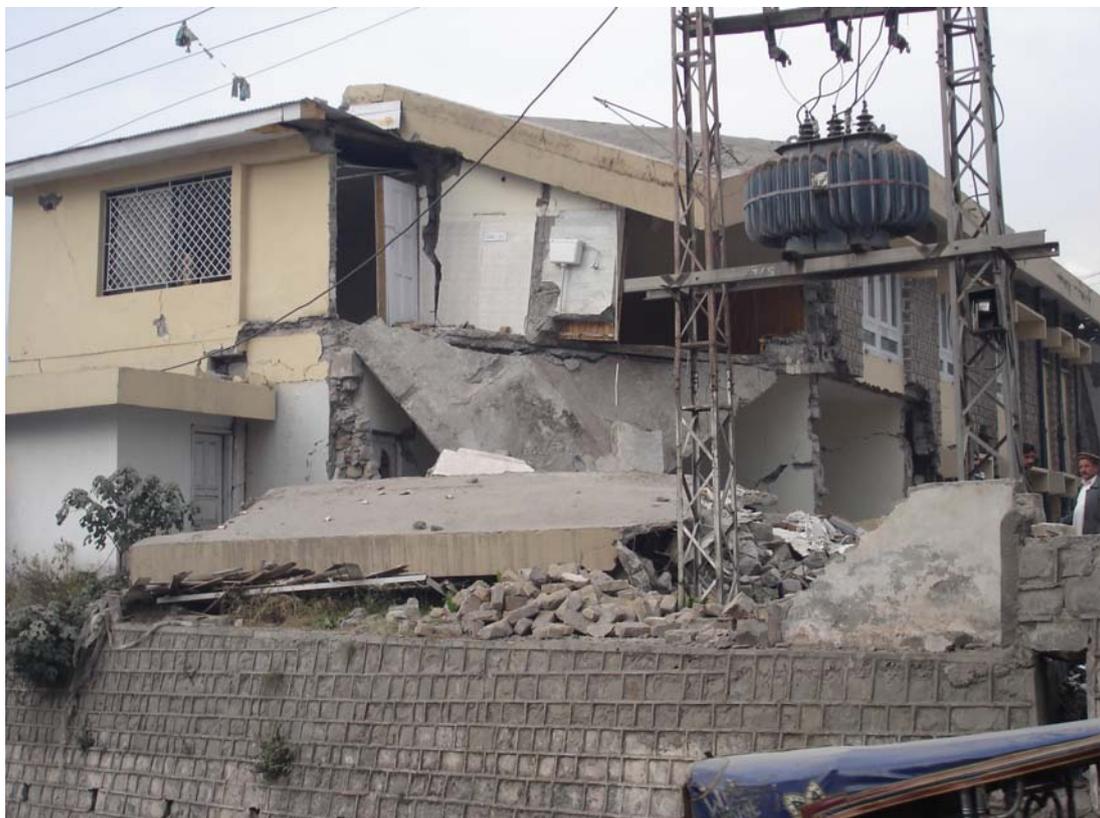
Figure 3.4: Damaged 2-storey concrete block masonry building in Muzaffarabad

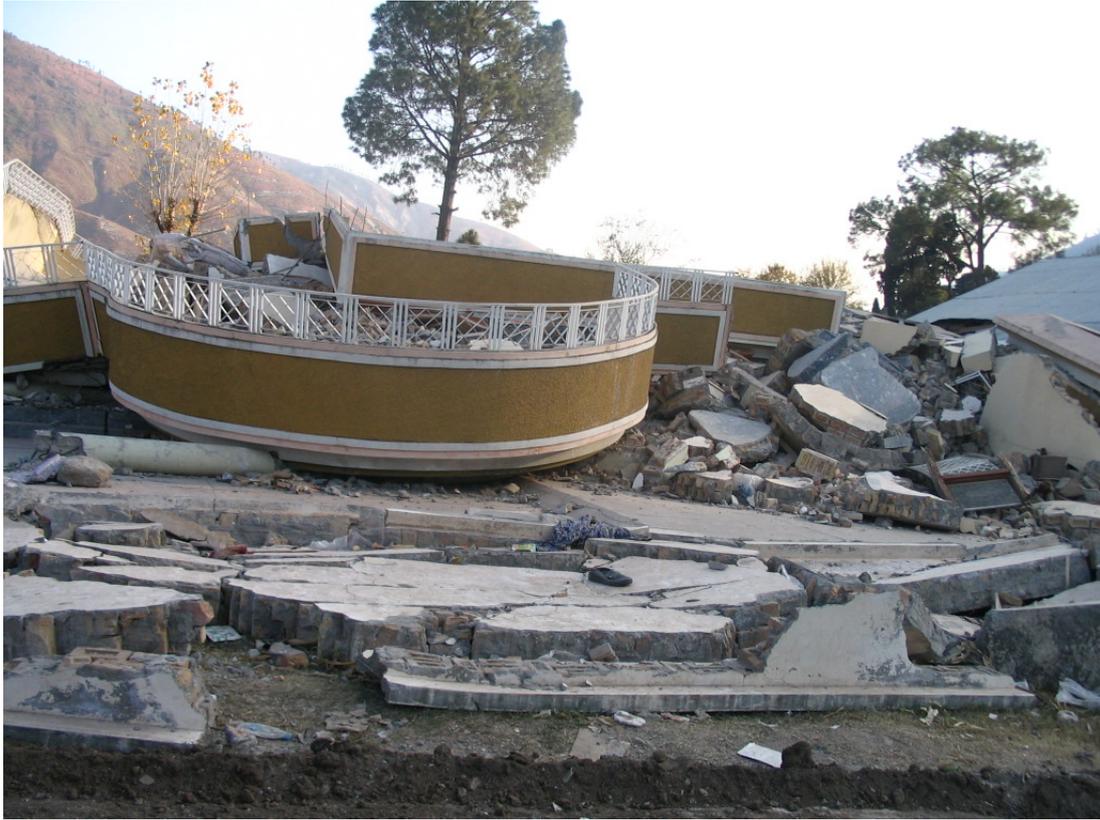
Figure 3.5: Collapsed unreinforced brick masonry house in Balakot

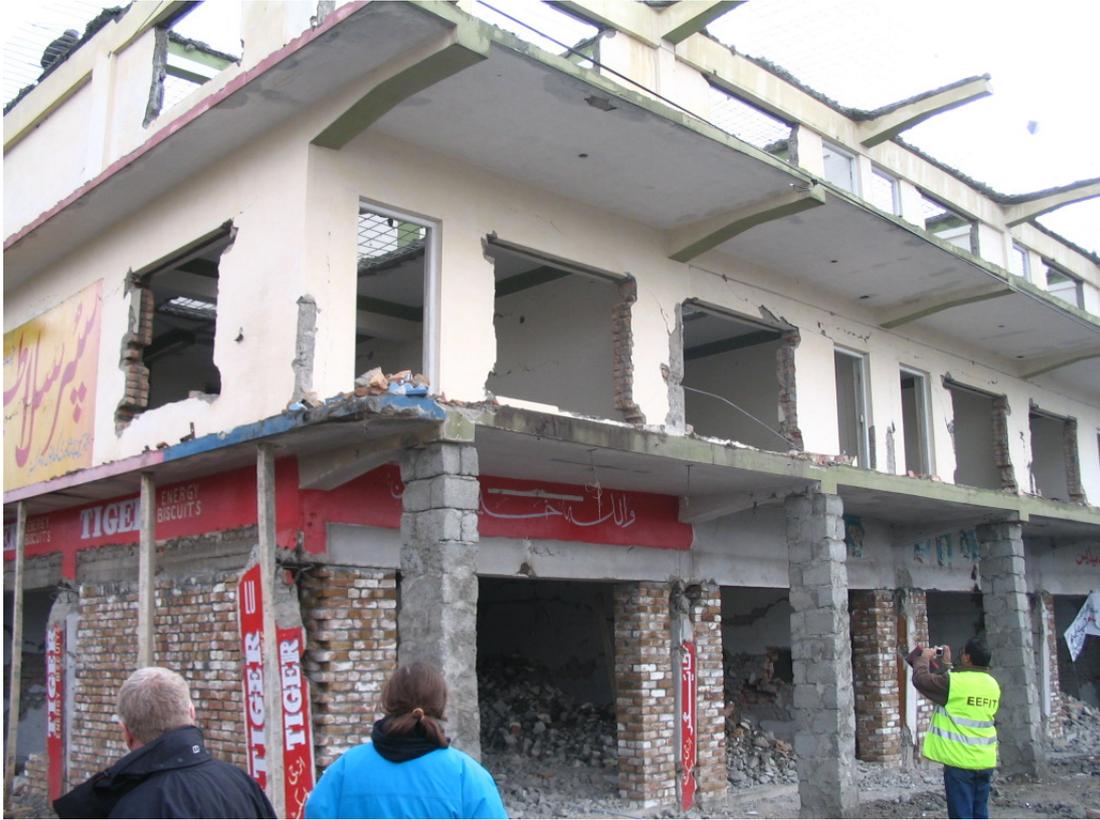
Figure 3.7: Moderately damaged commercial/retail building of RC frame and slab construction with brick masonry infill in Abbotabad

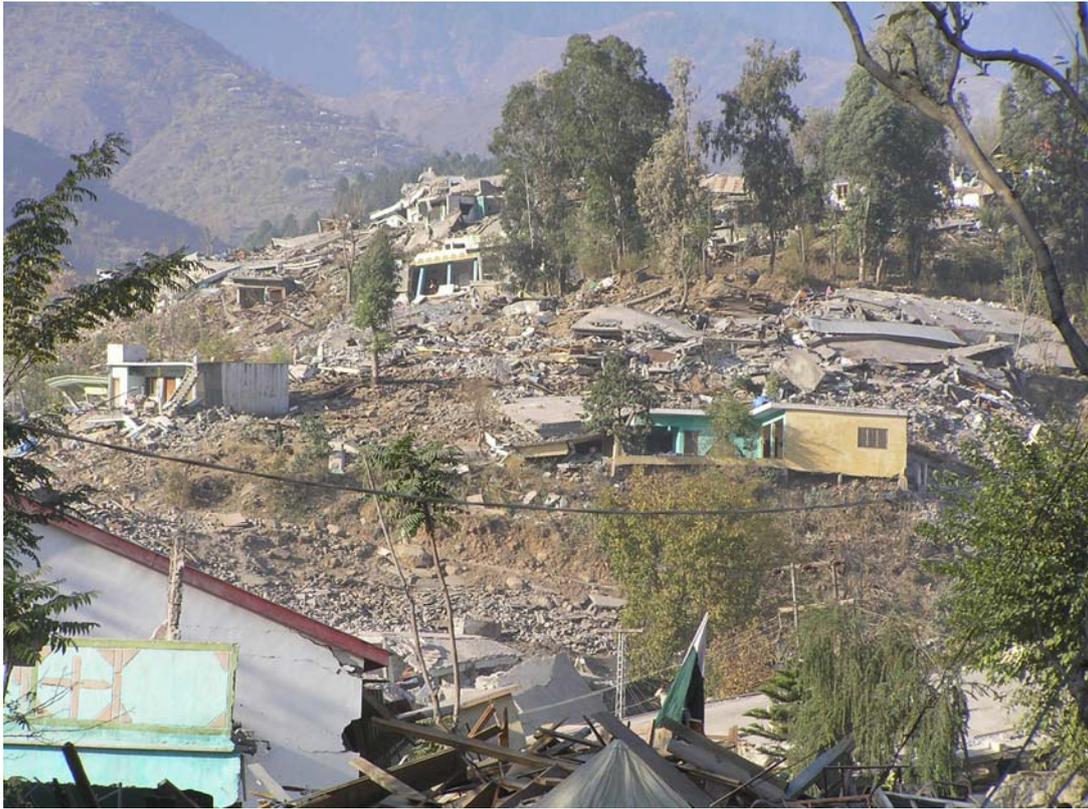
Figure 3.11: Collapsed and extensively damaged concrete block URM residential units on a hill northwest of Balakot city centre (zone 1)

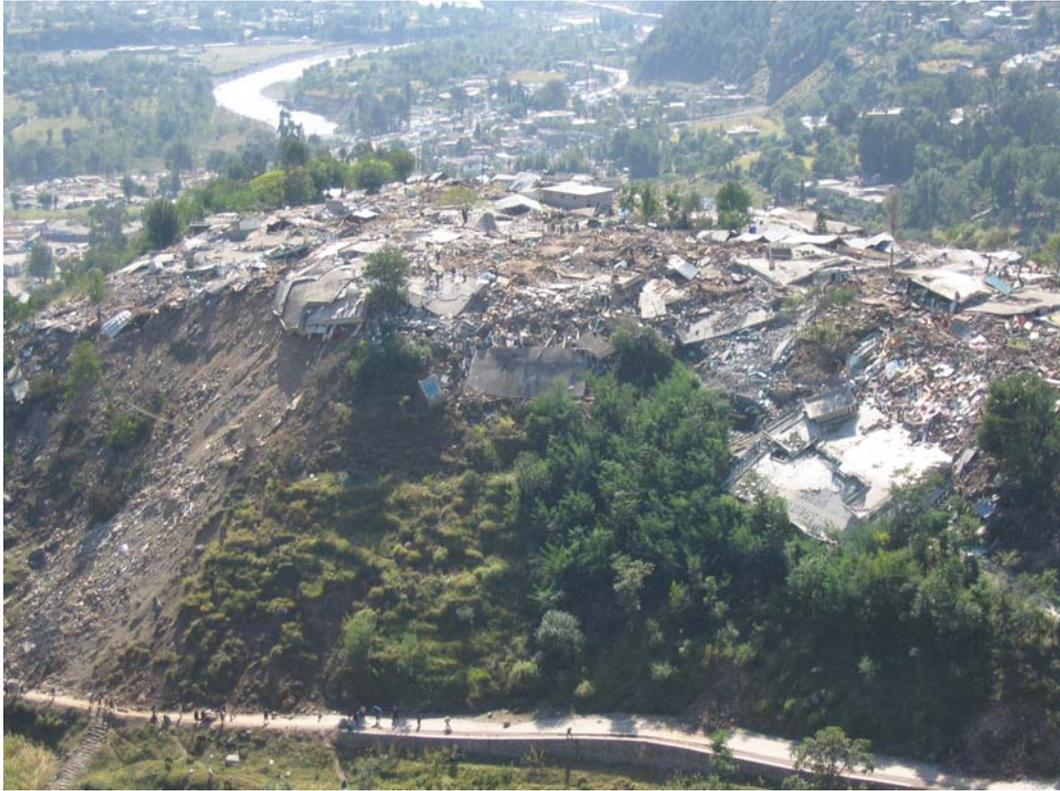
Figure 3.12: Collapsed and extensively damaged concrete block URM residential units in zone 1 overlooking Balakot city centre (photo by Kathrin Renner (Arup) and US Army)

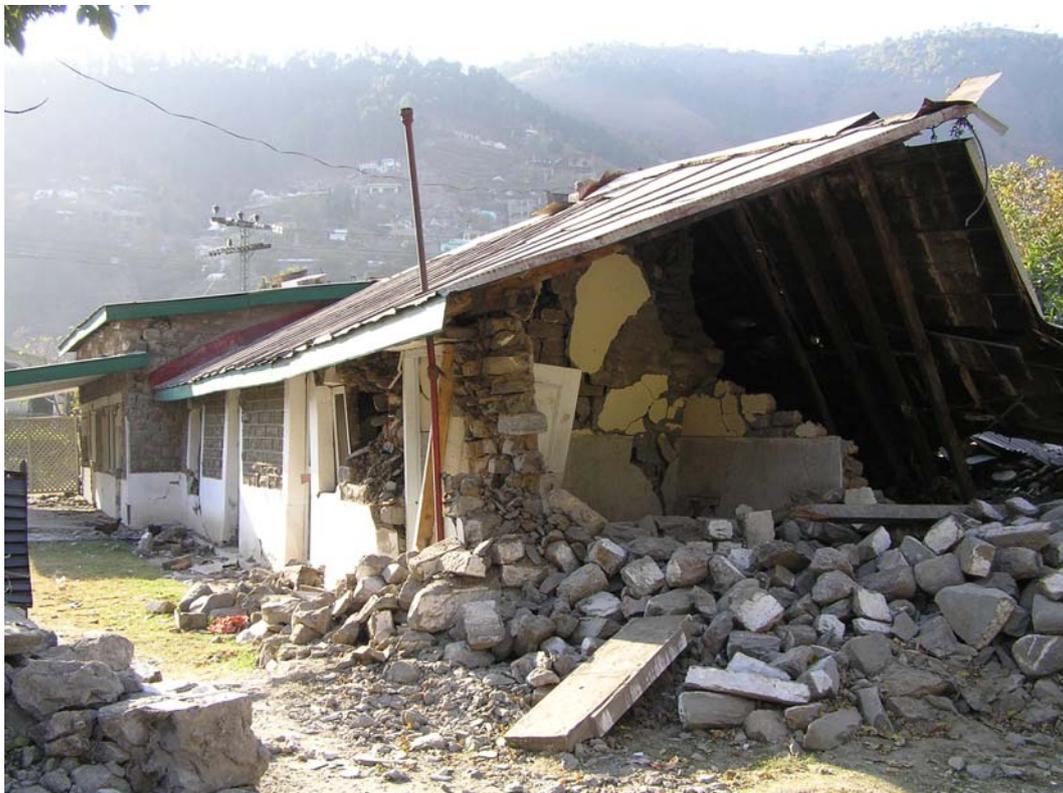
Figure 3.13: Extensively damaged stone URM building with metal roof in Balakot, used by the local audit officer

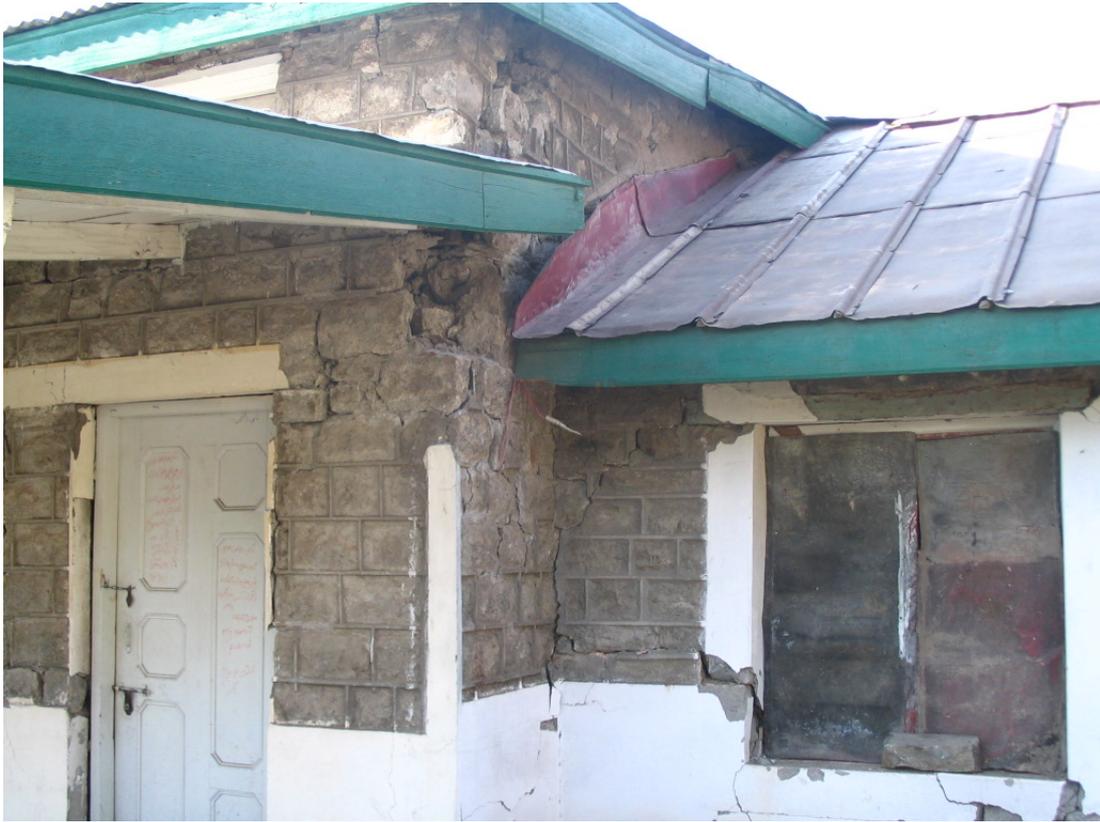
Figure 3.14: Cracks through stone and mortar in a stone URM building adjacent to the extensively damaged stone building in Figure 3.5

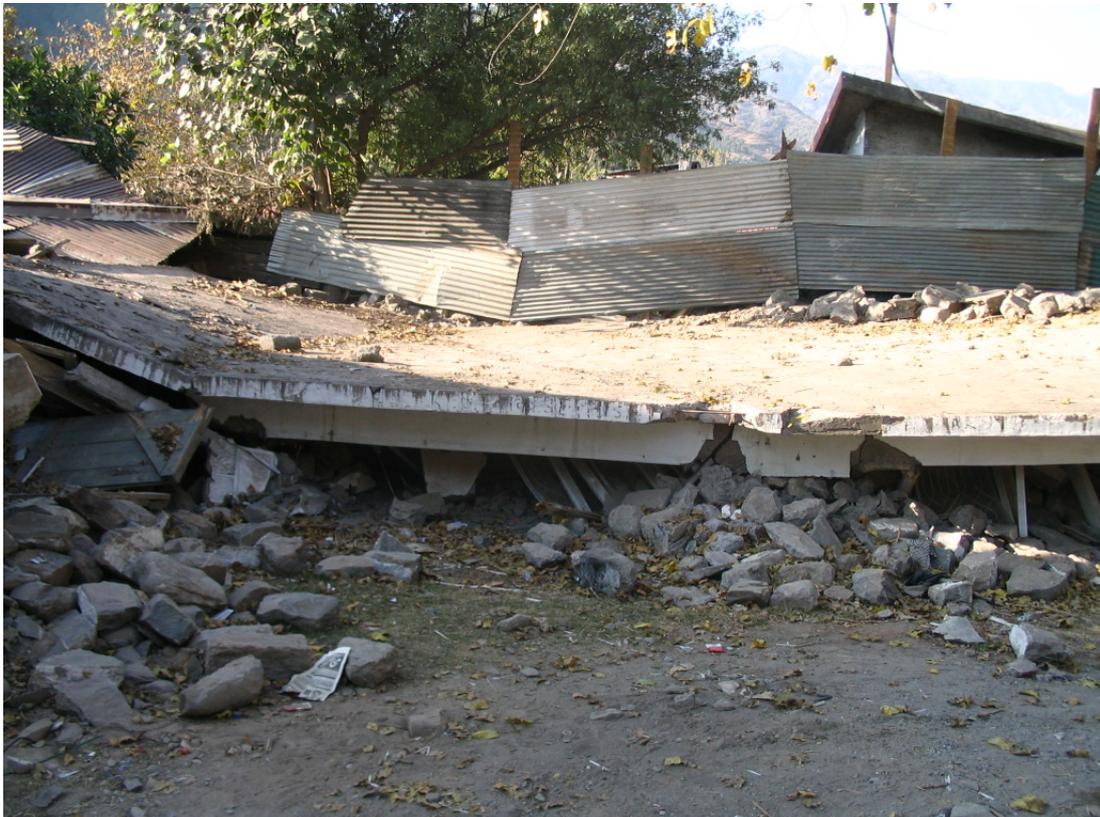
Figure 3.15: Collapsed concrete block URM residential building in Balakot

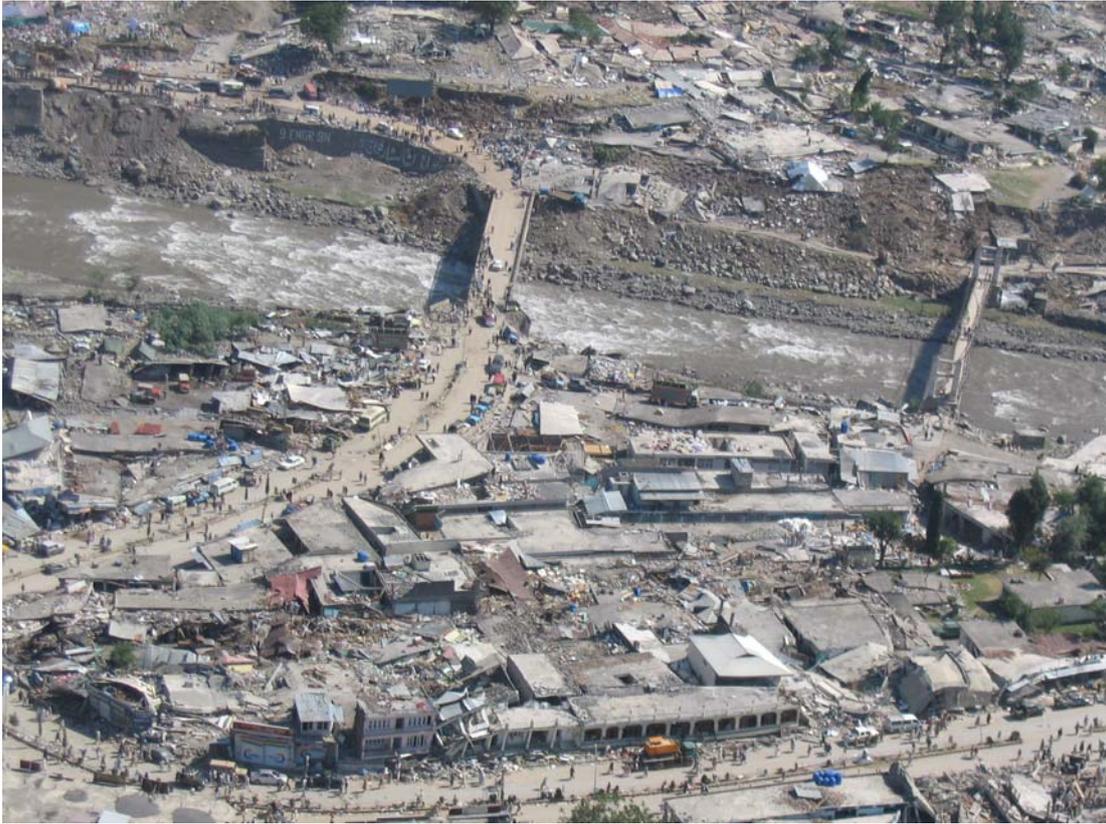
Figure 3.16: Aerial view of the damaged Balakot city commercial area (photo by Kathrin Renner (Arup) and US Army)

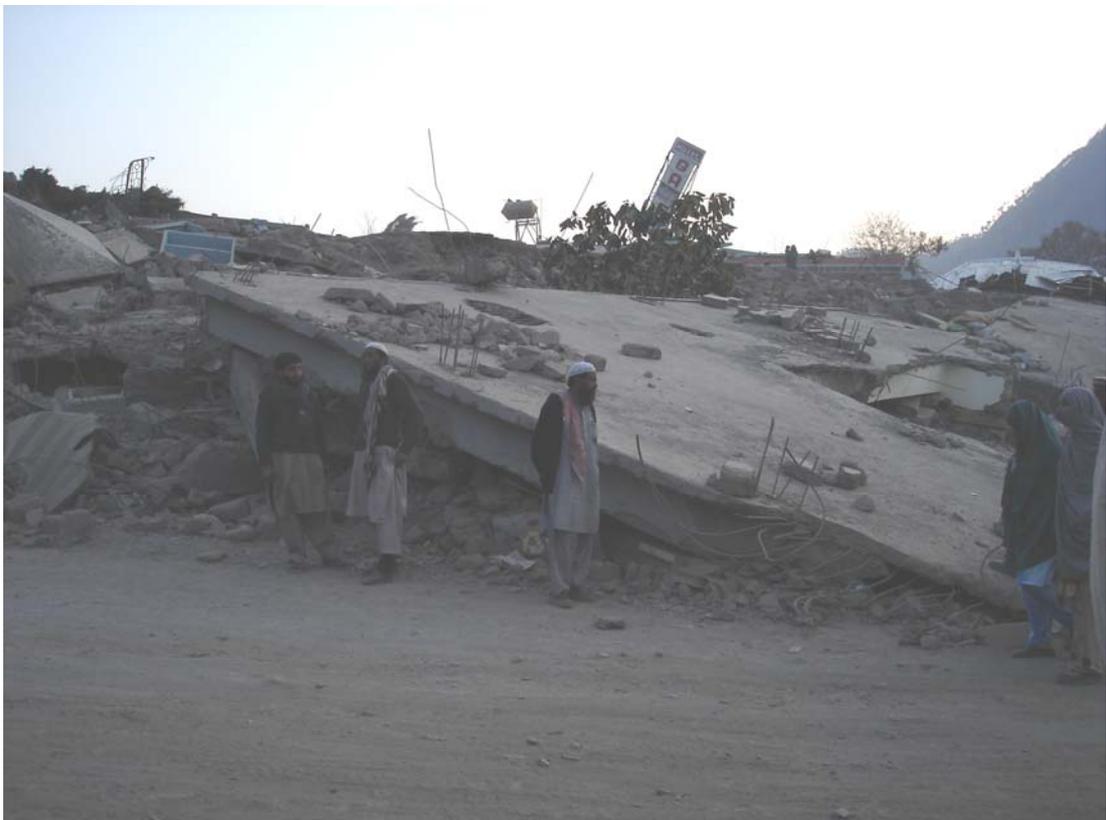
Figure 3.17: Collapsed single storey RC frame and slab commercial/retail building in Balakot city centre

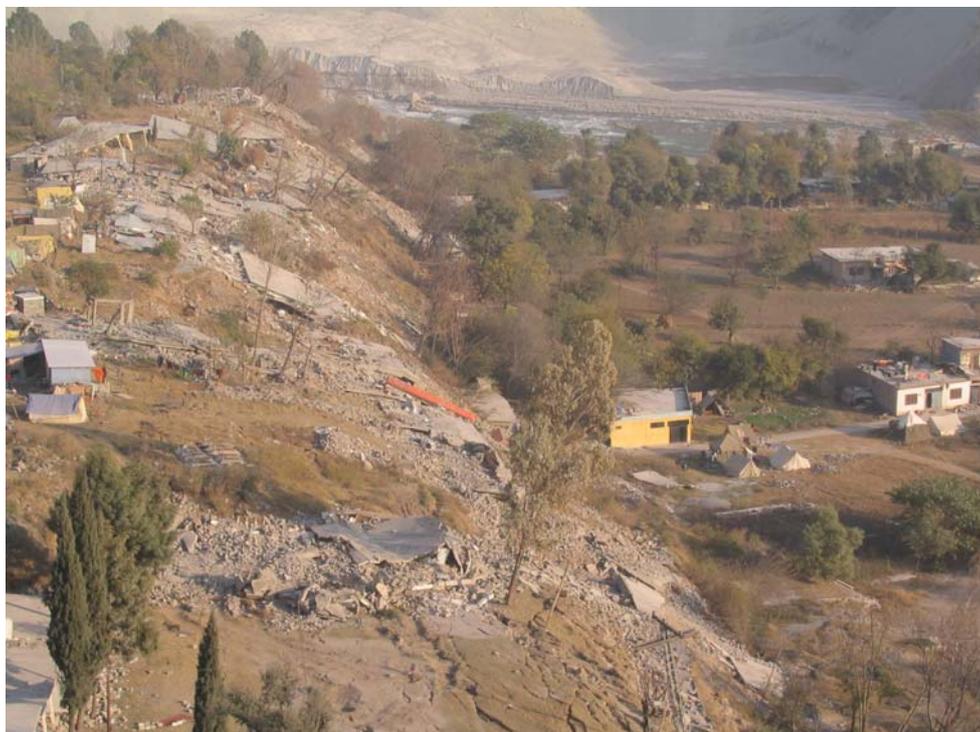
Figure 3.20: Collapsed stone and concrete block URM residential buildings on the hill and slight to moderately damaged residential buildings in the valley below. Collapse may be due to ridge effect or slope failure, Muzaffarabad

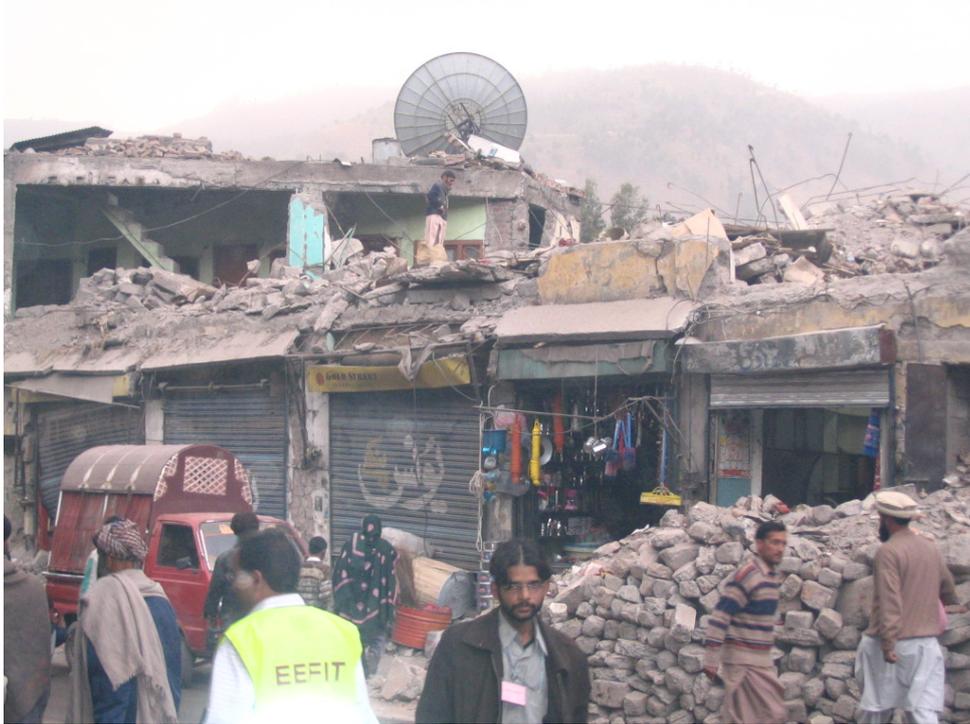
Figure 3.25: Collapsed roof of 2-storey RC frame and slab commercial buildings with concrete block masonry infill walls. Failure of beam/column connections at upper floor. Intact ground floor walls and first floor slab, Muzaffarabad

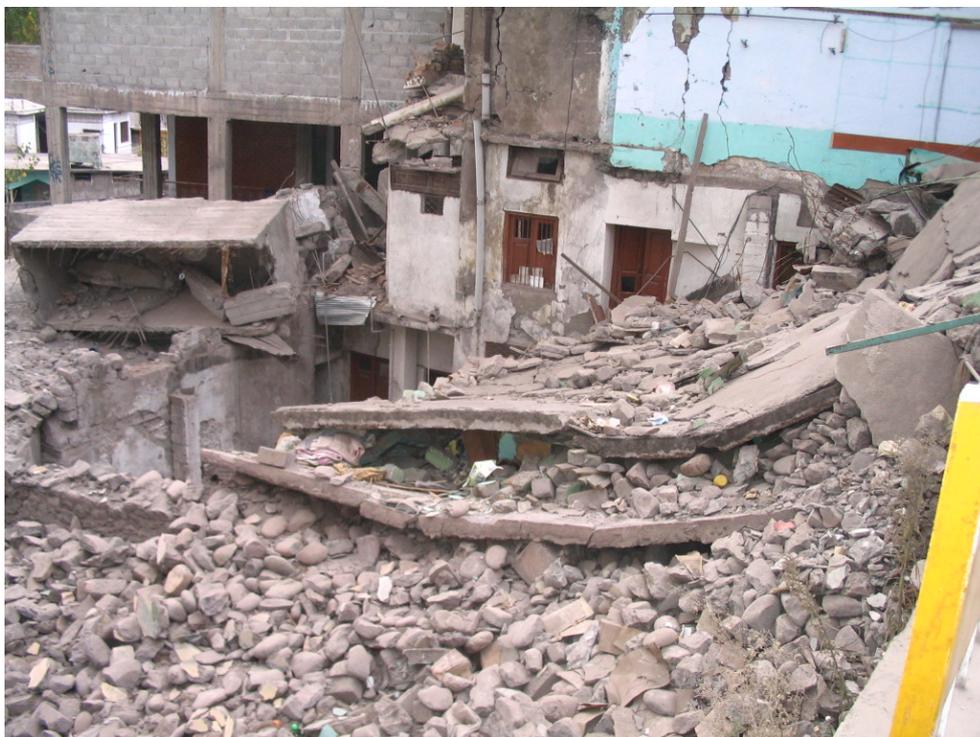
Figure 3.26: Collapsed 2-storey concrete block URM commercial building. Floor and roof collapse possibly due load bearing wall failure in shear and out-of-plane and high inertia loads from RC slabs, Muzaffarabad

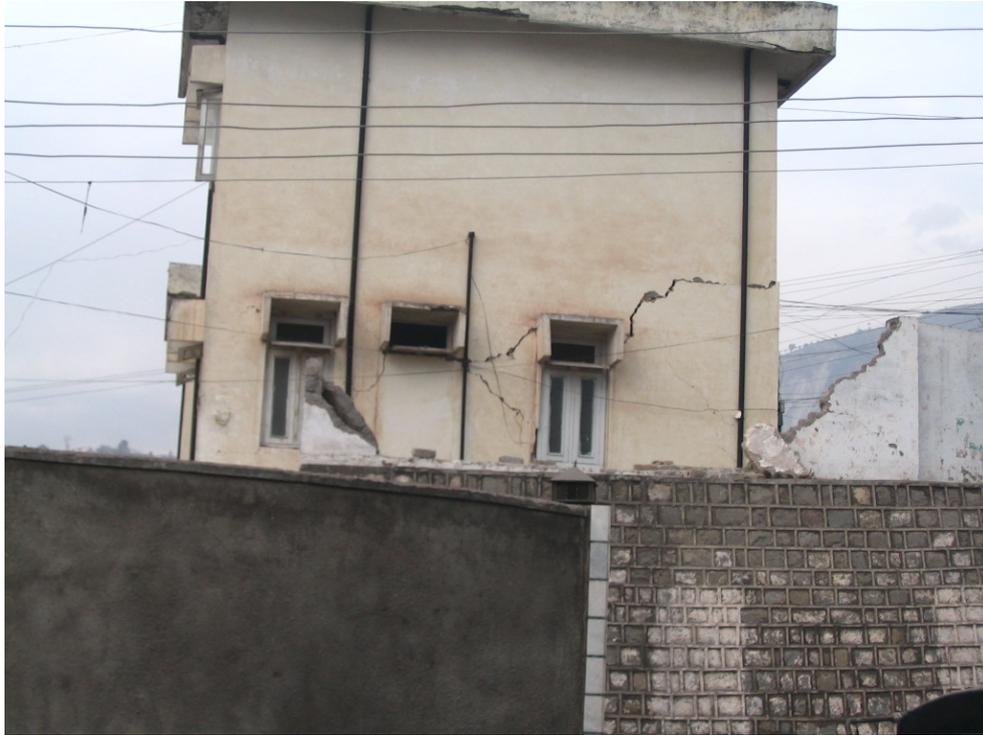
Figure 3.27: Diagonal shear cracks through concrete block wall of RC frame and slab commercial building with masonry infill walls, moderate damage, Muzaffarabad

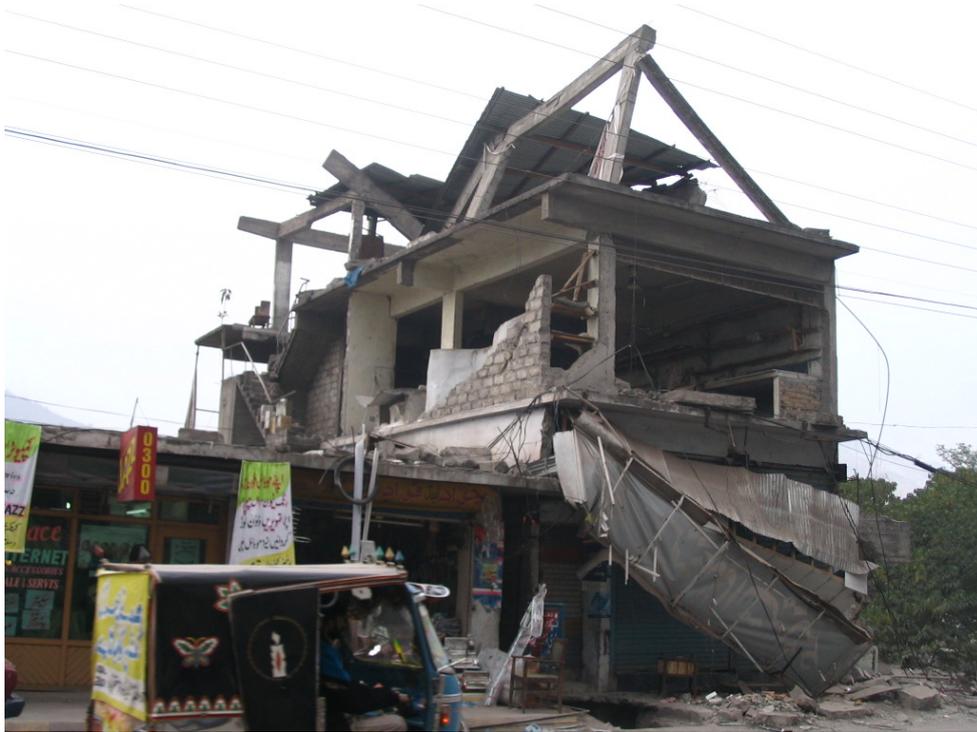
Figure 3.29: Collapsed RC frame of upper floor of 3-storey commercial building with concrete block masonry infill walls. Failure at beam/column connections of upper floor frame, Muzaffarabad

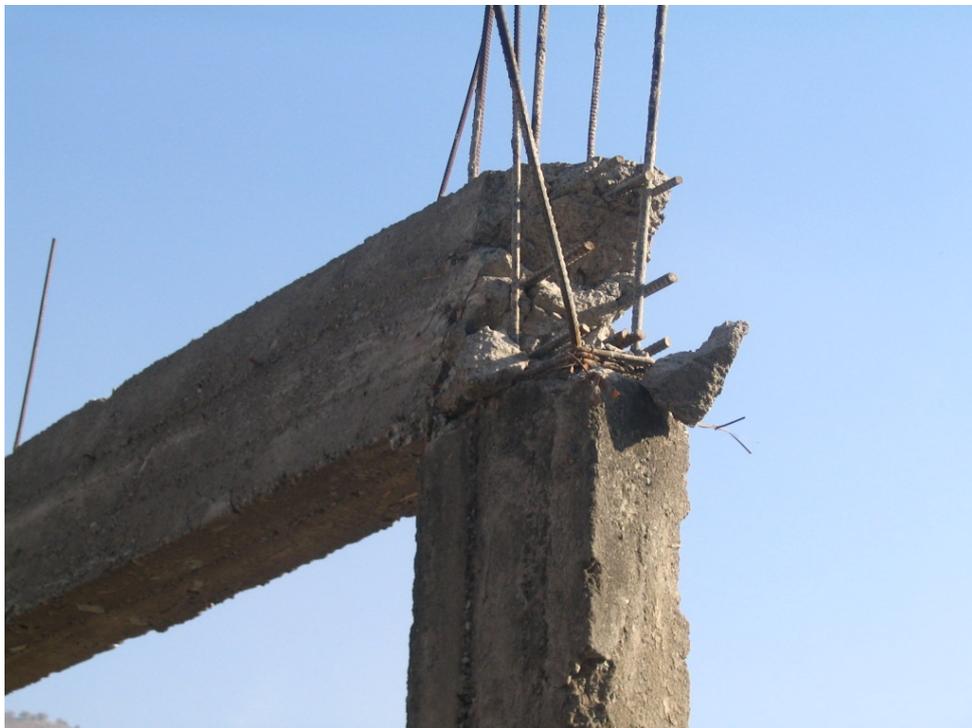
Figure 3.30: Example of poor beam/column reinforcement detailing. No proper connection of column and beam reinforcement for moment resisting action

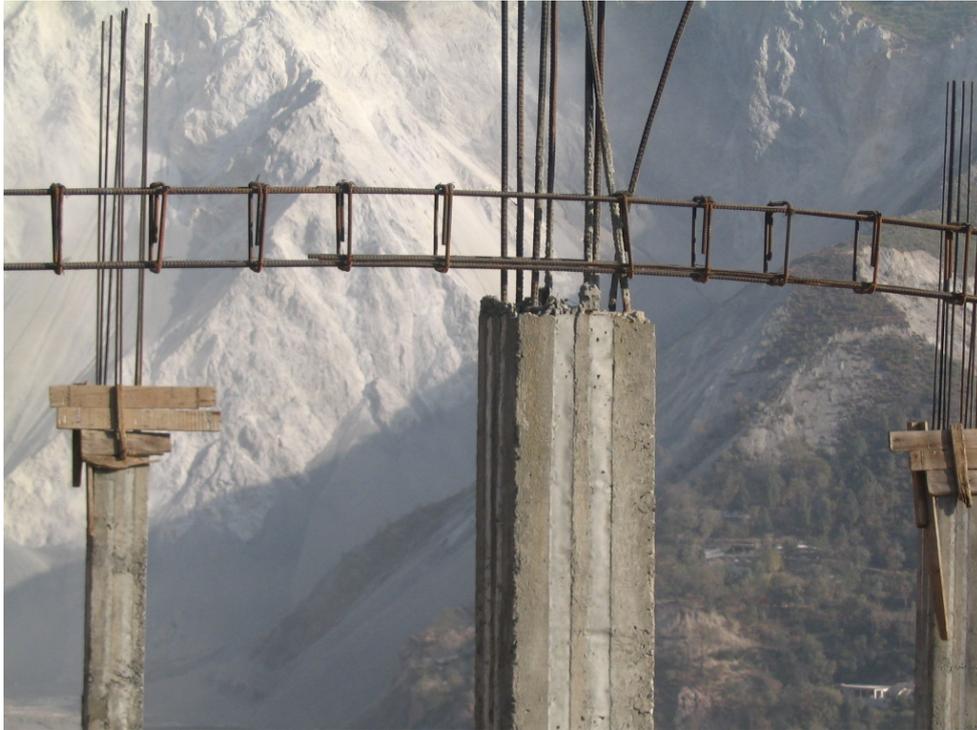
Figure 3.31: Incorrect splicing of reinforcing bar at beam/column connection of a moment frame under construction. Shear links configuration inadequate for seismic shear forces

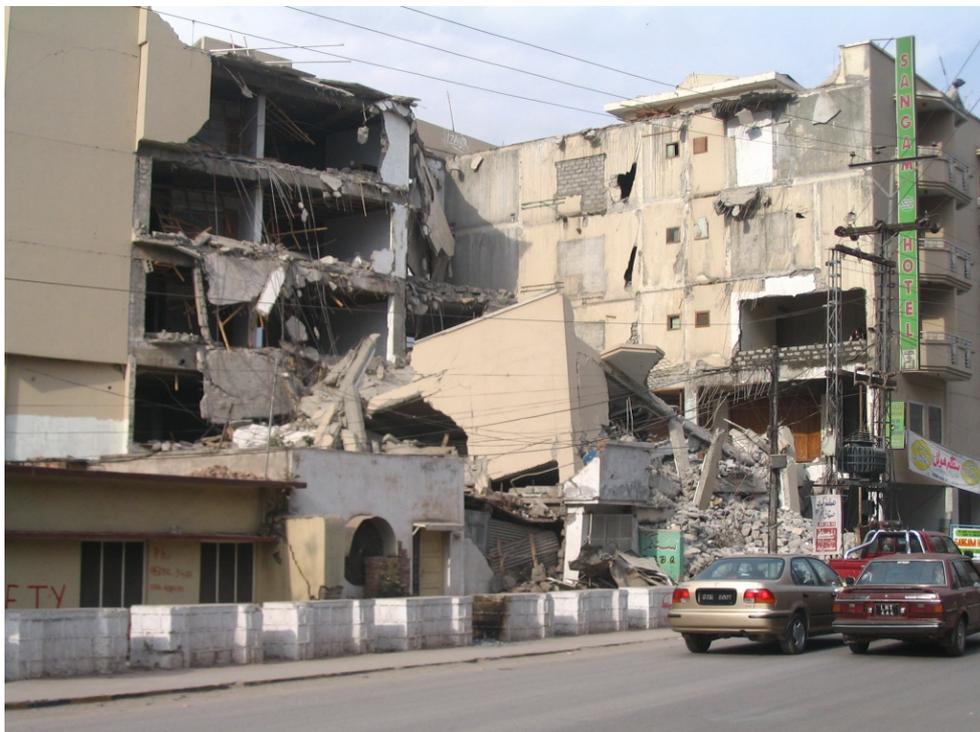
Figure 3.32: Collapsed section of Samgam Hotel, RC frame and slab construction, 5-storey. Collapse due to failure at beam/column connections, Muzaffarabad

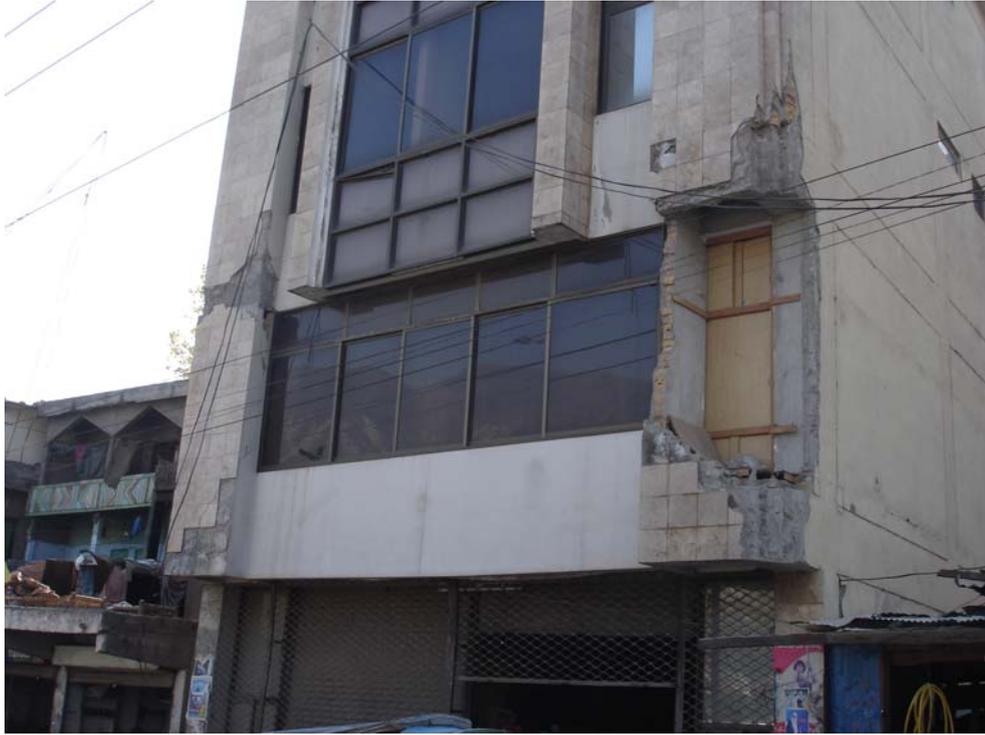
Figure 3.33: Slightly damaged 4-storey RC frame and slab commercial building with concrete block masonry infill, Muzaffarabad

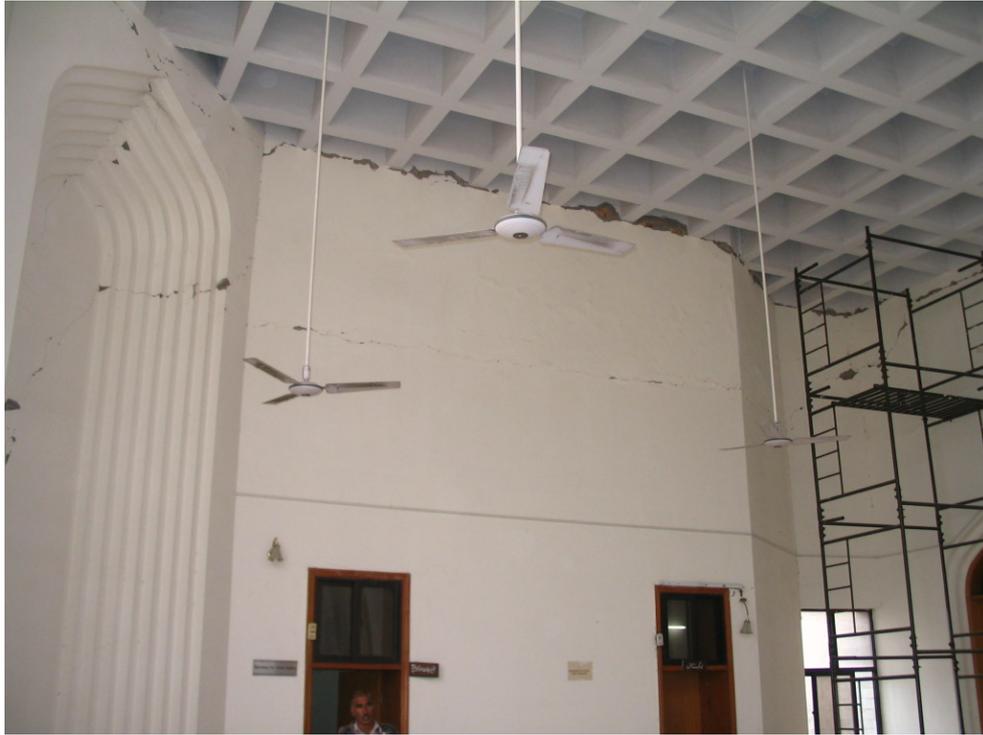
Figure 3.35: Shear cracks through the brick masonry walls of the Muzaffarabad Supreme Court building. Cracking visible at the roof/wall intersection, moderate damage

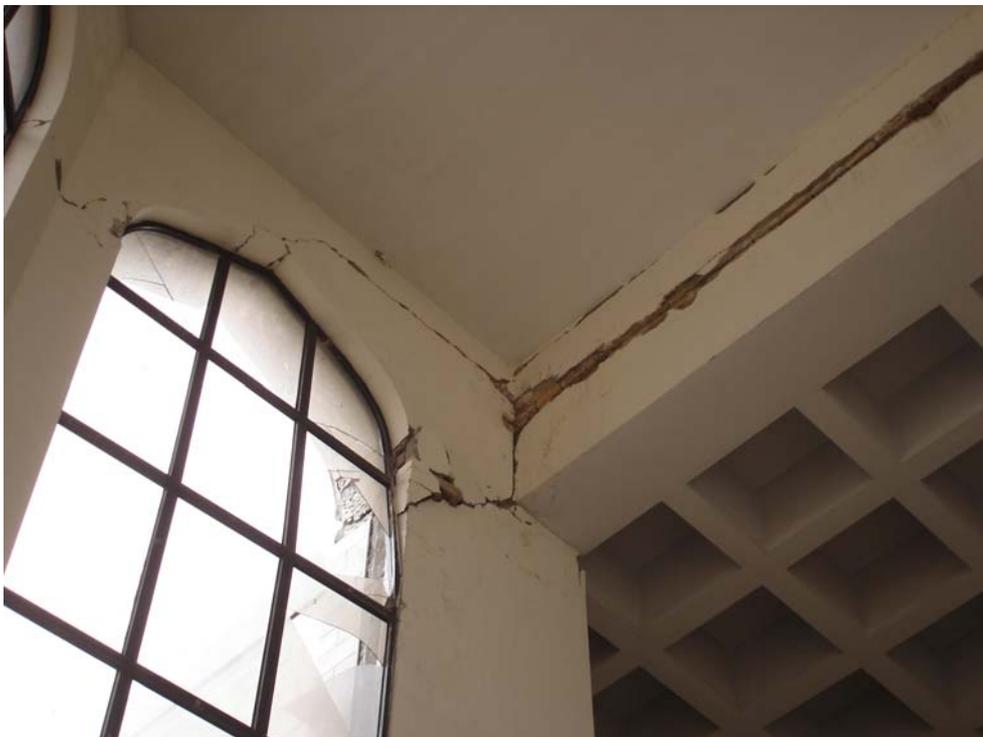
Figure 3.36: Shear cracks through the brick masonry column and roof beam connection at the Muzaffarabad Supreme Court building. Damaged glass due to shearing through the window

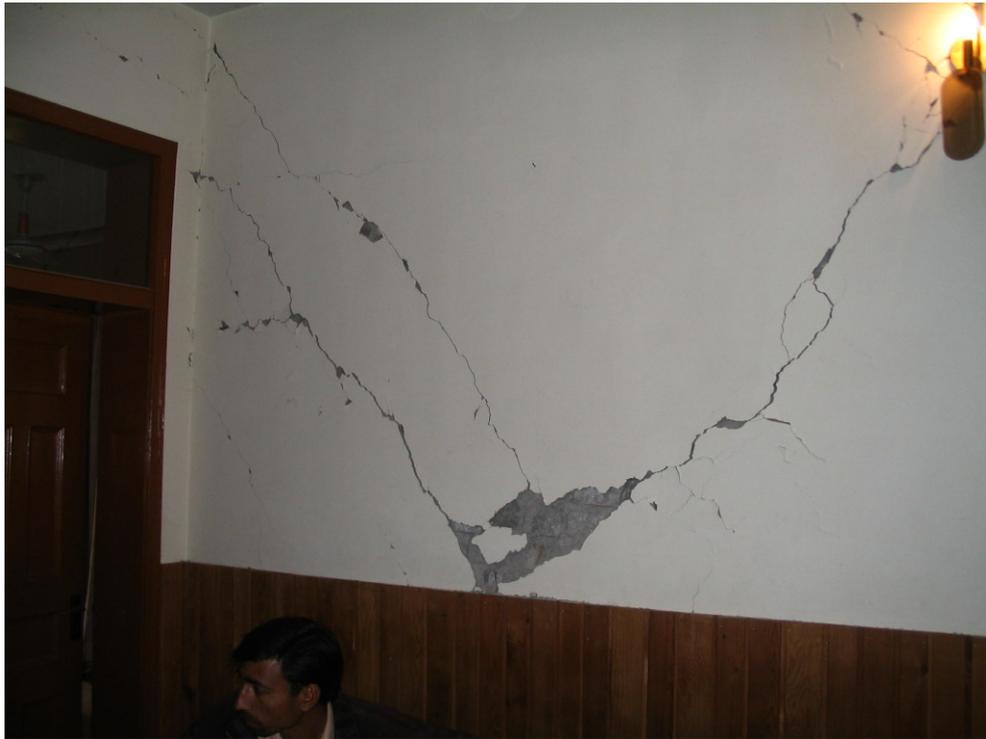
Figure 3.37: Diagonal shear cracks through the brick URM walls of the Muzaffarabad Tourist Information Office, moderate damage

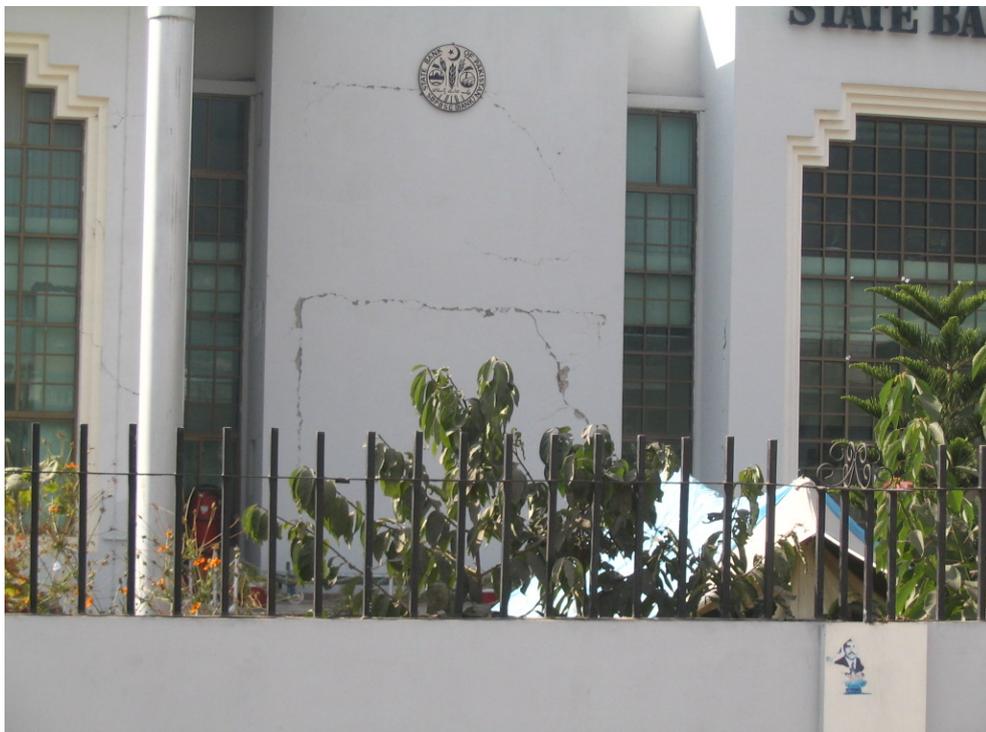
Figure 3.38: Shear cracks through the brick URM walls of the State Bank of Pakistan building, moderate damage

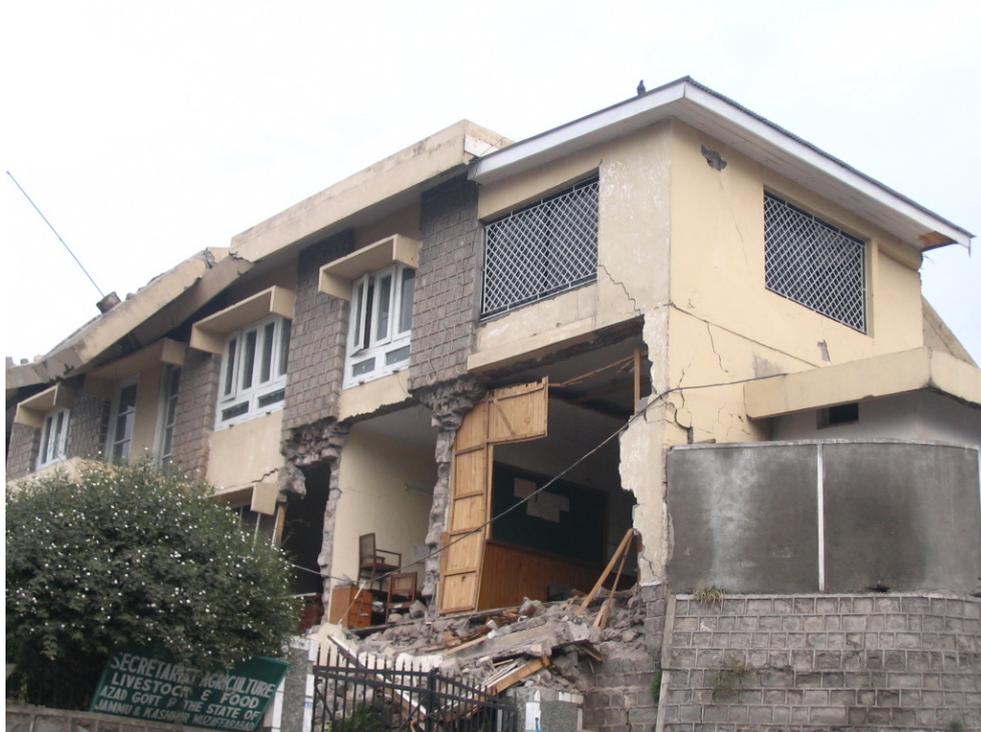
Figure 3.39: Collapsed wall sections of the concrete block URM, 3-storey building of the AJK Secretariat of Agriculture, Livestock and Food. Collapsed RC slab roof, extensive damage

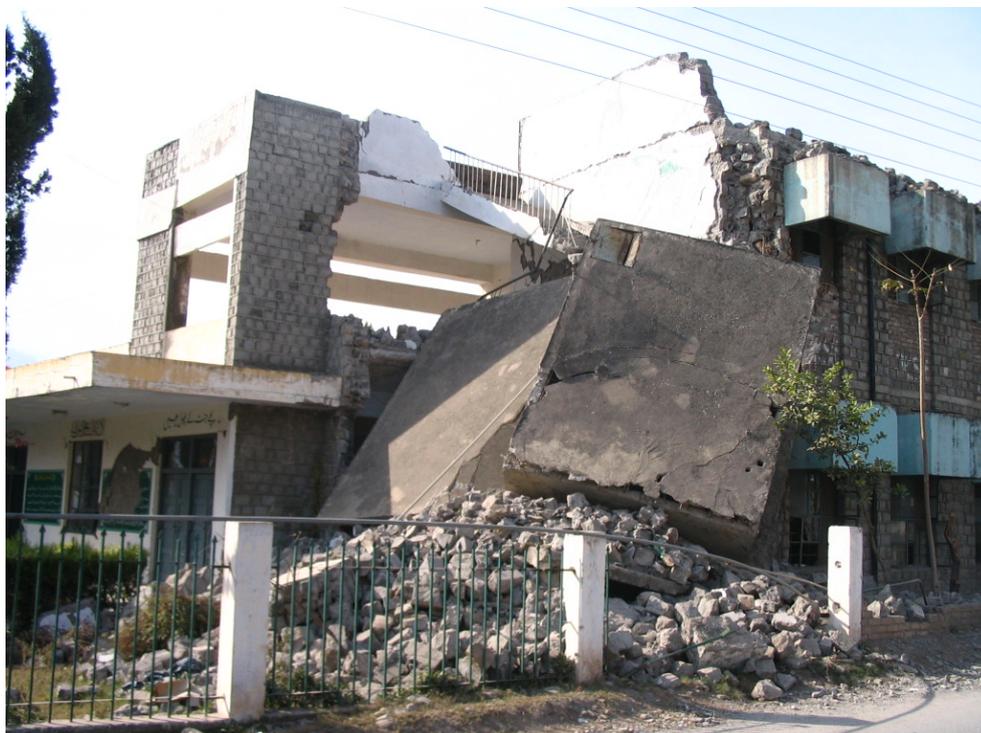
Figure 3.40: Collapsed sections of the concrete block URM, 2-storey school building. Roof and floor slab collapse due to failure of masonry bearing walls, Muzaffarabad

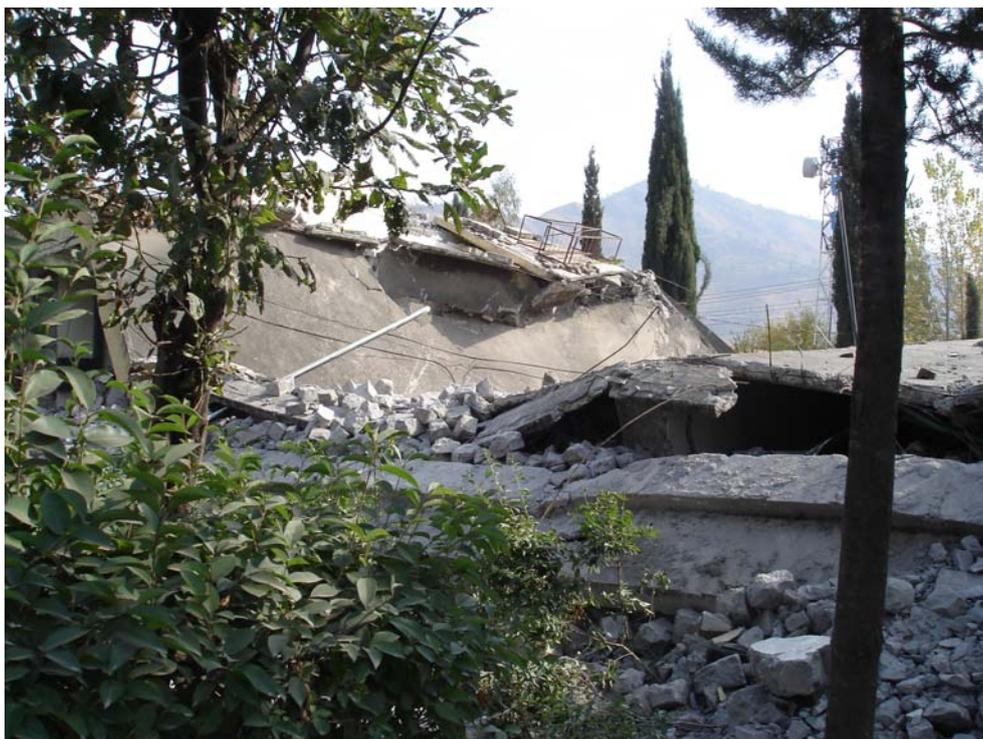
Figure 3.41: Collapsed concrete block URM school building, Muzaffarabad

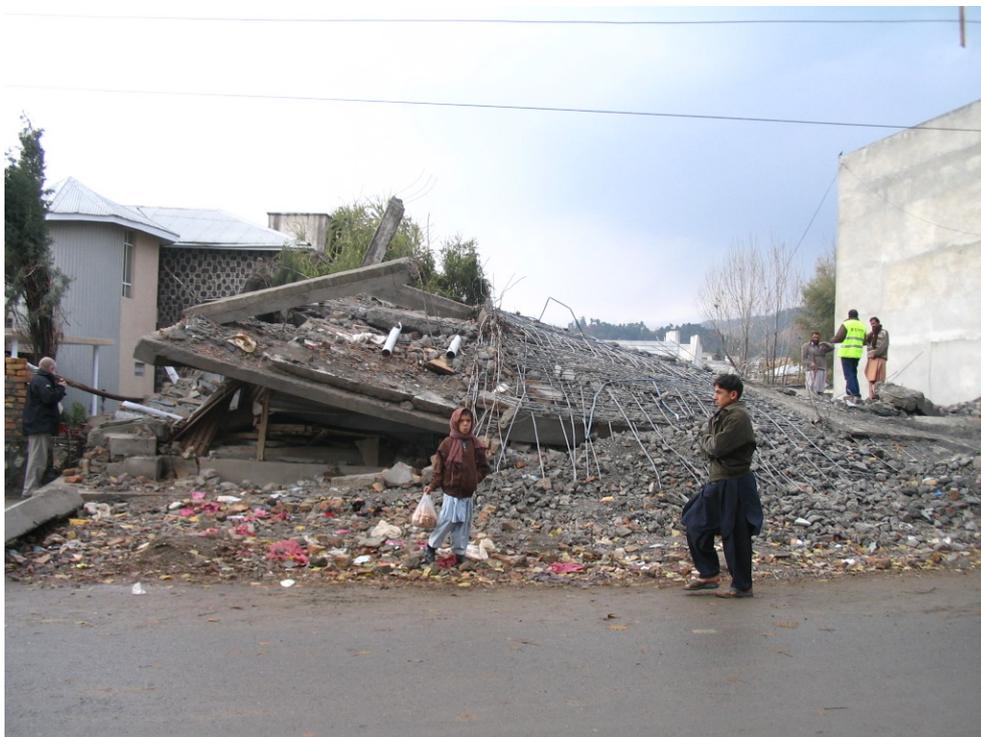
Figure 3.43: Collapsed RC 3-storey commercial and residential building. Collapse appears to be due to failure of beam/column connections, Abbottabad
