THE KASHMIR, PAKISTAN
EARTHQUAKE OF 8 OCTOBER 2005
A FIELD REPORT BY EEFIT

A FIELD REPORT BY EEFIT

Dr Navin Peiris
Dr Tiziana Rossetto
Dr Paul Burton
Mr Suqlain Mahmood

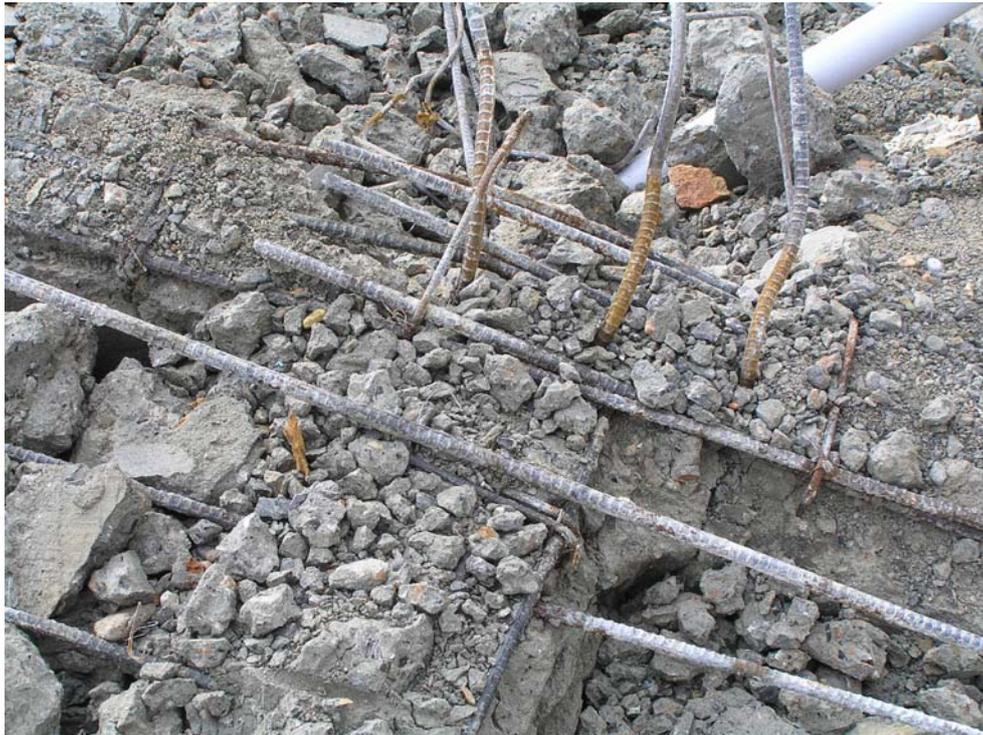
Figure 3.44: Lack of continuity of reinforcement detailing at the beam/column connection

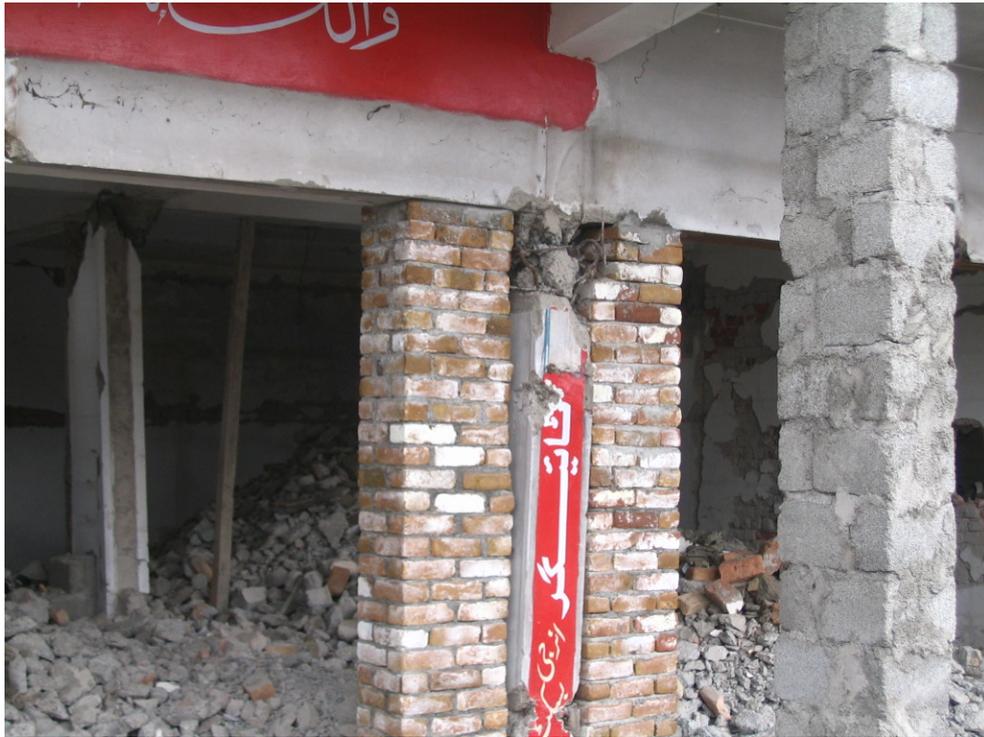
Figure 3.46: Extensively damaged 3-storey RC commercial building. Failed beam/column connections due to lack of shear or confinement reinforcement and inadequate layout, collapsed and cracked brick masonry infill walls inside the building, Abbottabad

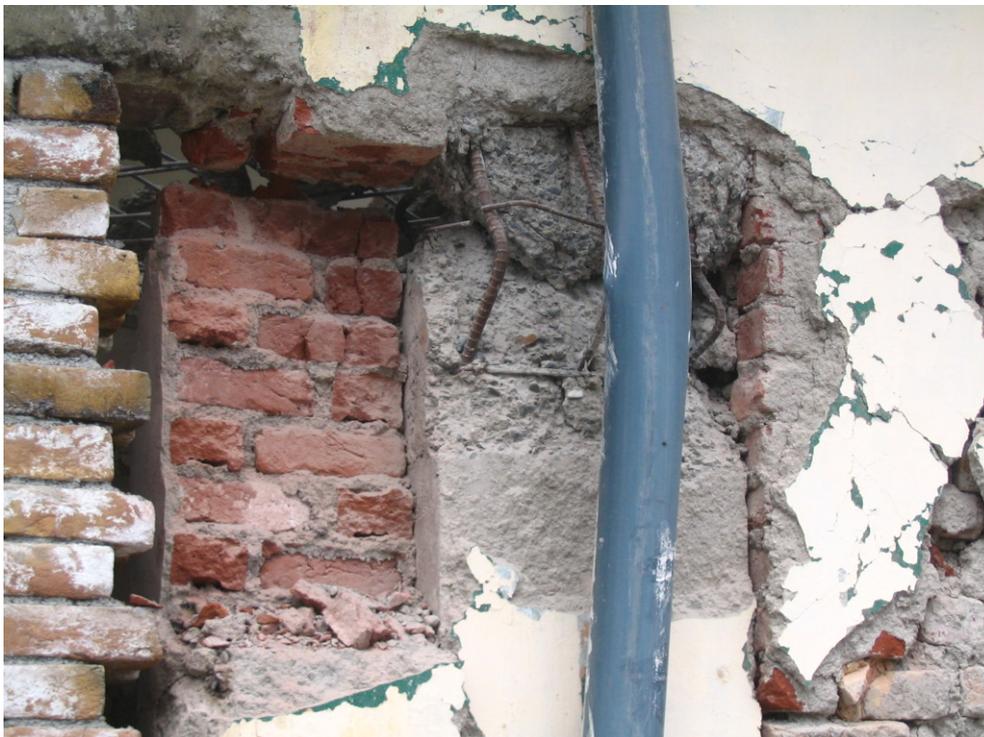
Figure 3.47: Example of failed beam/column connection due to poor shear and confinement reinforcement detailing

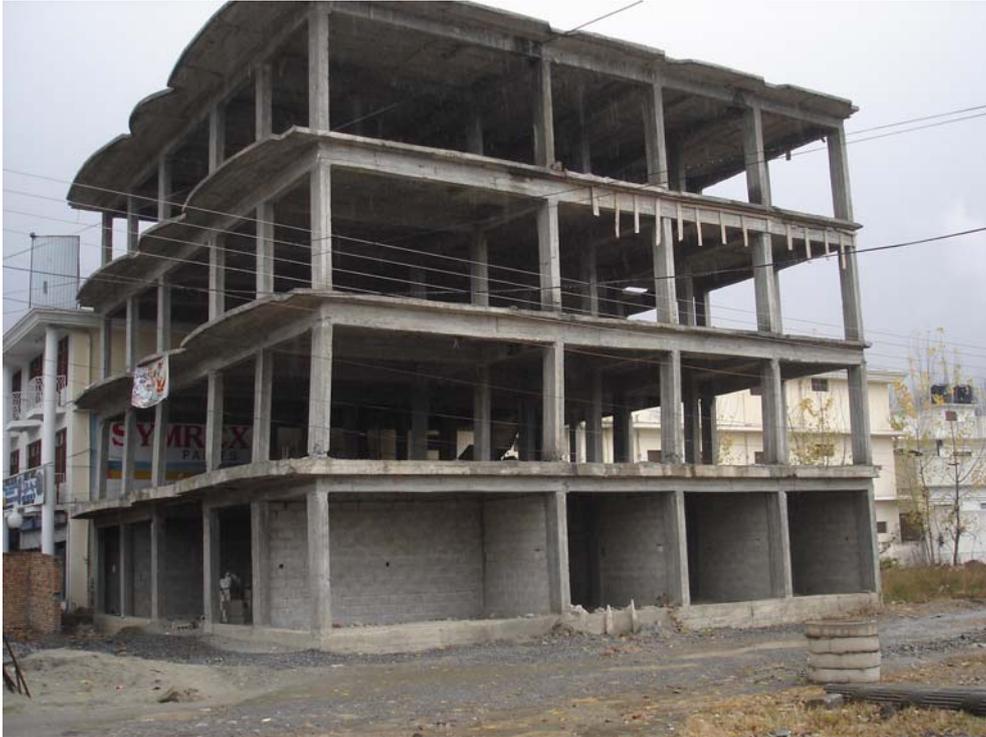
Figure 3.48: Permanent drift at the first floor of an RC frame and slab 4-storey commercial structure under construction, Abbottabad. Ground floor drift may have been prevented by the infill masonry walls

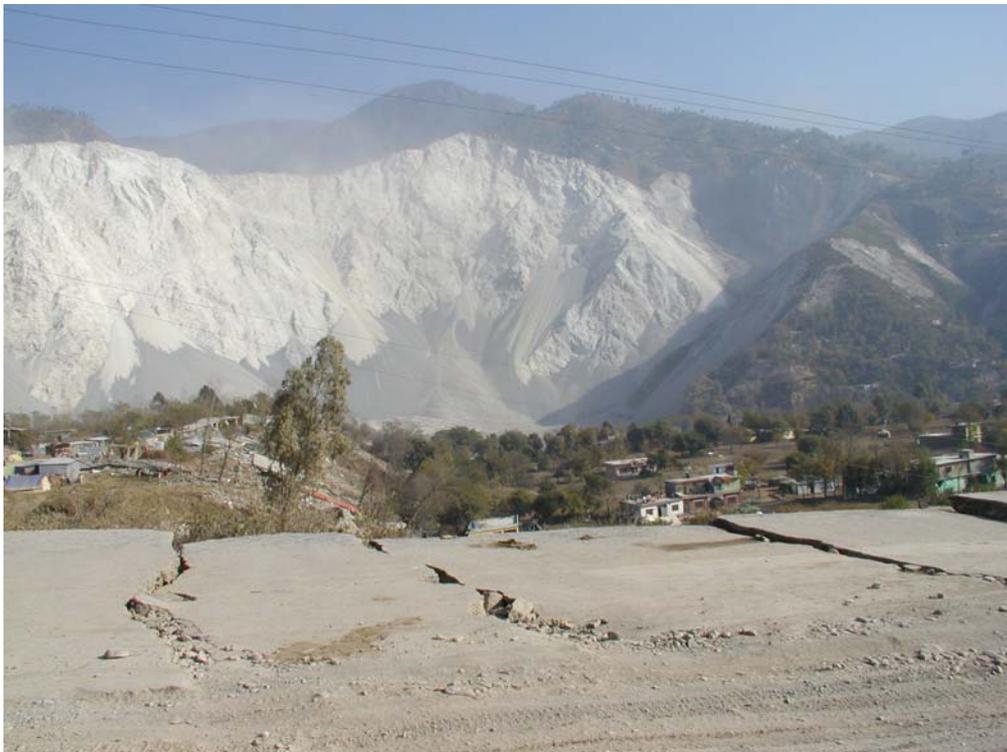
Figure 4.5: Kashmir earthquake October 8, 2005. Landslide in dolomite mountainside just north of Muzaffarabad at Chela Bandi. Also note cracks through road in foreground and damage to buildings in mid-distance

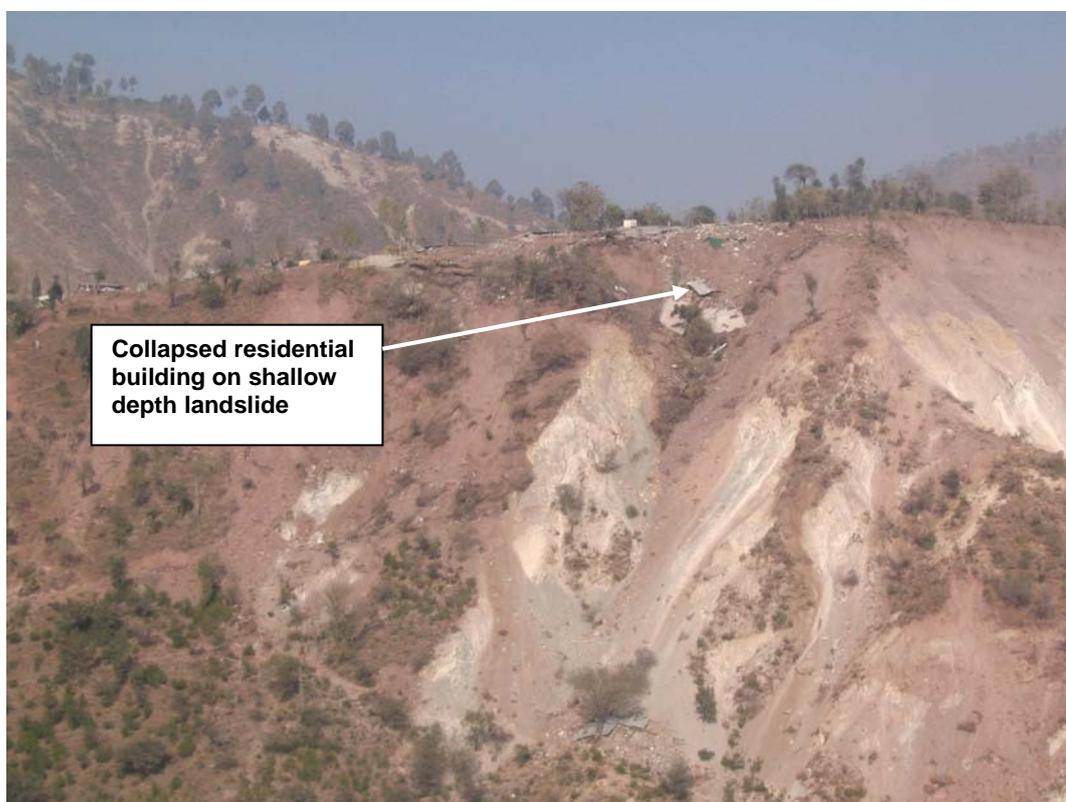
Figure 4.17: Collapsed residential building due to a shallow depth landslide north of Muzaffarabad City

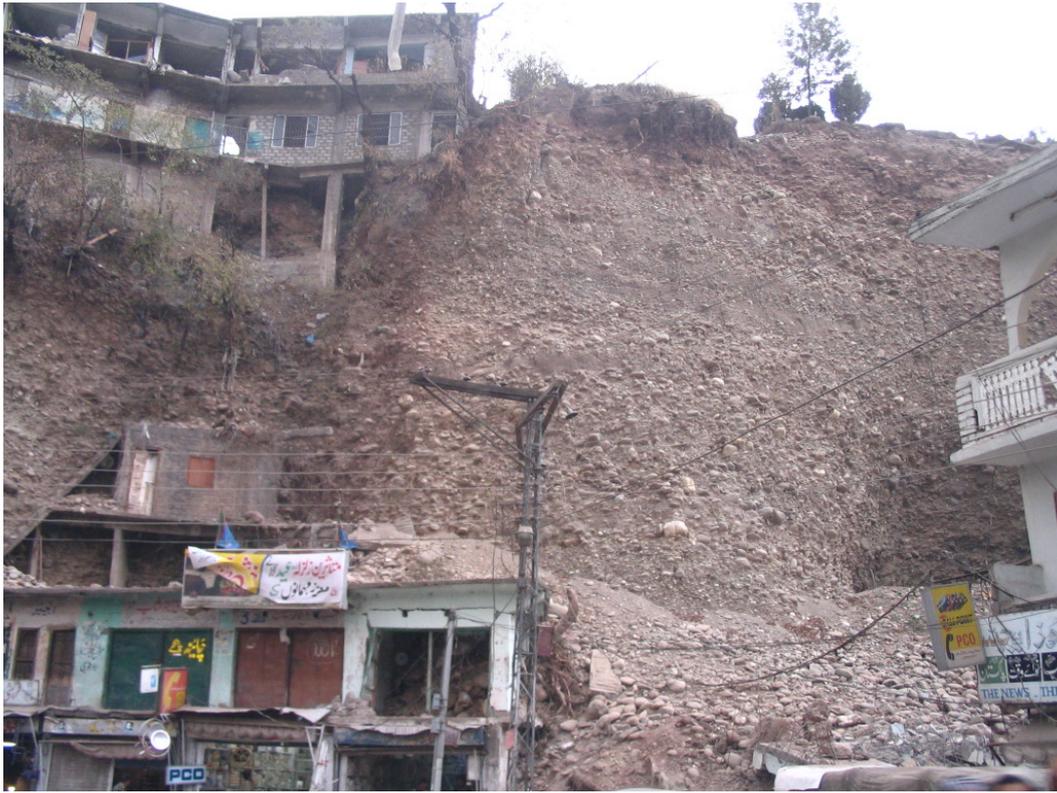
Figure 4.18: Slope failure burying and extensively damaging the commercial building below and destabilising the residential structure above, Muzaffarabad

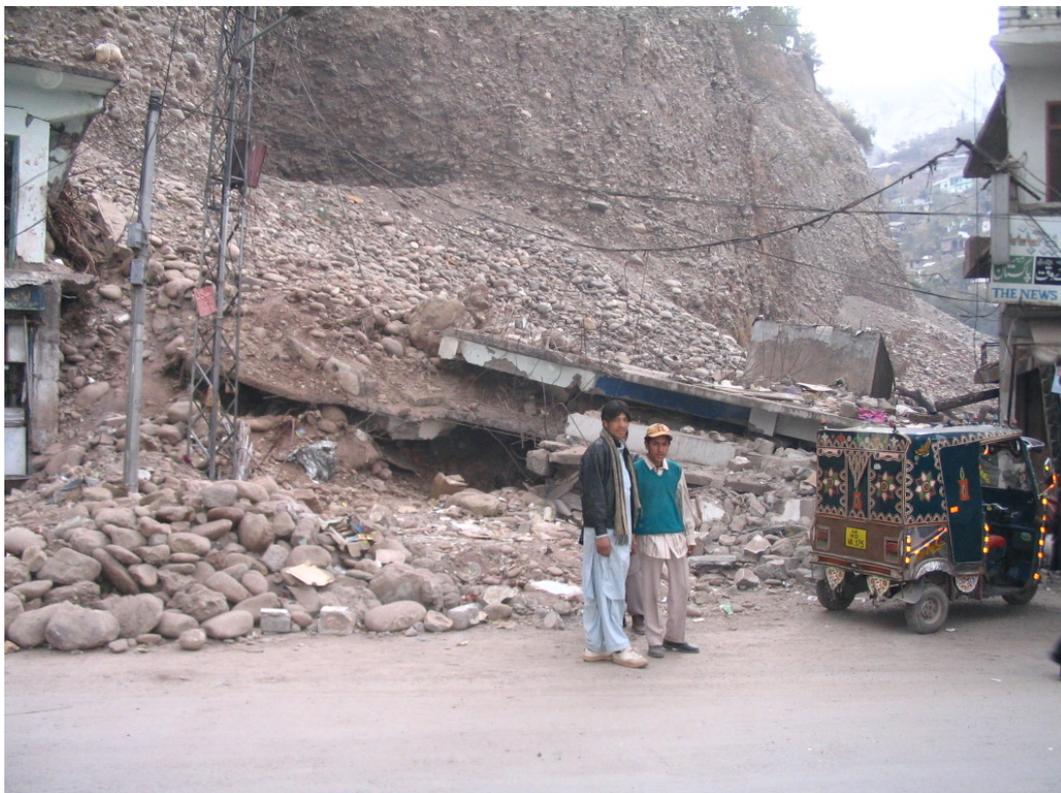
Figure 4.19: Collapsed and buried commercial building from the soil and rock due to the slope failure shown in Figure 4.18, Muzaffarabad

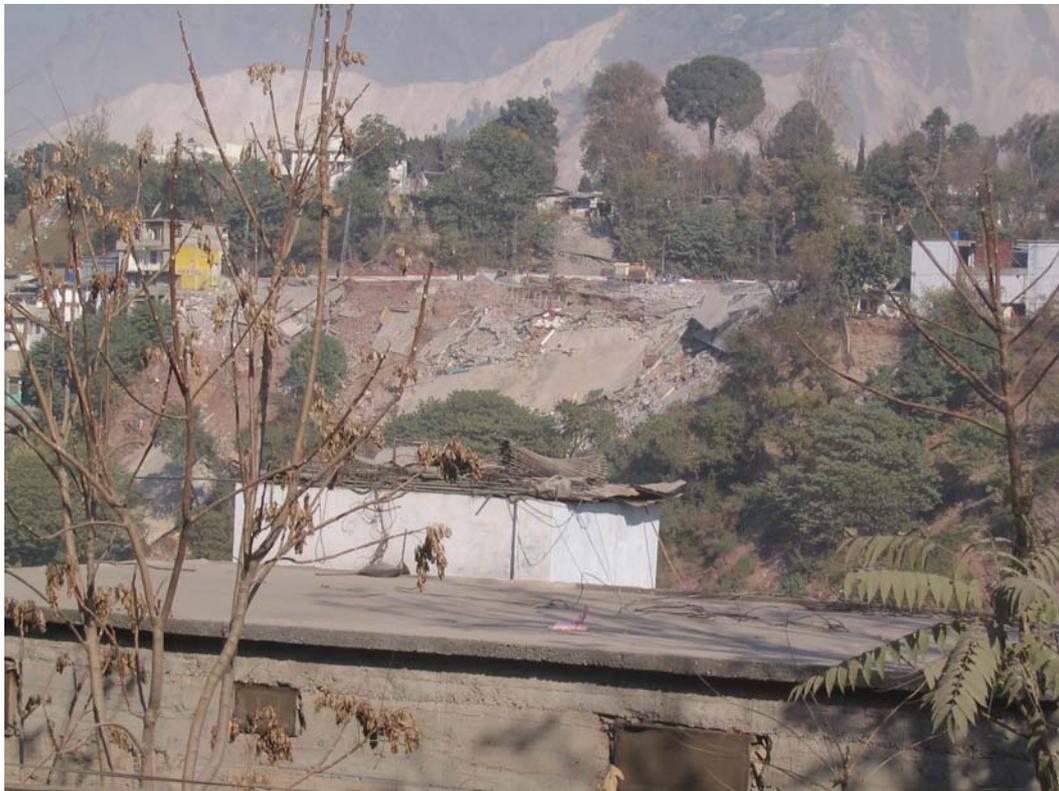
Figure 4.24: Collapsed concrete retaining wall section in Muzaffarabad leaving the road above vulnerable to further collapse

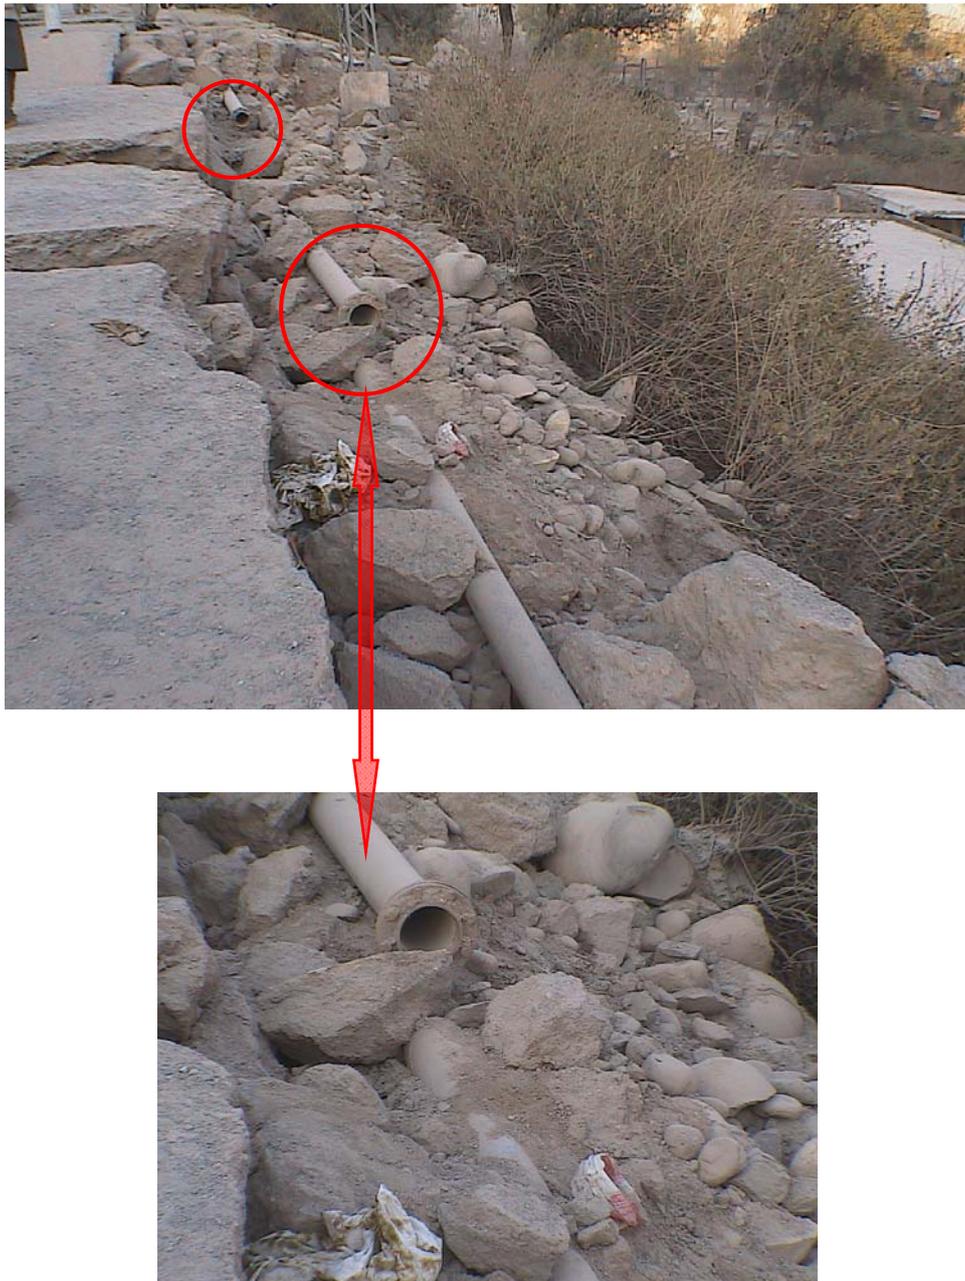
Figure 4.39: Smaller geotechnical failures: ruptured cast iron water pipe adjacent to the cracked and subsided road visible in the foreground of Figure 4.5

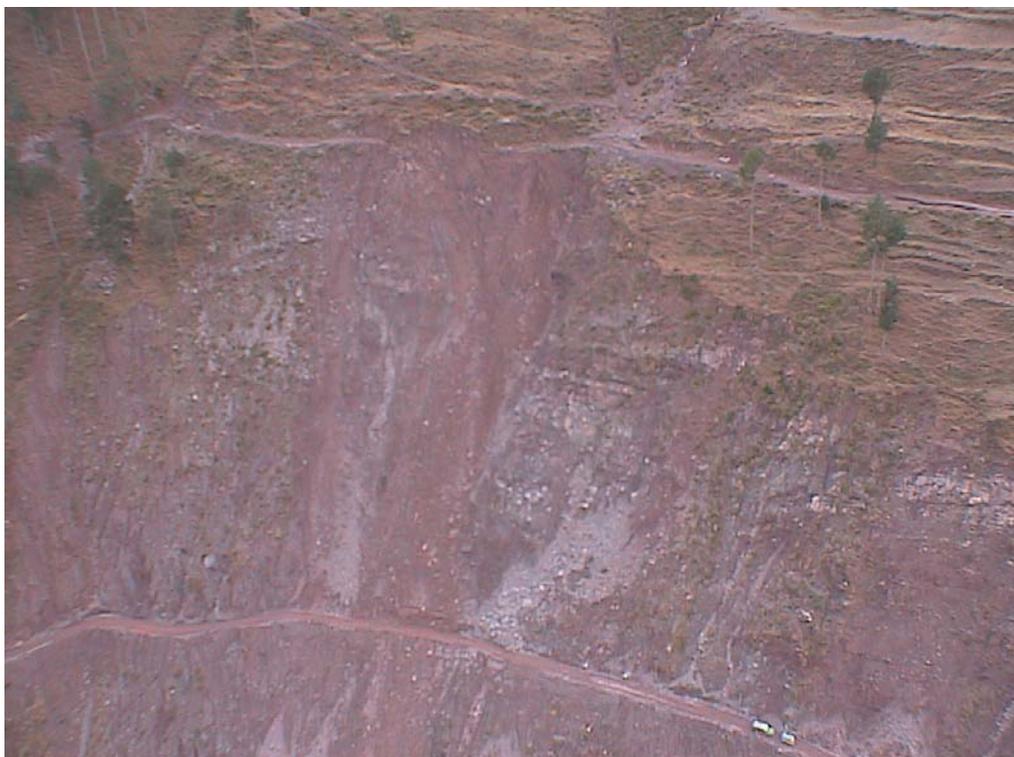
Figure 4.43: Agricultural terraces slipping down steep terrain and valley-side road, all threatened by landslide, near Dhanni Nelam (Dhanni Nelam-Islamabad flight)

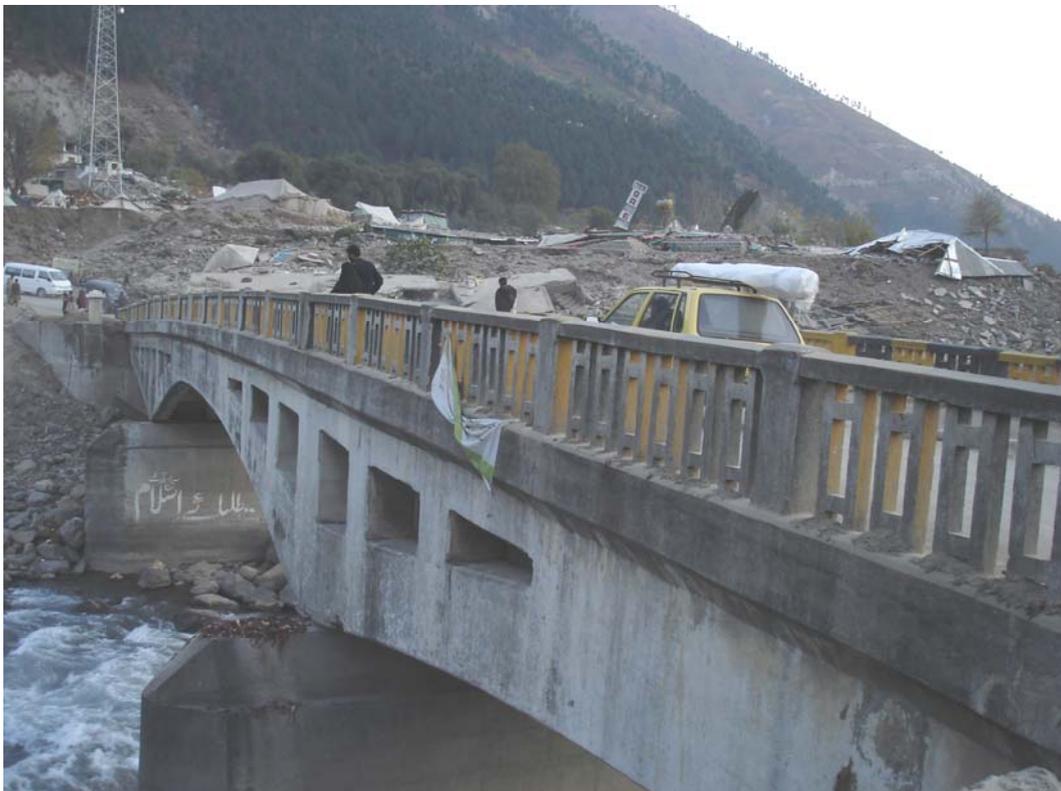
Figure 5.1: Laterally displaced RC deck of the vehicle bridge in Balakot

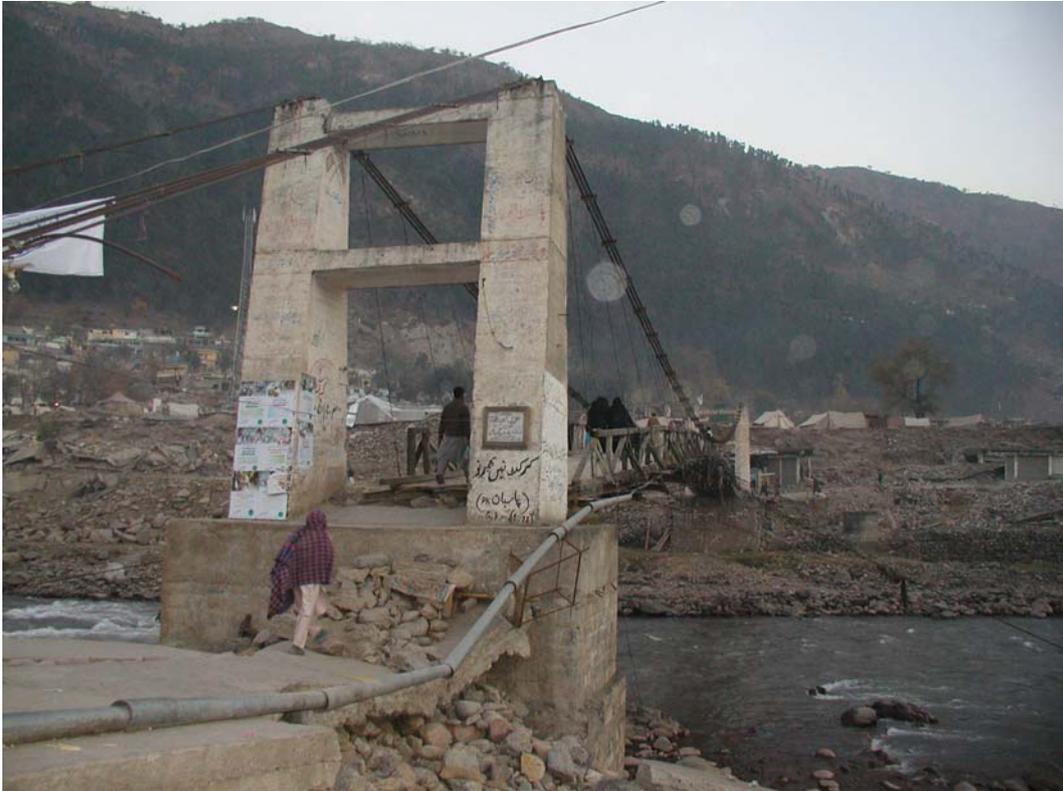
Figure 5.2: Pedestrian bridge with damaged approaches in Balakot

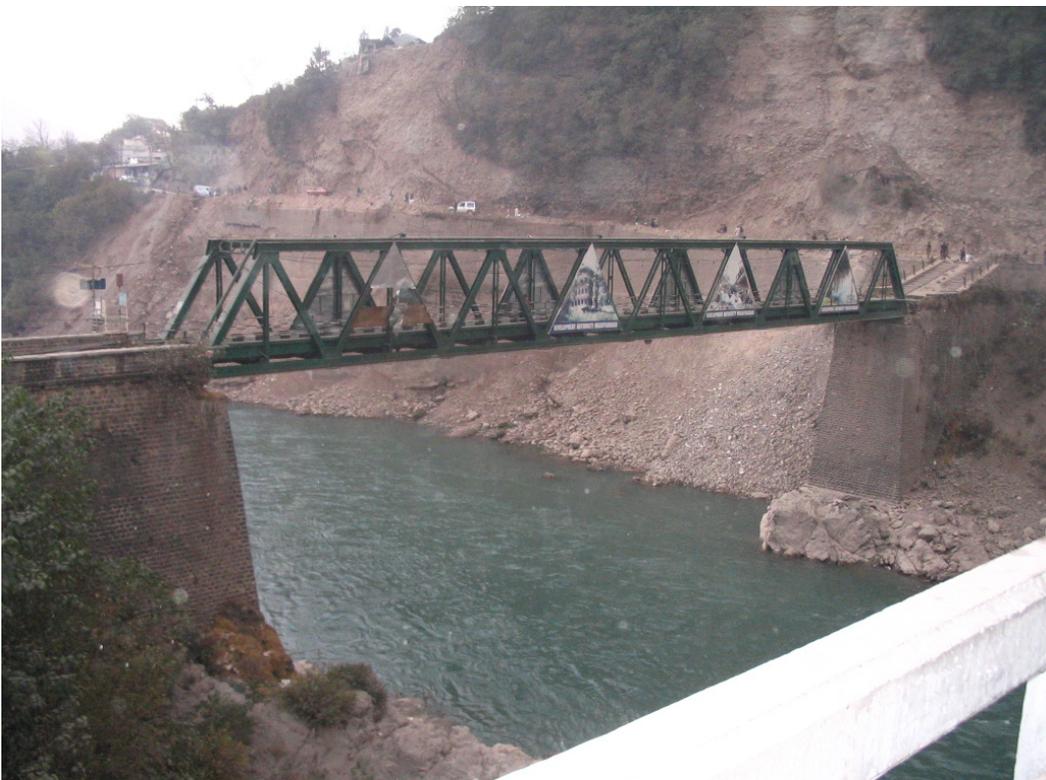
Figure 5.8: Slightly damaged pedestrian bridge across Nelum River, Muzaffarabad. Steel truss single span simply supported on brick masonry abutments

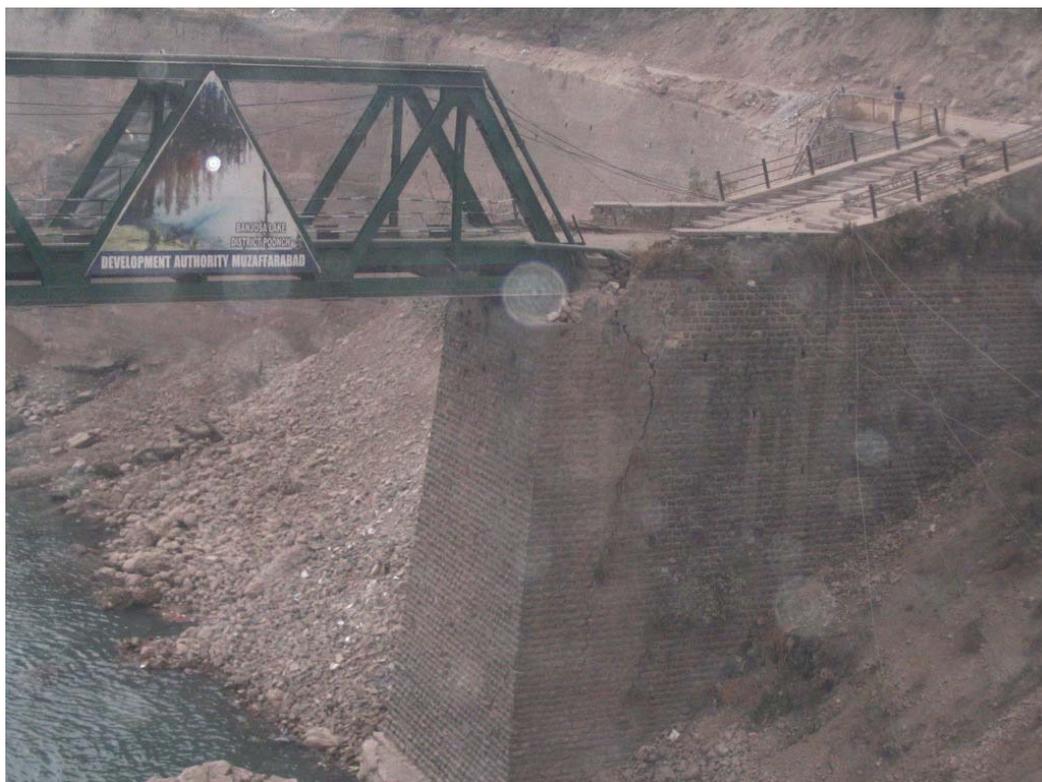
Figure 5.9: Crack at one of the masonry abutments of the pedestrian bridge shown in Figure 5.8

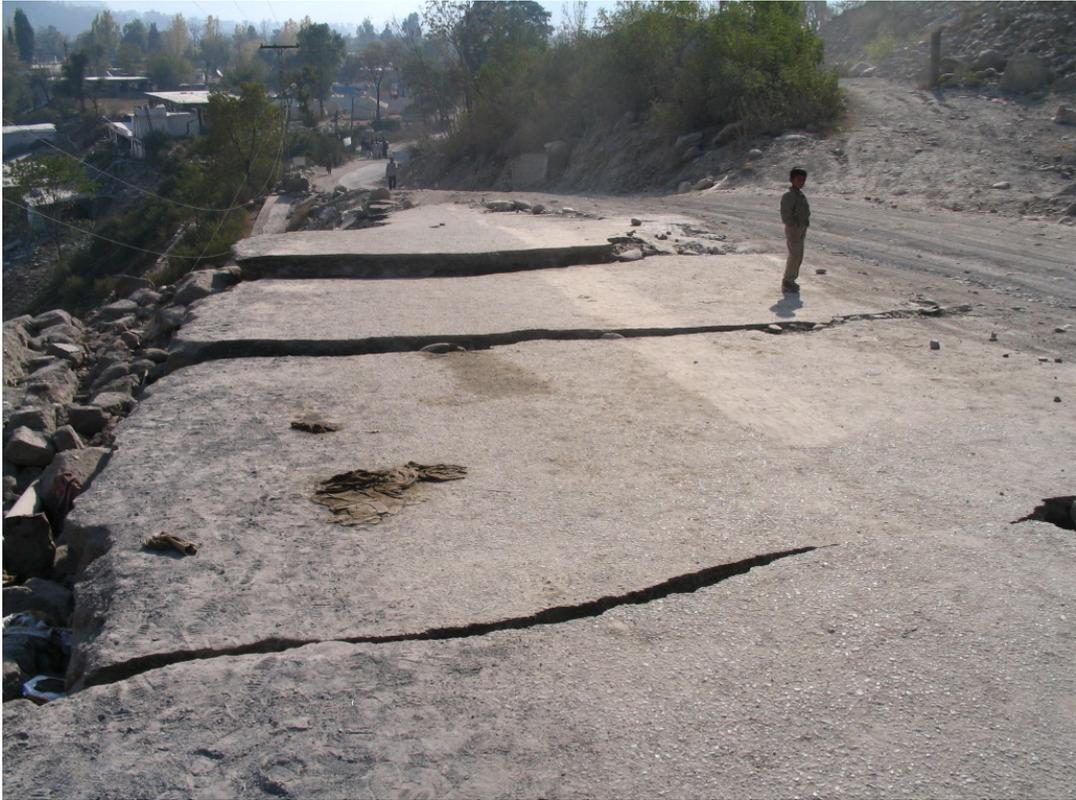
Figure 5.10: Ground cracks through a road in Muzaffarabad

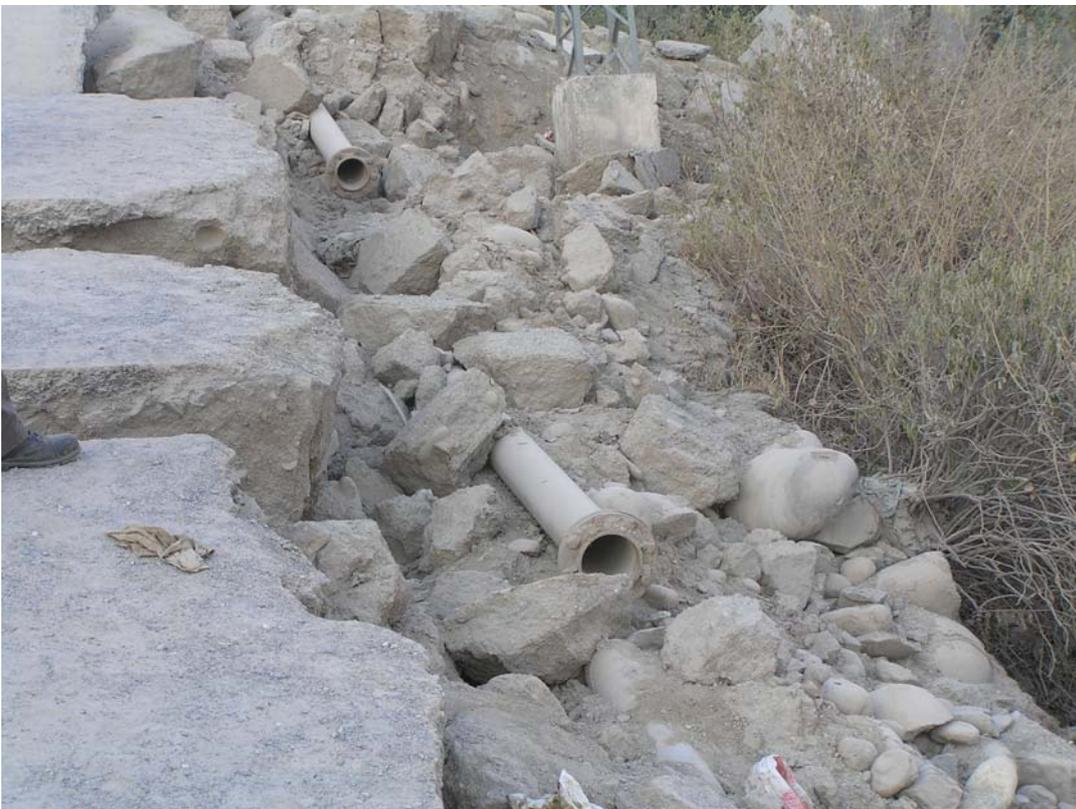
Figure 5.11: Separated segments of a water supply system due to ground cracks, Muzaffarabad
