PV cell and module degradation, detection and diagnostics

Eleni Kaplani

RES Lab, Mechanical Engineering Dept., Technological Educational Institute of Western Greece,
Meg. Alexandrou 1, Patra-26334, Greece
ekaplani@teiwest.gr

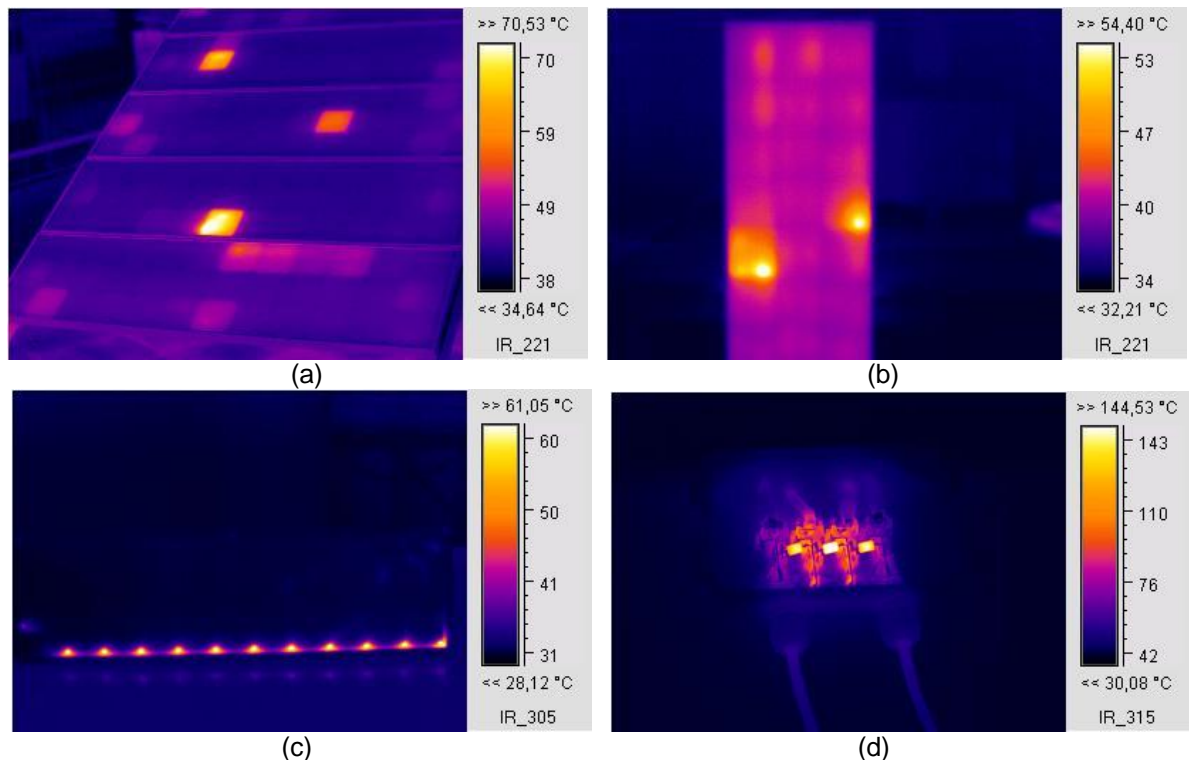
Infrared (IR) thermography is a powerful tool for the location of defected cells or cell areas that exhibit higher or lower localised temperature than the remaining part of the module or cell respectively. Fig.2(a) shows the IR image of several modules of a PV generator operating in field conditions for 20 years. The IR image is captured by means of an IR camera with spectral range 7.5 to 14 μm . Hot cells operating in temperatures of 20° to 30°C higher than the average temperature of the remaining part of the module are visible. Such large temperature differences signify defected cells. IR thermography may also be taken in the dark with the module forward-biased using a DC power supply. Fig.2(b) shows a sc-Si PV module with 20 year outdoor operation tested in the lab. The IR image reveals two cells having a hot spot at the busbar. By reverse-biasing the module in the dark it is possible to check diode functionality. Fig.2(c) shows the IR image of a flexible a-Si PV module with bypass diodes connected across each of the 11 cells, and Fig.2(d) shows the junction box of a pc-Si PV module reverse-biased showing the operation of the three diodes.

Fig.2. Infrared thermography of (a) a sc-Si PV generator operating at load in the RES Lab for 20 years, (2) a sc-Si PV module forward-biased in the dark within the lab, (c) a flexible a-Si PV module reverse-biased in the lab, (d) the junction box of a pc-Si PV module reverse-biased in the lab.

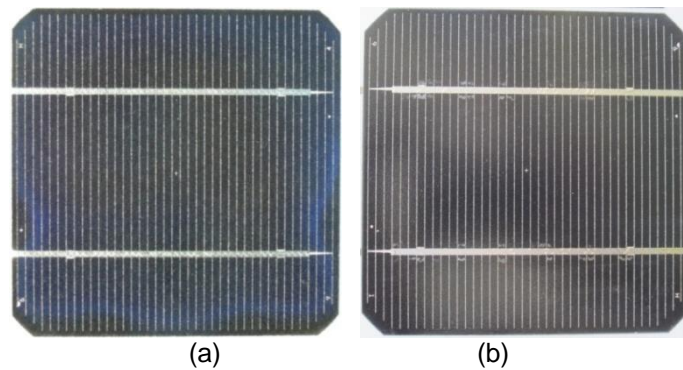
A sc-Si PV module operating outdoors for 15 years exhibits mild signs of AR deterioration and degradation in the cell-encapsulant interface at the proximity of the busbars, see Fig.6. IR thermography shows a rather uniform temperature distribution of the module with only one cell exhibiting higher temperature by about 10°C from the average temperature of the module, Fig.7(a). EL imaging further reveals cells with several interrupted grid lines, Fig.7(b).

Fig.6. sc-Si PV module operating outdoors in the RES Lab for 15 years exhibiting mild signs of degradation of the (a) AR coating, (b) the cell-encapsulant interface.

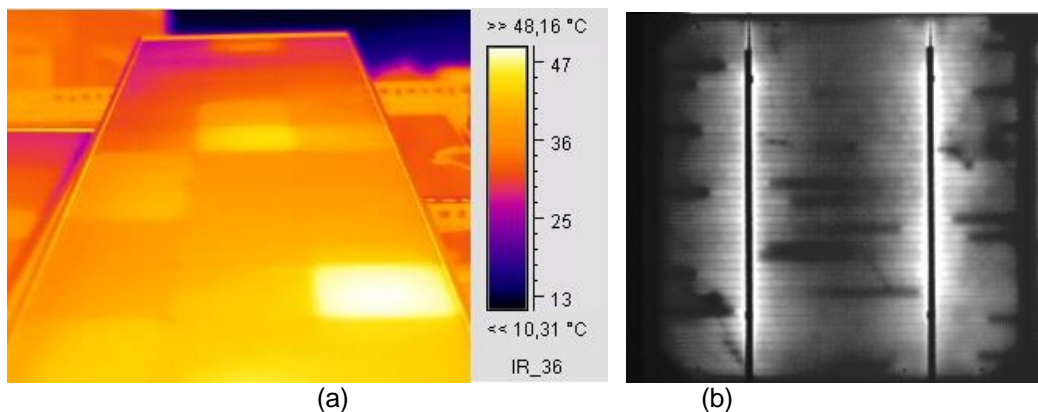
Fig.7. sc-Si PV module operating outdoors in the RES Lab for 15 years exhibiting mild signs of degradation (a) IR image (b) EL image of one of the cells

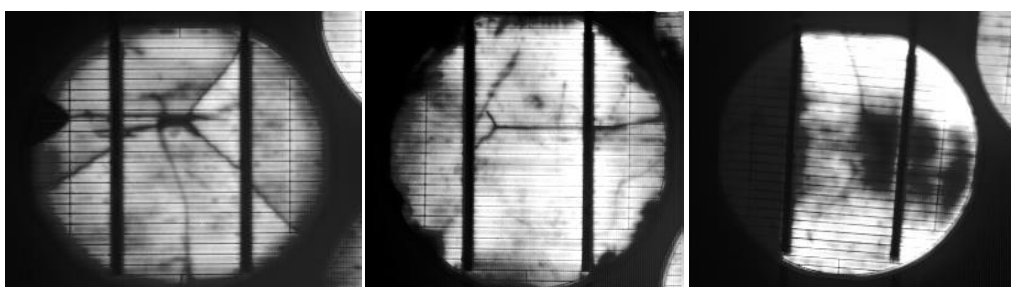
Other sc-Si PV modules operating outdoors in the RES Lab for 24 and 25 years, and have aged naturally, exhibit a rather uniform temperature distribution (Fig.9(a)). Further investigation through electroluminescence reveals the existence of cracks in several cells, some of which isolate a part of the cell, inactive areas and inhomogeneous EL emission, Fig.9(b),10.

Fig.10. EL image of cells from the module in Fig.9 exhibiting cracks

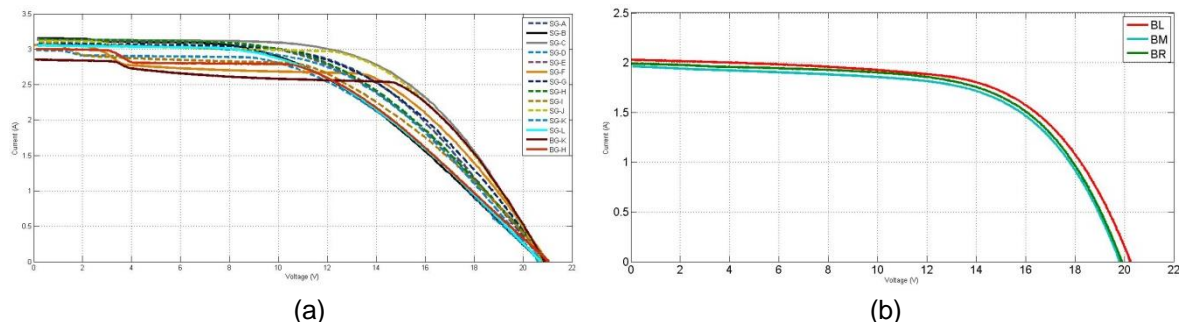
An estimate of the degradation of the 20 and 25 year old PV modules experiencing induced and natural ageing respectively is carried out through I-V curve analysis. The STC normalised I-V curves of the modules that experienced induced shading effects in the past are displayed in Fig.11(a). Large deviations in the I-V curve characteristics are observed in this modules, some of which reveal the

existence of some optically degraded cells, while others reveal an increased series resistance due to corrosion, as regarded in the slope of the curve at open circuit voltage. The relative reduction in power output ranges between 25%-41%, in the short circuit current 6%-15%, in the open circuit voltage 3%-5% and in the fill factor 12%-34%. On the other hand, the naturally aged 24-25 year-old modules have non-deformed I-V curve characteristics, with relative reduction in the fill factor of only 4%-5%. The relative reduction in power output ranges between 20%-25%, which is mostly attributed to the short circuit current with a relative reduction of 13%-15%. This is only partly due to the optical losses caused by the severe EVA browning that affects all cells of the module (Fig.3(a)), but is also due to the several cracks and inactive areas in the cells revealed by the EL image. The reduction in the open circuit voltage is in the range of 5%-7%.

Fig.11. STC normalised I-V curves (a) 20 year-old modules with induced shading effects, (b) 24-25 year-old modules with natural ageing.
