# Degradation in Field-aged Crystalline Silicon Photovoltaic Modules and Diagnosis using Electroluminescence Imaging

E. Kaplani

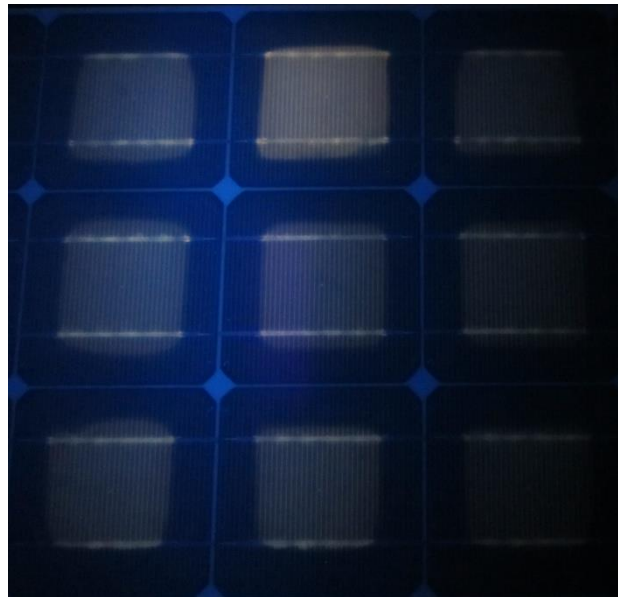
Visual inspection is a simple procedure for the detection of most defects, from early signs of delamination and AR degradation. EVA browning may be detected by illuminating the module with UV light at 375nm [2,9]. In Figure 1 the pattern of EVA browning in a 15 year old sc-Si PV module is revealed through UV light illumination.

Figure 1: sc-Si PV module illuminated with UV light at 375nm revealing EVA browning in its cells.

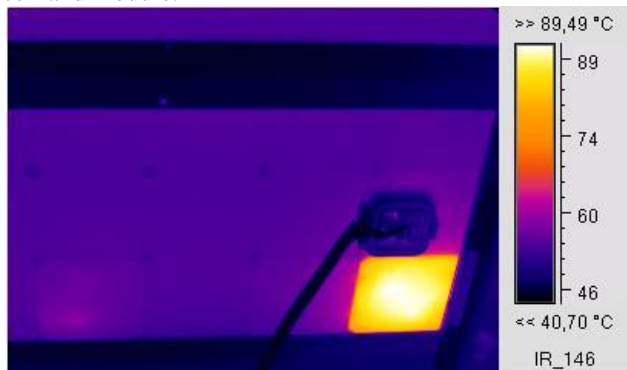
Defects that give rise to hot spots, such as resistive bus-bars and contacts, often due to corrosion, are located using IR thermography. The IR image of a 20 year old sc-Si PV module that had experienced degradation through induced shading for a prolonged period [8] is shown in Figure 2. The IR thermography was captured with an IR camera with spectral range 7.5 to 14 $\mu$ m. The cell affected by extensive EVA browning exhibits temperature difference of more than 30 $^{\circ}$ C from the neighbouring cells of the module. Temperature differences in this range cause large mismatch and further severe degradation of the affected cell and module.

Figure 2: IR thermography taken from the back of a PV module during operation exhibiting a hot cell.

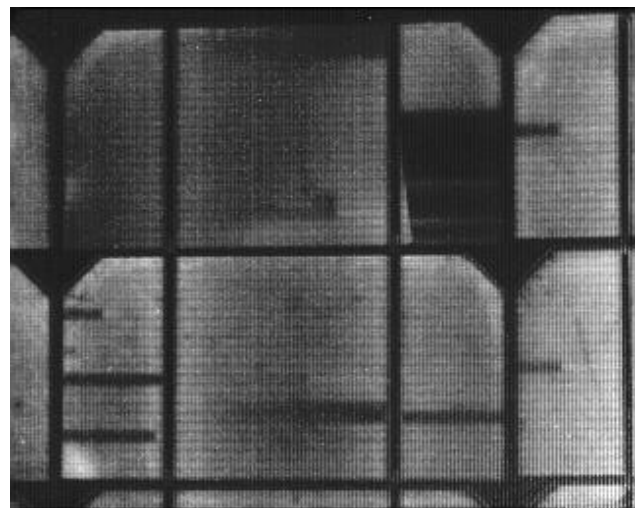
Figure 3: EL image of part of a PV module with several hundred hours of field operation.

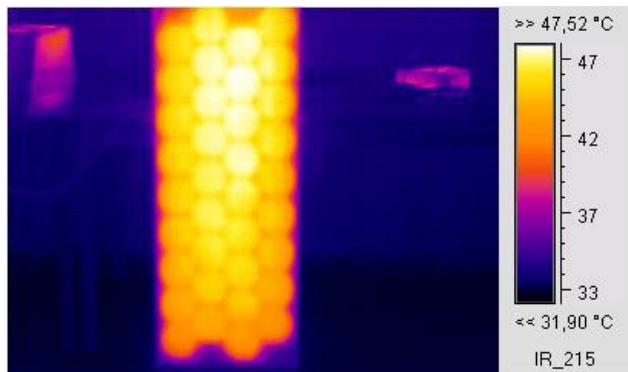
The IR thermography of a 25 year old sc-Si PV module captured in the dark under forward-bias as seen in Figure 5 suggests a uniform degradation of the module. The module exhibits extensive EVA browning covering almost the entire cell surface of all cells in the module. The EL image of the module reveals several micro-cracks, shunts, in-active regions and non-uniform EL emission (Figure 6). I-V characterisation of the PV module resulted in 25.7% reduction in the STC normalised  $P_m$ , with a 16.7% reduction in the STC normalised  $I_{sc}$ . The reduction in current mainly attributed to the extensive EVA browning. However, the existence of shunts, several micr-cracks and in-active regions explains the further reduction with an average power degradation of 1%/year. This is realised by a reduced shunt resistance of 110 Ohm for the above module and a series resistance of 1.05 Ohm.

Figure 5: IR thermography of a PV module in the dark under forward-bias.

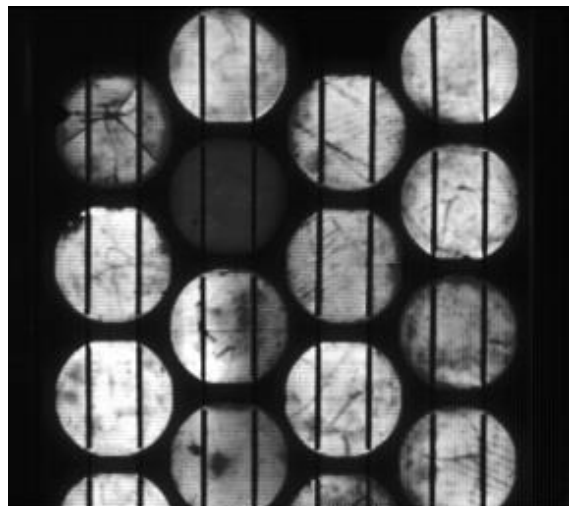
Figure 6: EL image of sc-Si PV module exhibiting micro-cracks, in-active regions and inhomogeneous EL emission.

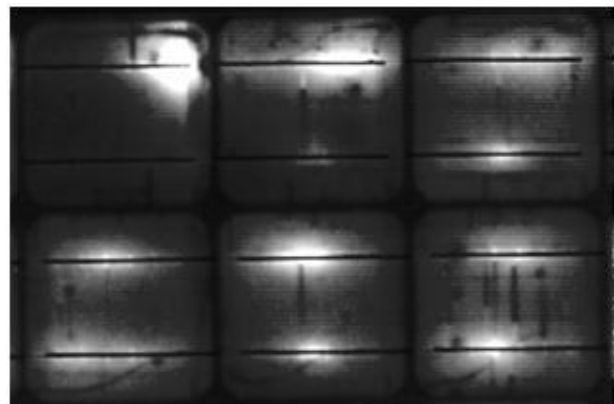
A severely degraded sc-Si PV module with a defected cell exhibiting EVA browning and corrosion on the bus-bar and contact is detected in the EL image in Figure 7, along with other defects including interrupted gridlines, shunts and micro-cracks in the neighbouring cells. The corrosion on the bus-bar appears in the IR thermography with an extreme hot spot exhibiting temperature 40°C higher than the average temperature of the module (Figure 8).

Figure 7: EL image of a severely degraded sc-Si PV module.

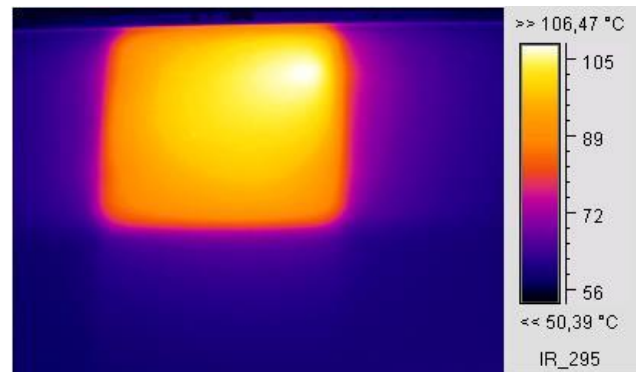
Figure 8: IR thermography revealing extreme hot spot in the severely degraded cell appearing in the top left part of the sc-Si PV module in Figure 7.
