River bank erosion rates and the case for willow spiling as a bank stabilisation solution

Lenka Anstead MSc

Submitted for the degree of Doctor of Philosophy

**School of Environmental Sciences
University of East Anglia, UK**

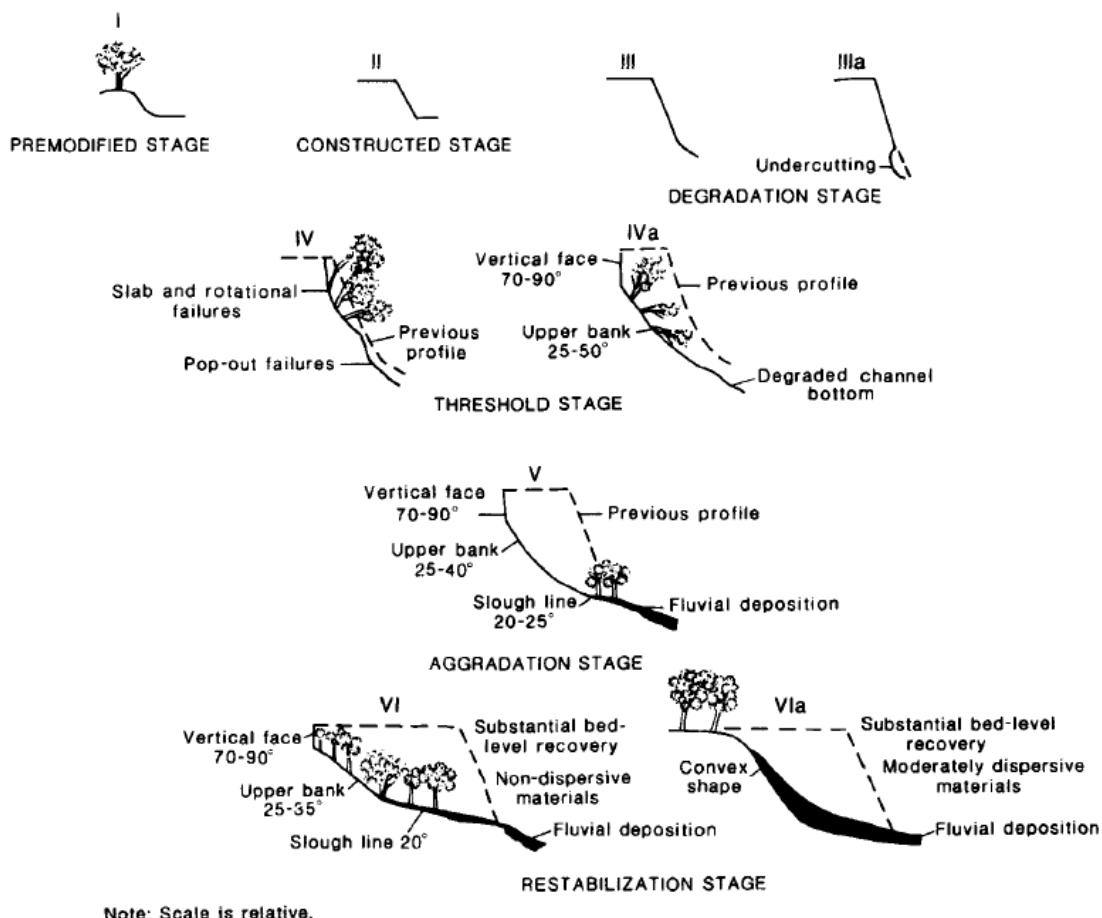
Fig. 2.1.1 Six channel evolution stages for unstable streams (Simon 1989a).

Because river channels undergo a systematic series of morphological changes over time, historical, current and future channel processes can be described according to the phases of channel evolution that lead towards self-stabilisation (Hupp & Simon 1986; Simon 1989a; Rosgen 2001). Six stages have been identified by Simon (1989a) for unstable channels: (1) Premodified; (2) Constructed; (3) Degradation; (4) Threshold; (5) Aggradation and (6) Restabilisation stages (Fig. 2.1.1 & Table 2.1.1).

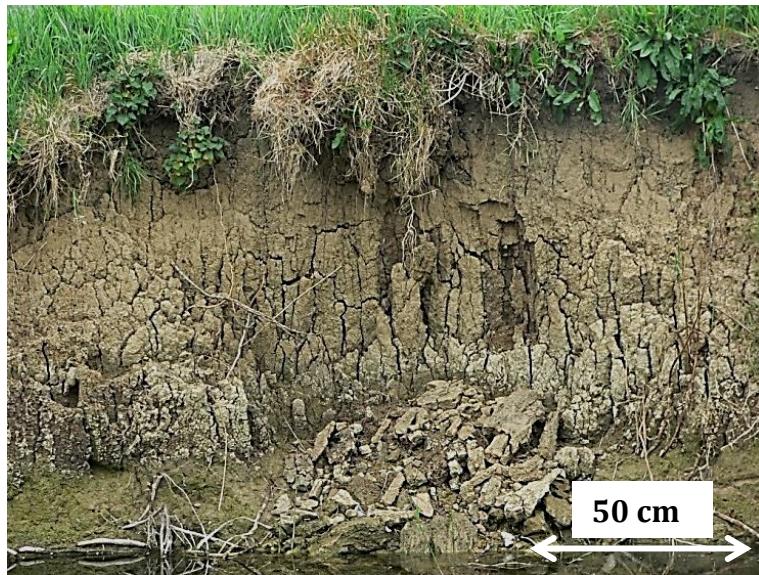
Fig. 2.2.1 An example of river bank with ped fabric structure that has numerous desiccation cracks, on the River Stour in East Anglia (Chapter 1, Fig. 1.1.1). The actual size of peds will be an indication of the mechanical properties of the material (e.g. larger peds would normally be associated with higher cohesive strength).

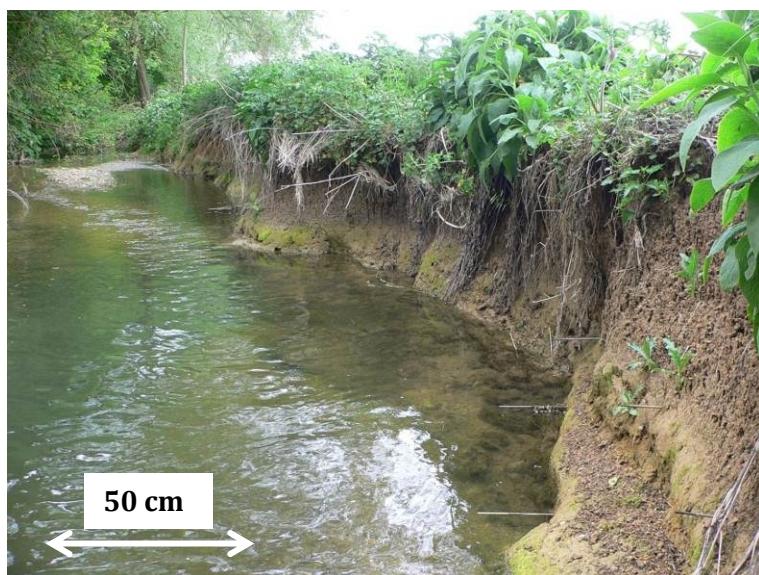
Fig. 2.2.2 Signs of fluvial erosion illustrated by the exposed erosion pins, research site on the River Stour in East Anglia (Fig. 1.1.1), May 2009.

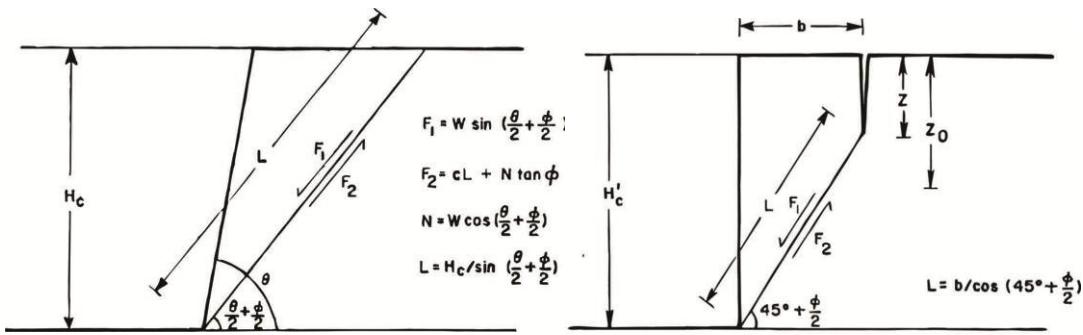
Fig. 2.2.4 Culman's stability analysis for plane slip failure on the river bank (left) and the stability analysis modified to account for effects of tension crack (right), (Thorne 1982).

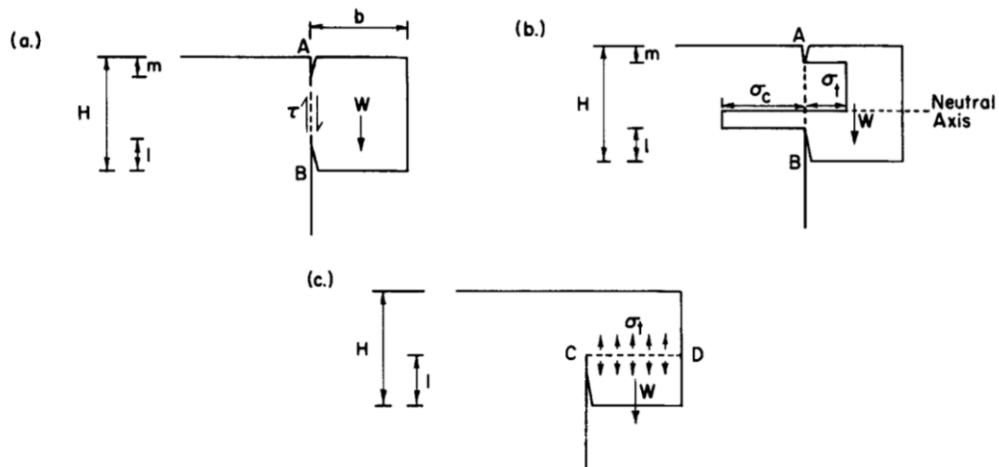
Fig. 2.2.5 Forces of weight, shear, compression and tension acting on a cantilever with regard to the three modes of failure: (a) shear failure (b) beam and (c) tensile failure. Individual stability equations apply for each type of cantilever failure (Thorne & Tovey 1981).

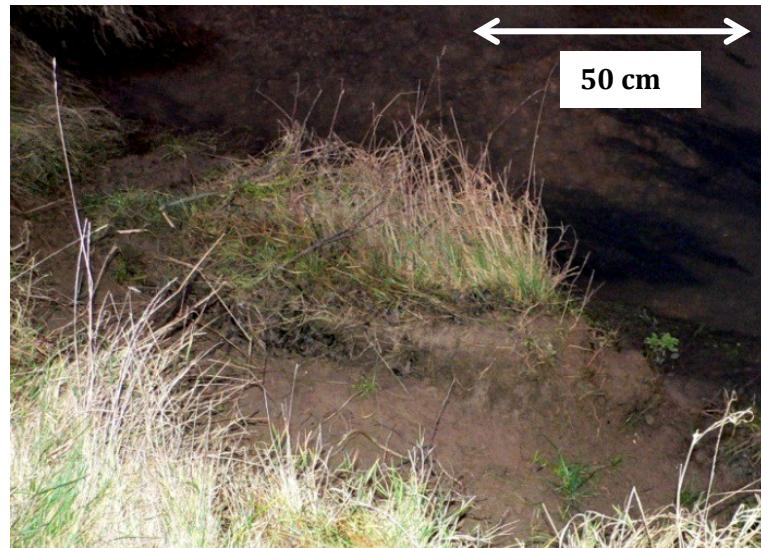
Fig. 2.2.6 An example of a recently failed cantilever on the River Stour in East Anglia (Chapter 1, Fig. 1.1.1), February 2009.

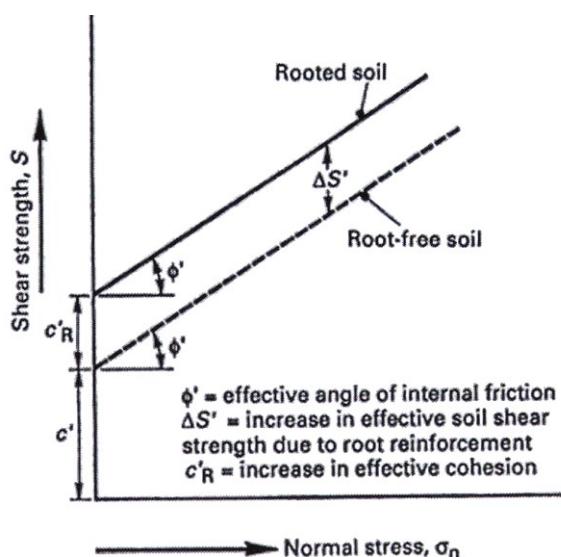
Fig. 2.4.1 Contribution to soil cohesion through the presence of root systems. Soil with roots has similar values for the angle of friction (ϕ) as soil without roots (Coppin & Richards 1990).

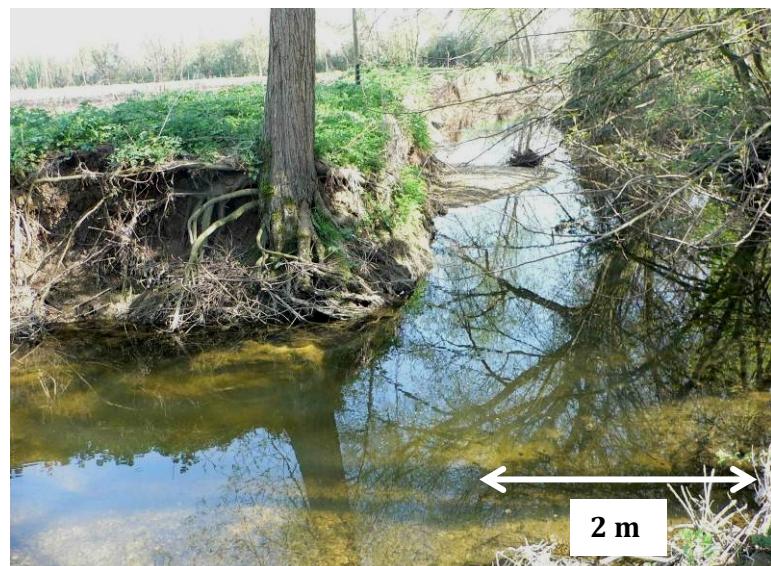
Fig. 2.4.2 Bank scour caused by back eddies scouring around the solitary tree trunk upstream of research site on the River Stour in East Anglia (Chapter 1, Fig. 1.1.1), May 2009.

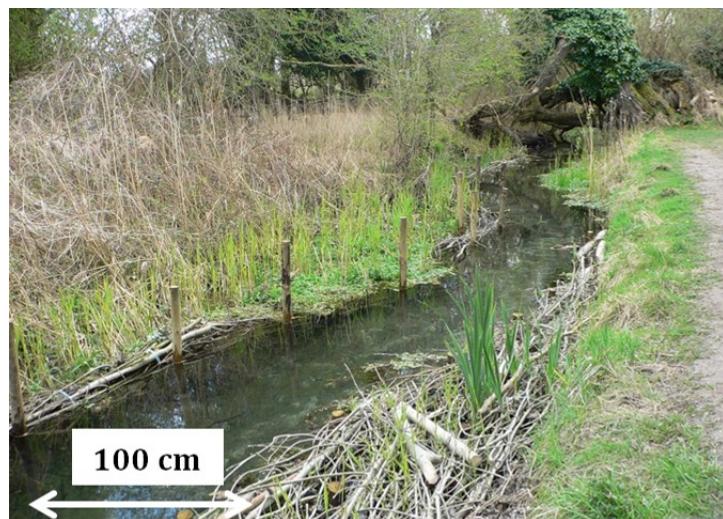
Fig. 2.5.1 Revetment using willow stakes, hazel faggots and reeds for river narrowing and habitat improvement, the River Shep, Cambridgeshire (TL384473), April 2008.

Ecologically, soil bioengineering methods offer a natural restoration solution (Gray & Sotir 1996; Schiechtl & Stern 1997) and enhance the aesthetic value of a stream (Ree & Palmer 1949; Parsons *et al.* 1963; Schiechtl & Horstmann 1980), (Fig 2.5.1). The most commonly used ground bioengineering methods are described by Schiechtl and Stern (1997) and Hemphill and Bramley (1989). Schiechtl and Stern (1997) used their experience of observing vegetative protection measures on banks of rapidly flowing watercourses in an Alpine region. Vegetation measures that can withstand the erosion forces of torrent streams were more likely to be effective for most erosive situations, including those stretches along spillways and below weirs. Gerstgraser (2000) built and tested common bioengineering methods on an artificial flume in the Austrian Alps, observing them fail or succeed.

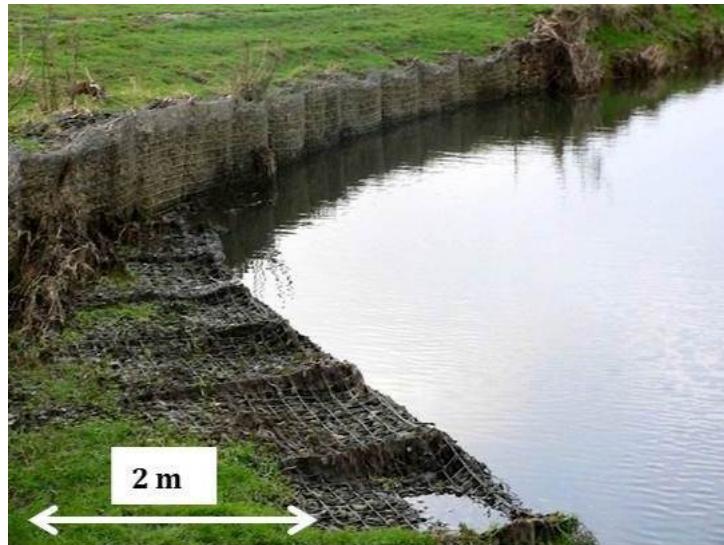
Fig. 2.5.2 Example of a two-tiered gabion revetment, flood relief channel upstream on the River Stour in East Anglia (Chapter 1, Fig. 1.1.1).

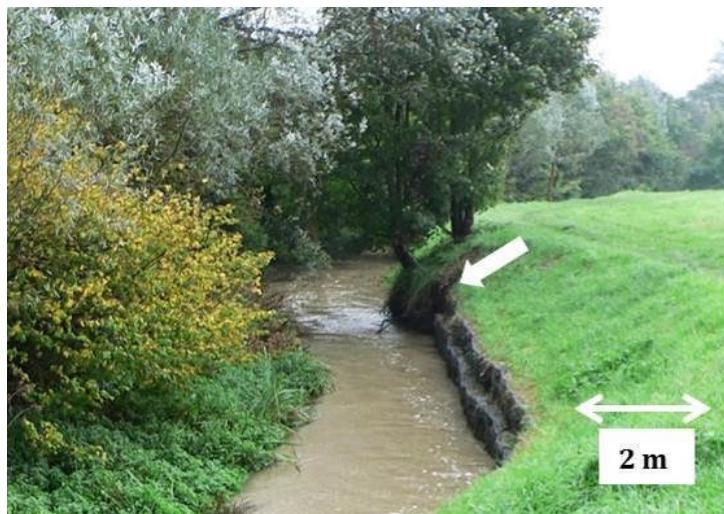
Fig. 2.5.3 Gabion revetment on the River Stour (Chapter 1, Fig 1.1.1). The arrow points to the location of a large scour at the end of the revetment. Note also the sliding tree that is falling into the channel.

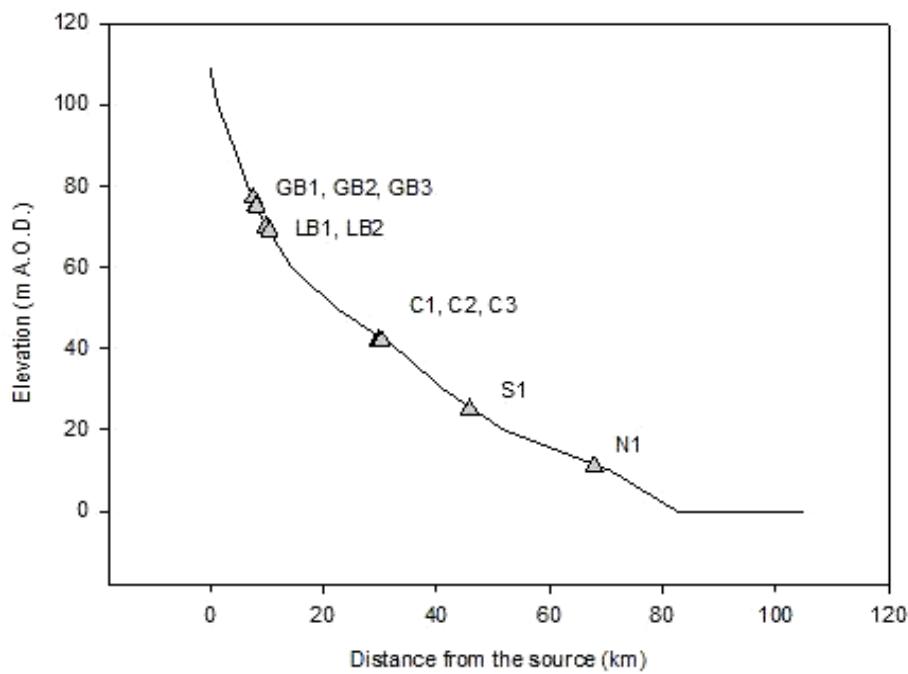
Fig. 3.1.2 Long profile of the River Stour showing positions of the field sites. (Based on data from the analysis of OS 1:10 000 maps.)

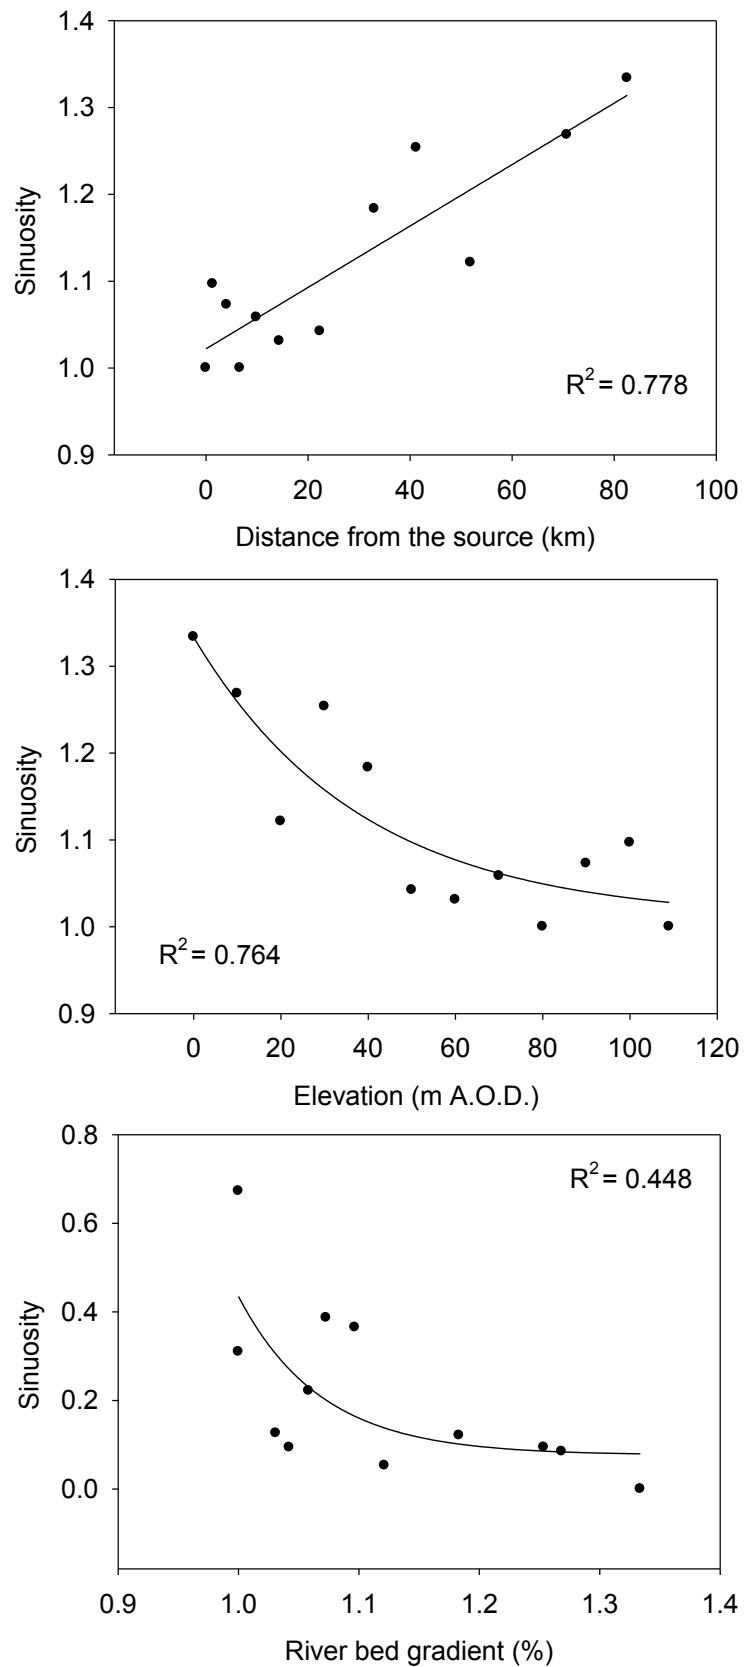
Fig. 3.1.3 River sinuosity versus distance, elevation and river bed gradient based on 10 m elevation contour intervals. (Based on data from analysis of Ordnance Survey 1:10 000 maps).

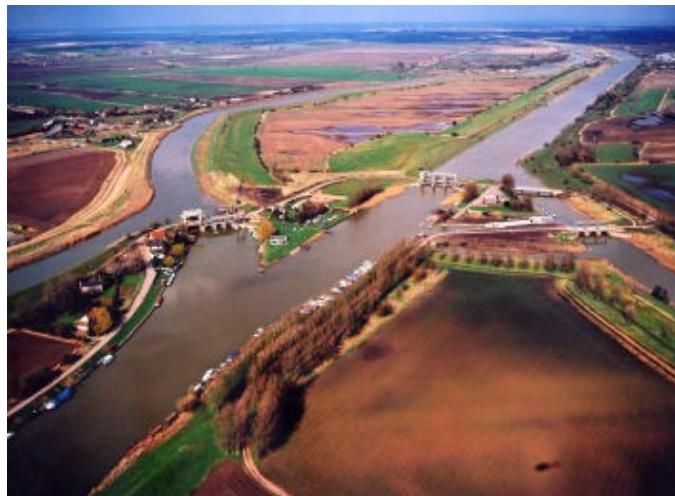
Fig. 3.1.5 Aerial view of the Denver Complex in Norfolk (ESW 2011).

The water that supplies the scheme comes from the River Great Ouse. It is transferred to the flood protection scheme 'Cut-off Channel' at Denver *via* a complex that sends water in the opposite direction (Fig. 3.1.5).

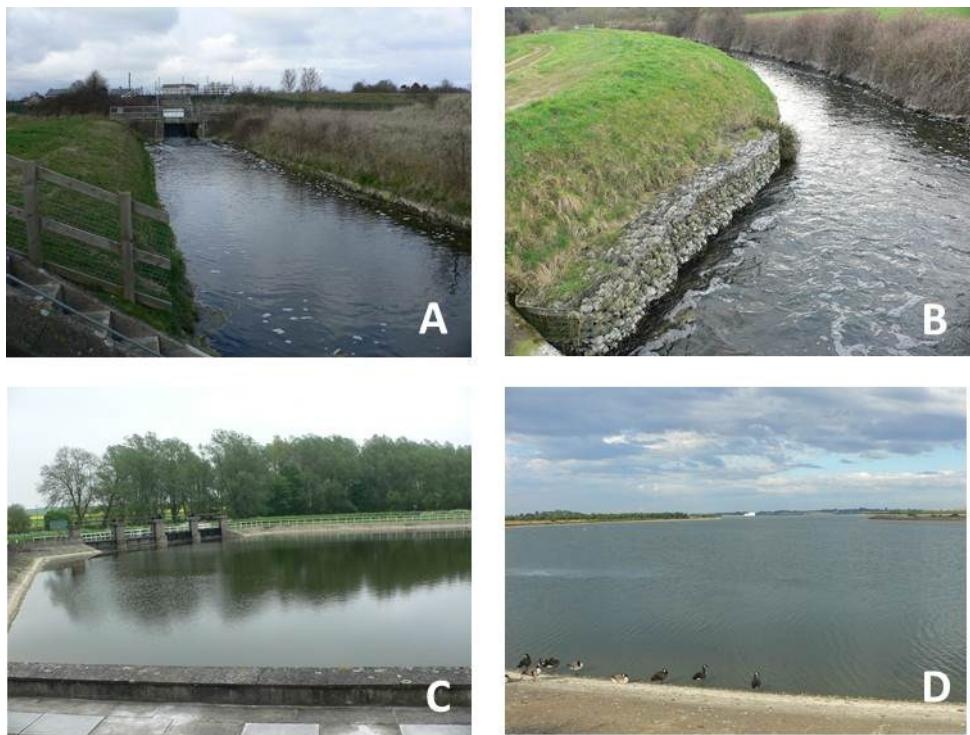
Fig. 3.1.7 The Stour part of the Ely Ouse to Essex Water Transfer Scheme (EOETS): (A) Outfall from the Kirtling pumping station, looking upstream; (B) Kirtling channel with weirs taking the water down to the River Stour, looking downstream, (C) Wixoe pumping station hexagonal reservoir and (D) The Abberton reservoir.

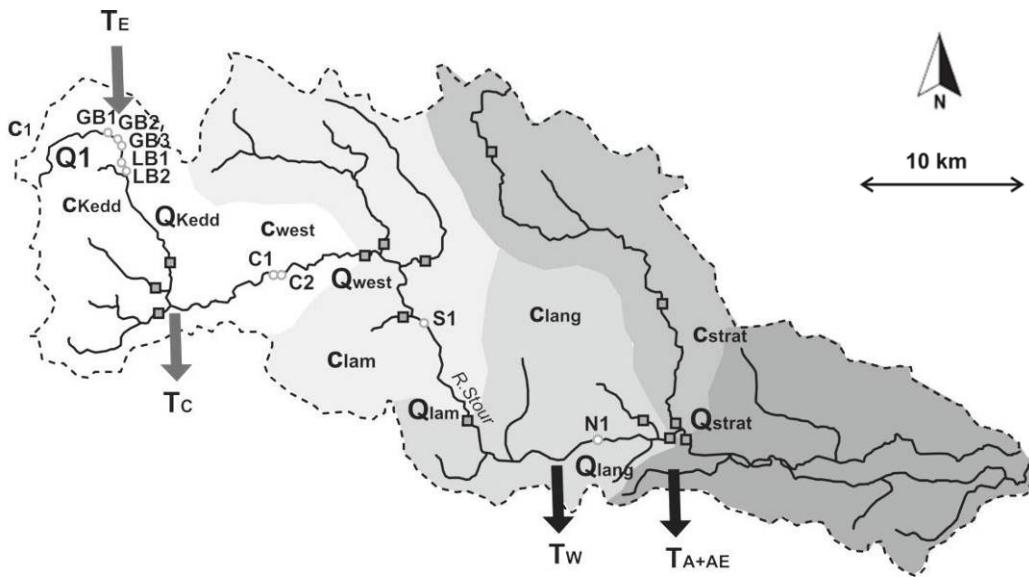
Fig. 3.1.9 Schematic contribution of the water transfer to each sub-catchment (for legend see Table 3.1.2).

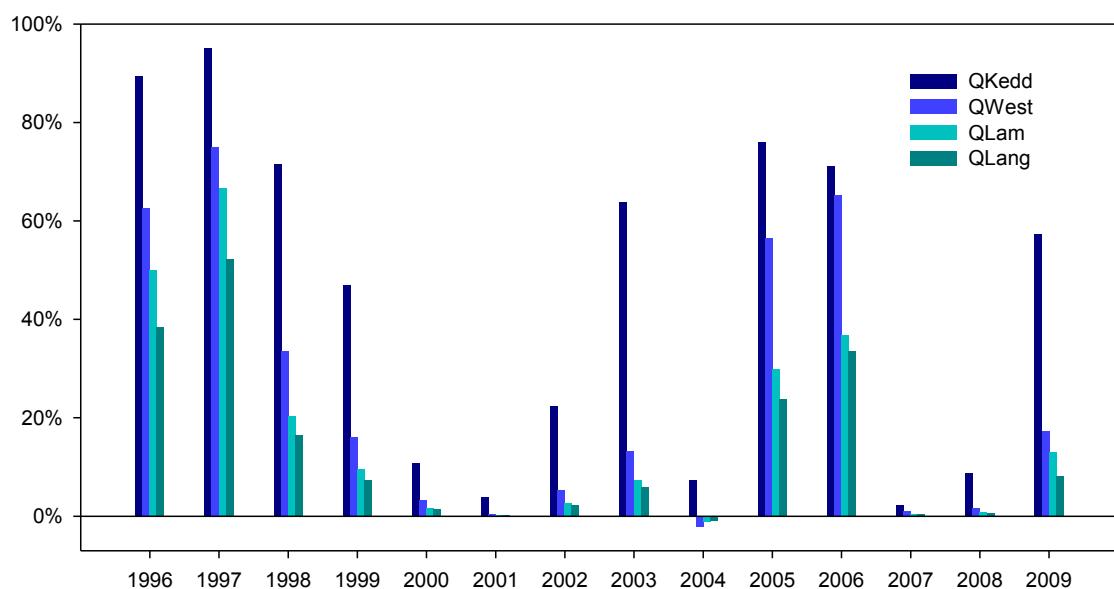
Fig. 3.1.10 Contribution of transferred flows to the overall flows, based on total amounts in ML/year. Q_{Kedd} is the annual discharge at Keddington, Q_{West} at Westmill, Q_{Lam} at Lamarsh and Q_{Lang} at Langham gauging stations (Data were derived from raw mean daily discharges provided by the Environment Agency).

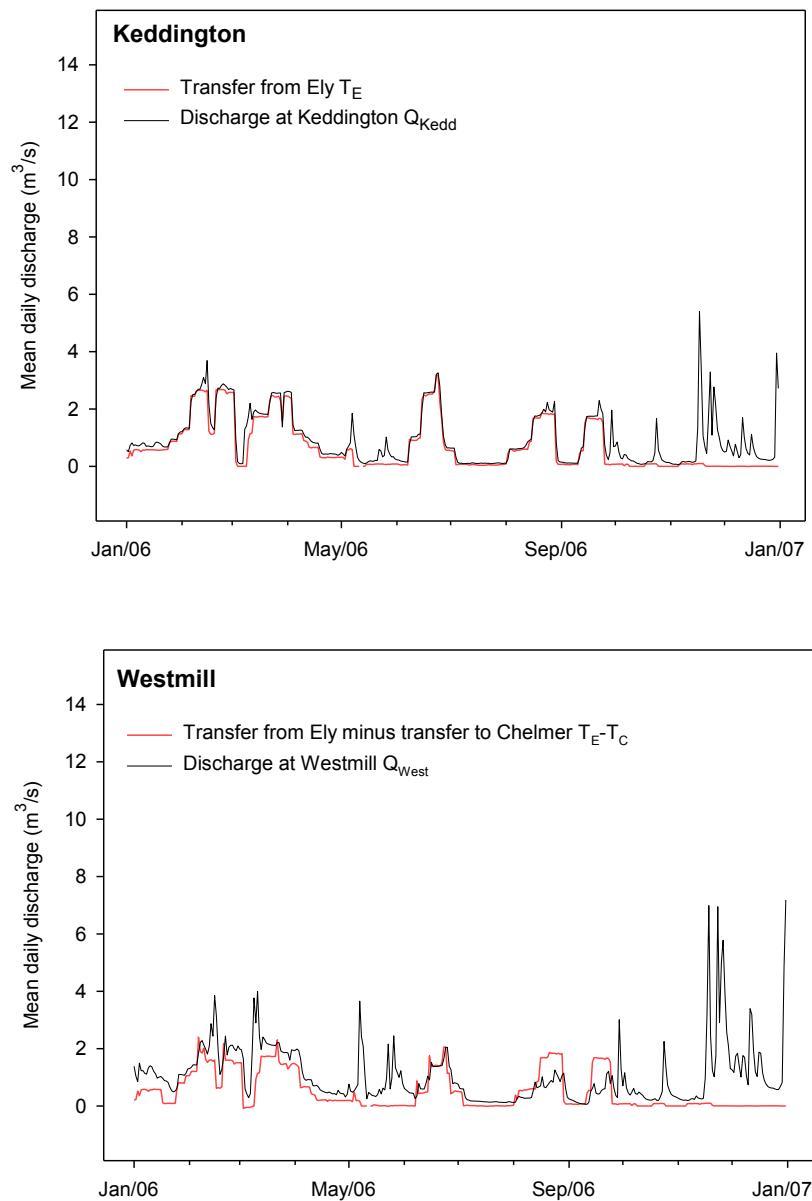
Fig 3.1.11 Transferred flows and natural river flows (represented as mean daily discharge) at Keddington and Westmill stations. (Plots based on data for mean daily discharge provided by the Environment Agency).

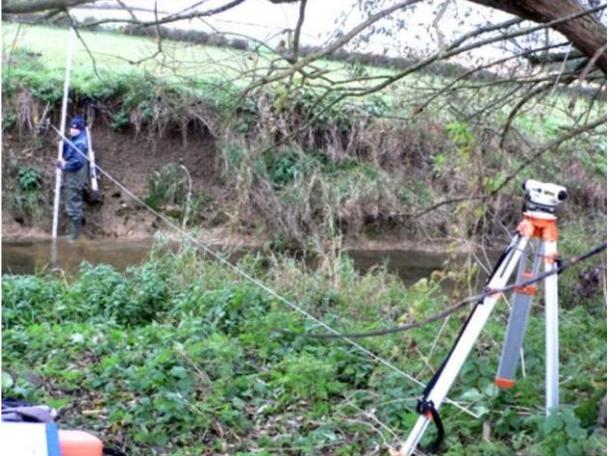
GB3
(OS GR 567442, 253472)

- Site is situated 70 m downstream of GB2 on a slight bend north-east of Great Bradley.
- Subject to impact of full water transfers.
- Planform geometry similar to the GB2.
- Land on both banks arable, footpath on the edge of outer bank, narrow buffer zone.
- Right bank is nearly vertical.
- Cantilever failures are the most typical.
- Bed is varied in depth and type of substrate, narrow riffle section at entry of site changes into pool section.
- Outer bank foot is heavily silted. Inner bank is less steep with large herbaceous vegetation.
- Land on both banks is arable but with narrow buffer strip.

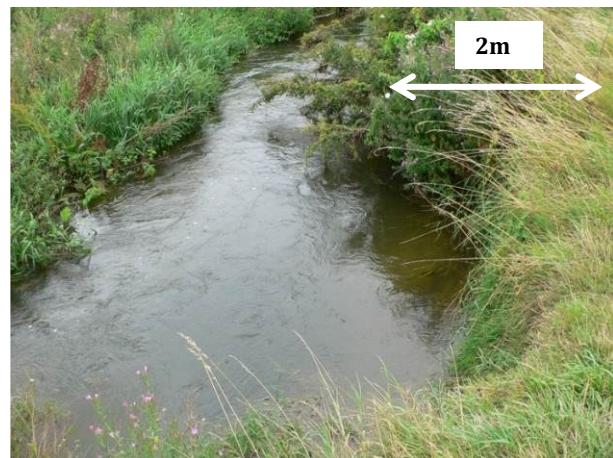
LB1
(OS GR 567928, 252034)

- Site situated 200 m upstream of a weir close to the village of Little Bradley.
- Signs of straightening in the past (prior to 1886) but now starting to meander.
- Wide channel with large gravel bar and >2 m deep pool at the entry section of the site.
- Bed profile changes from pool into narrow step alongside a bar and a riffle.
- Bare banks are exposed to weathering and fluvial entrainment.
- Prolonged water transfers have possibly created a 'dent' in the outer bank.
- Outer bank is arable close to the edge, inner bank is set to mixed tree plantation.

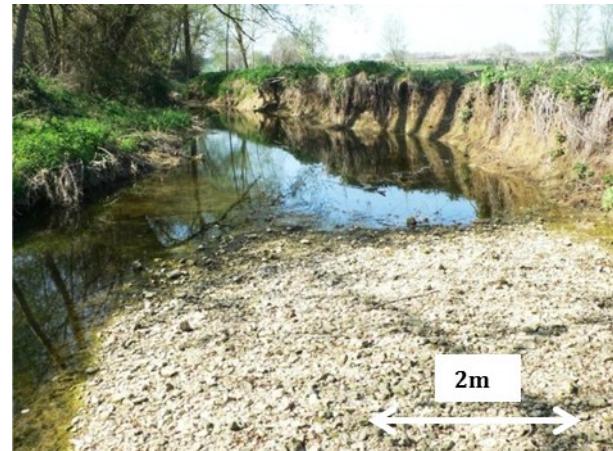
LB2**(OS GR 568028, 251468)**

- Site located on a narrower stretch 400 m downstream of a weir south of Little Bradley and close to Little Thurlow to the south.
- Channel planform appears artificial, similar to LB1.
- Left bank is naturally steep and high supported by woody vegetation.
- Right bank (monitored) low but nearly vertical and less stable with common occurrence of cantilever failures.
- Riffle at the entry section of the site.
- Large gravel bar in the channel is possibly a result from accumulation of materials used for restoring some spawning gravels upstream of the site (T. Barratt, personal communication 2006).
- Gabion baskets installed on two stretches upstream of the site.
- Right bank is grassland and left bank is steep with bushy and tree vegetation.

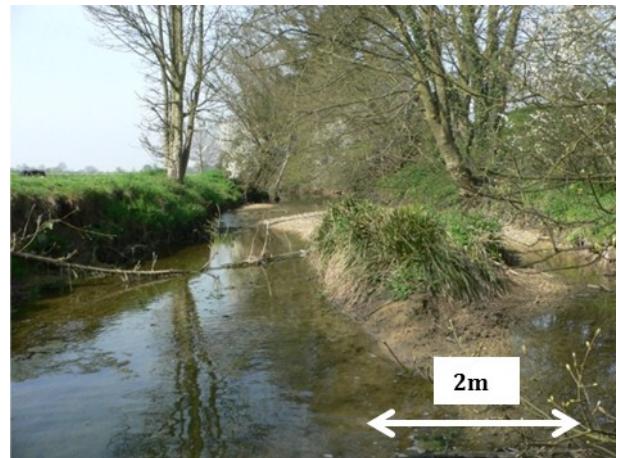
**C1****(OS GR 577571, 244979)**

- Growing meander bend 350 m located downstream of flood gate situated south of the village of Clare.
- Section of river that carries flows reduced by extraction at Wixoe (Q3).
- High and steep cohesive banks.
- No signs of overhangs or significant weathering.
- Bed varied with riffle at the entry section composed of fine gravel that transforms to deep pool section downstream.
- Large number of signal crayfish burrowing at this site.
- Inner bank is grassland and outside bank is arable but with 10 m strong buffer strip.

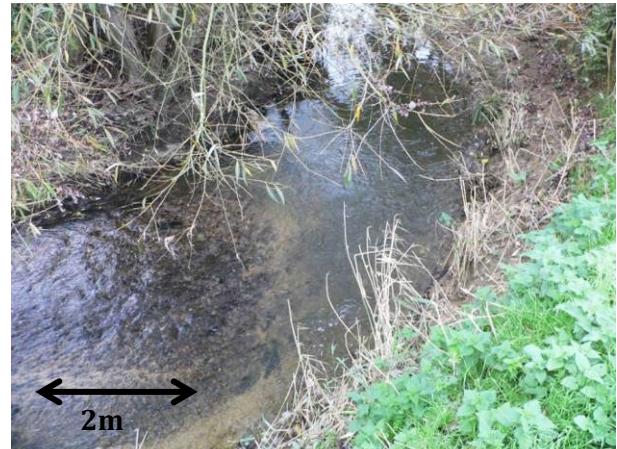
C2
(OS GR 577682, 244968)

- Site situated 220 m downstream of C1 on a large meander bend.
- Migrating meander approaching the stage of meander cut off and termination.
- Steep bare banks with signs of weathering and cantilevers.
- Fallen blocks of silty material visible at bank foot and on the riffle at the downstream part of the site.
- Bed is varied in depth but largely silted and no point bars are present.
- Entry and points of the meander are shallow while the middle reach is very deep and silted, therefore unsafe for wading any time of the year.
- Right bank is arable land with a 10 m wide buffer and left bank is grassland.

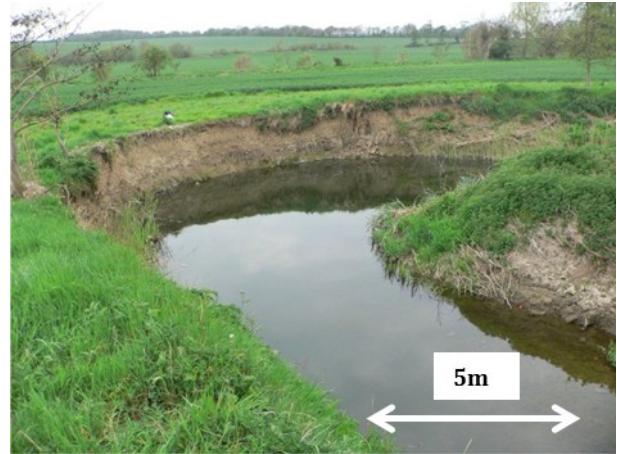
S1
(OS GR 586791, 241843)

- Site situated in the conservation area of water meadows near Sudbury.
- The flows are the natural and transferred flows minus the extraction at Wixoe (Q3).
- Channel straightened in the past, now recovering sinuosity by lateral erosion.
- Located on the main channel, about 100 m downstream of a weir.
- Banks made of layers of silt with varying clay content.
- Typical are cantilever failures and slumping.
- Bed varied with deeper stretch in the upstream section.
- Bed silted near the bank, otherwise chalk bedrock and gravel.
- Large gravel bar at the right inner bank. The gravel was introduced to river as part of the restoration project to support barbel (*Barbus Barbus L.*).
- Both banks used as grassland.
- Site taken on later in the project because of the ranger's interest and used as a willow spiling demonstration site (referred to as the 'cohesive site', Chapter 5).

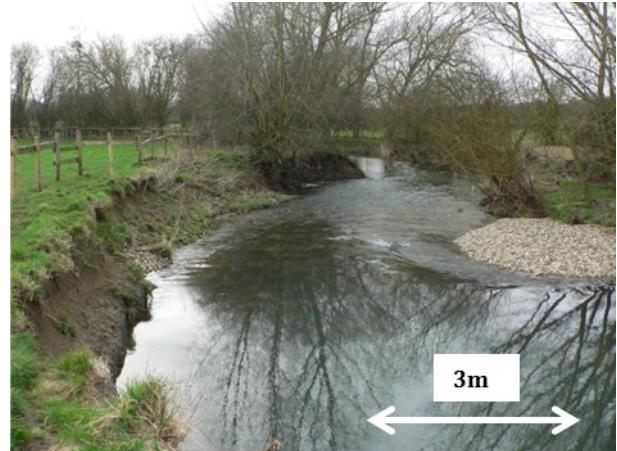
N1
(OS GR 597428, 233740)

- Site situated approximately 200 metres downstream from a confluence of the flood alleviation channel built in 1968 and the old Stour near the village of Nayland.
- Situated on a downstream end of large migrating meander.
- The only site with non-cohesive bank material seen on the river.
- Recent erosion rates very high (up to 1.3 m/year).
- High but less steep banks.
- Gravel bed varied in form and depth.
- Both banks are grassland.
- The site was taken on later in the project at landowner's suggestion and was used as the second willow spiling demonstration site (in Chapter 5 referred to as the 'non-cohesive site').

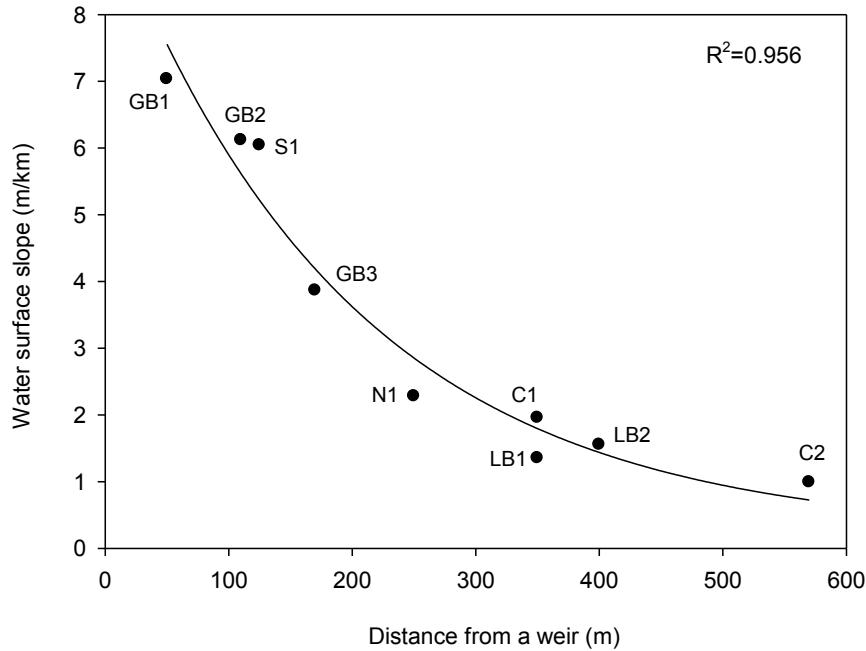
Fig. 3.2.1 Water surface slope relationship with increasing distance from the nearest upstream weir, based on nine field sites. The regression curve is a hyperbolic decay and the function is $f(y) = -7.91 + (2582.85 * 0.27) / (0.27 + x)$. (Probability of curve fitting is 95%).

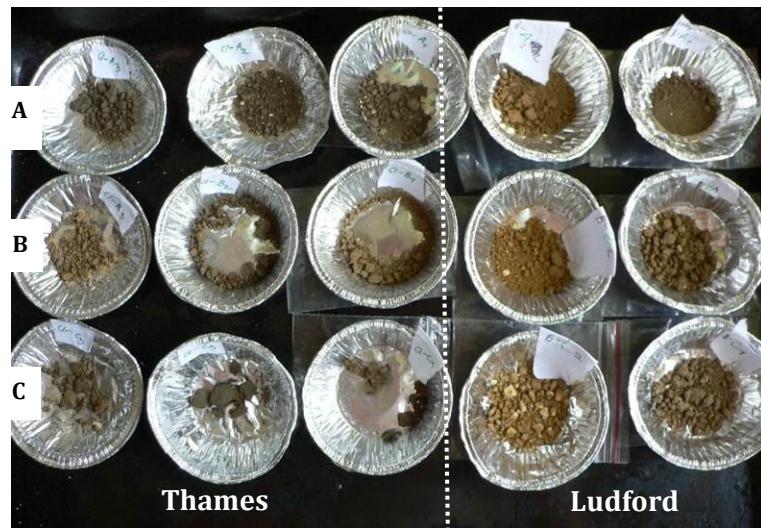
Fig. 3.2.3 Example samples from field sites in Clare (C1), left and Great Bradley (GB1), right illustrating the variability in texture and colour between the Thames and Ludford Associations. The samples are arranged into rows based on the section of the bank profile: bank top (A), middle (B) and bank foot section (C).

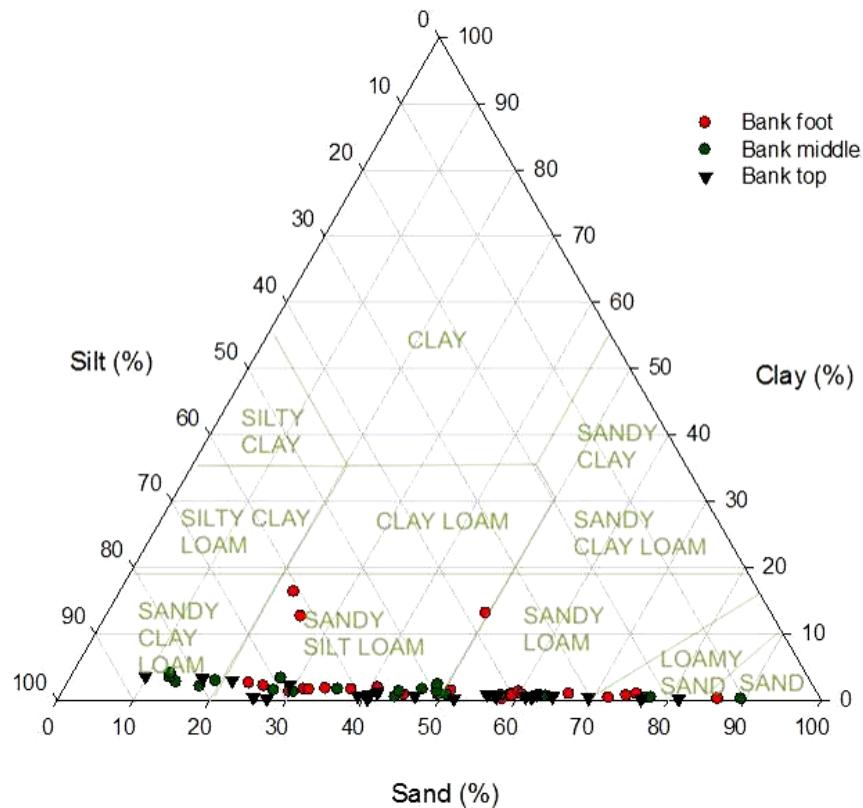
Fig. 3.2.5 Soil triangle for each of the soil samples taken from the bank top, middle and bank foot sections based on volumetric percentage of soil, silt and sand particles in the sample.

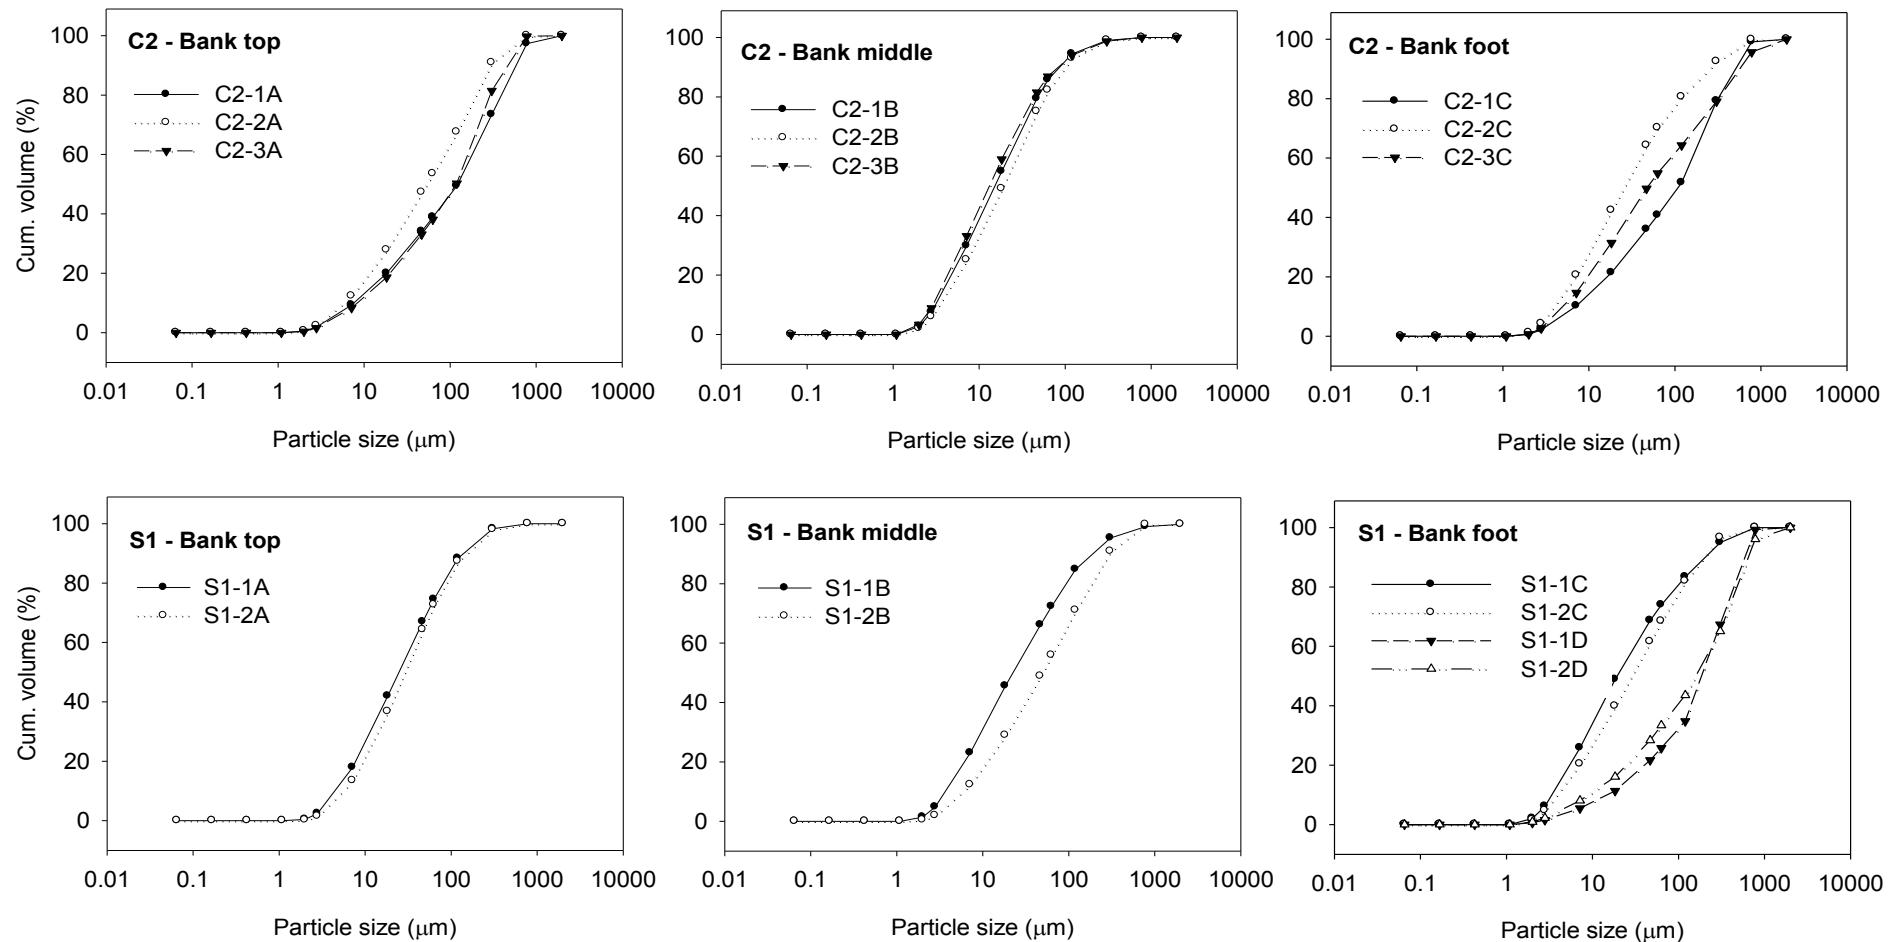
Fig. 3.2.11 Cumulative volumetric percentage of particle size fractions for three sections of banks at sites C2 and S1 for particles of size below 2 mm. The x axis is logarithmic expression of particle size in μm . Each site is represented by the three charts – for top (A), middle (B) and lower section of the bank (C).

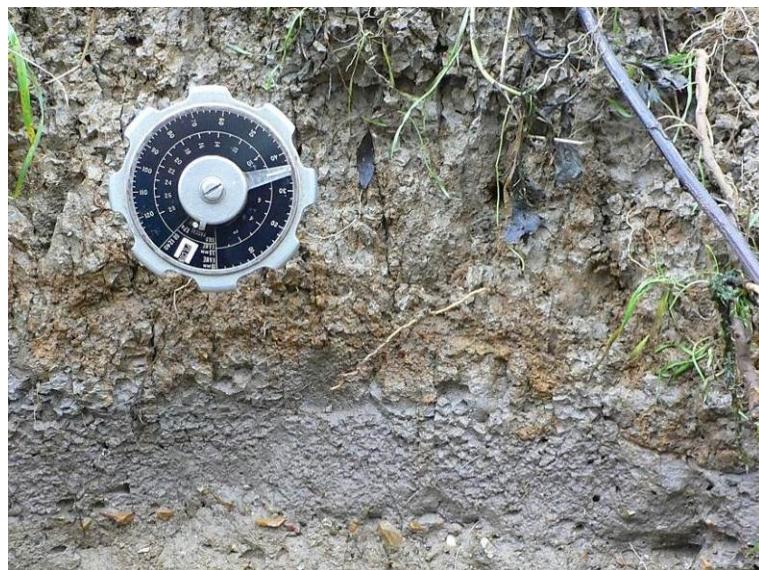
Fig. 3.2.12 *In situ* soil shear strength testing using the Field Vane at the S1 site (Fig. 3.1.1). Sedimentary layers with material of different texture are distinctive in the bank, mainly the grey lens of clay below more sandy and silty material.

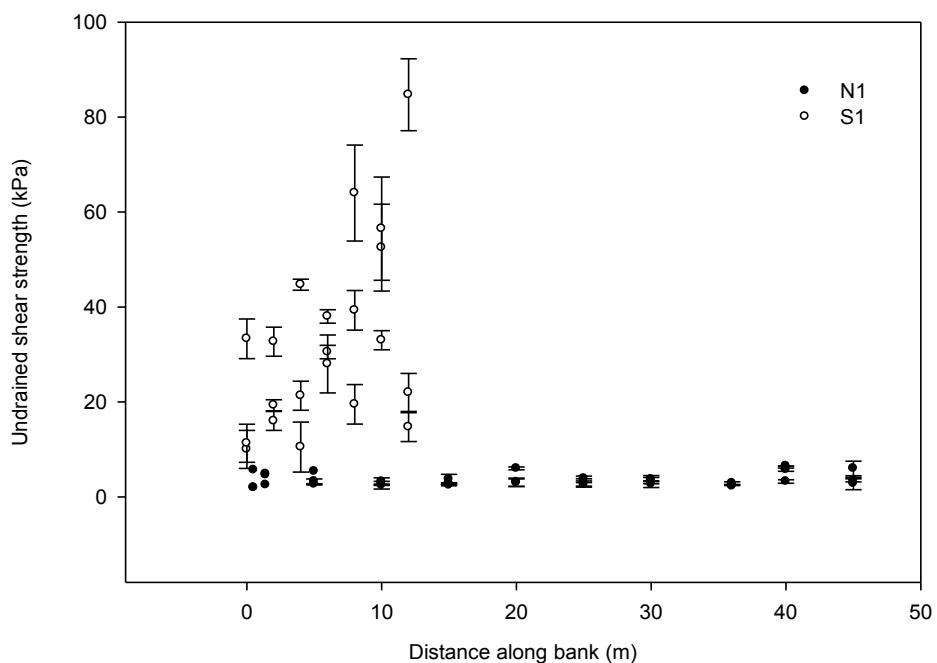
Fig. 3.2.13 Comparison of the mean undrained shear strength measured at the S1 site on 24.6.2008 and at N1 site on 25.1.2008 under unsaturated conditions using Pilcom Field Tester (in kPa). Error bars represent the standard deviation (square root of variance, representing the spread of values around the mean). Measurements were taken in three bank sections: top, middle and lower.

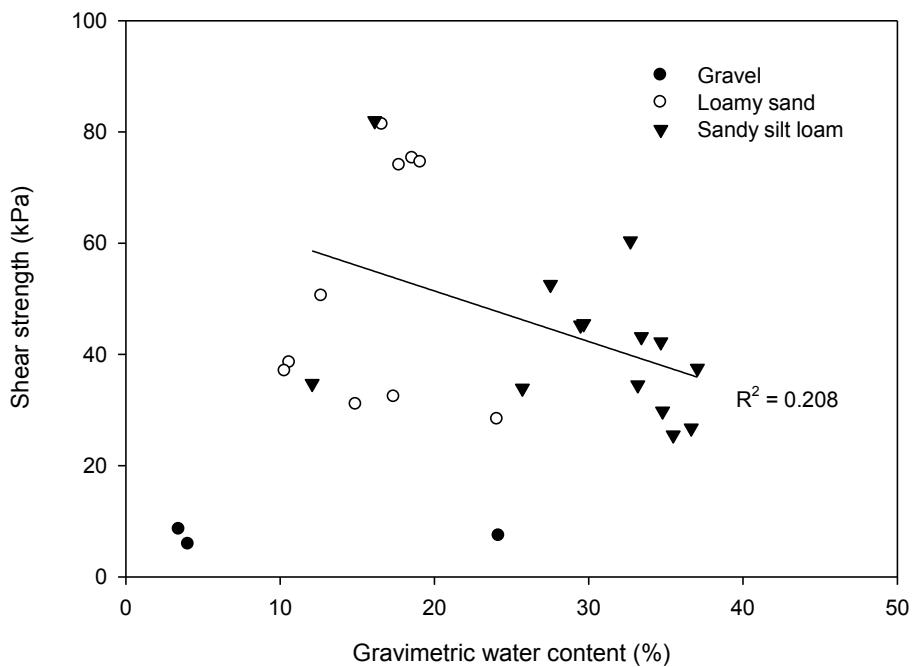
Fig. 3.2.14 Sample shear strength with given water content for some chosen gravel, loamy sand and sandy silt loam samples under undrained conditions. Linear regression applies to sandy silt loam samples.

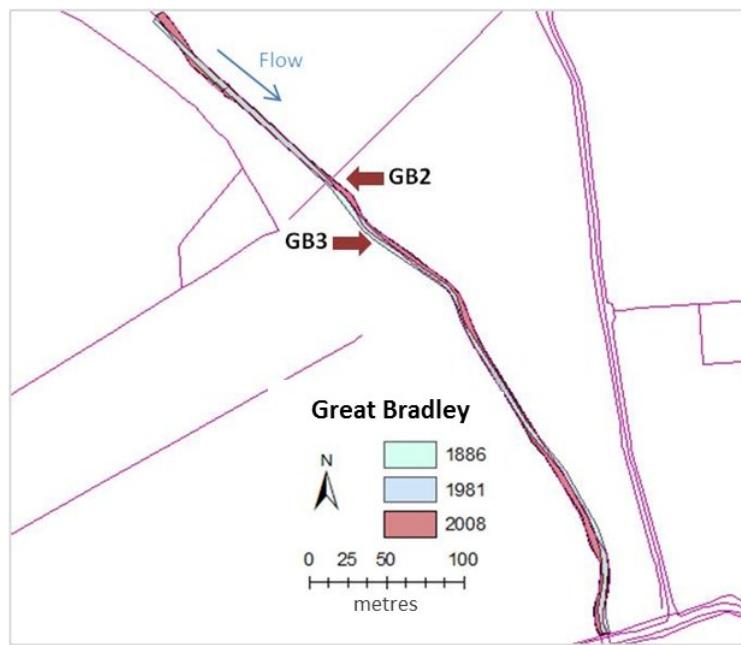
Fig. 3.3.3 The channel of the River Stour showing GB2 and GB3 sites in 1886, 1981 and 2008 (Base map is 2008 Mastermap © Crown Copyright/database right 2008. An Ordnance Survey/EDINA supplied service).

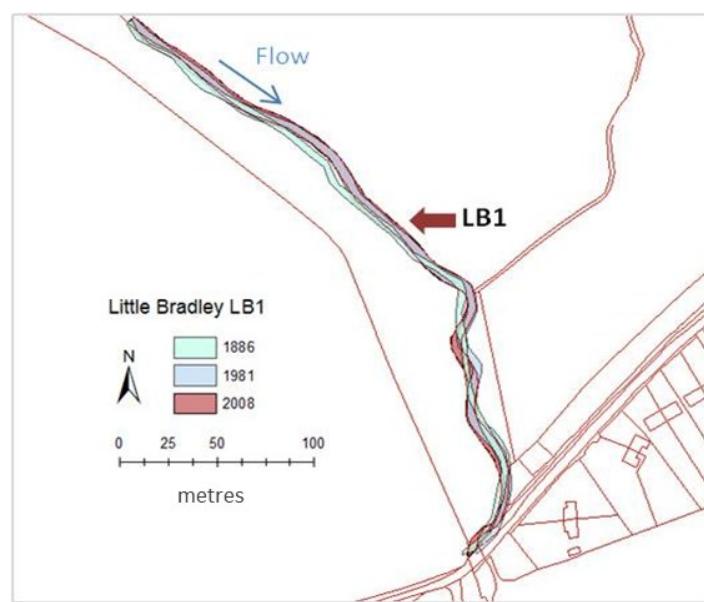
Fig. 3.3.4 The channel of the River Stour with the LB1 site in 1886, 1981 and 2008. (Base map is 2008 Mastermap © Crown Copyright/database right 2008. An Ordnance Survey/EDINA supplied service).

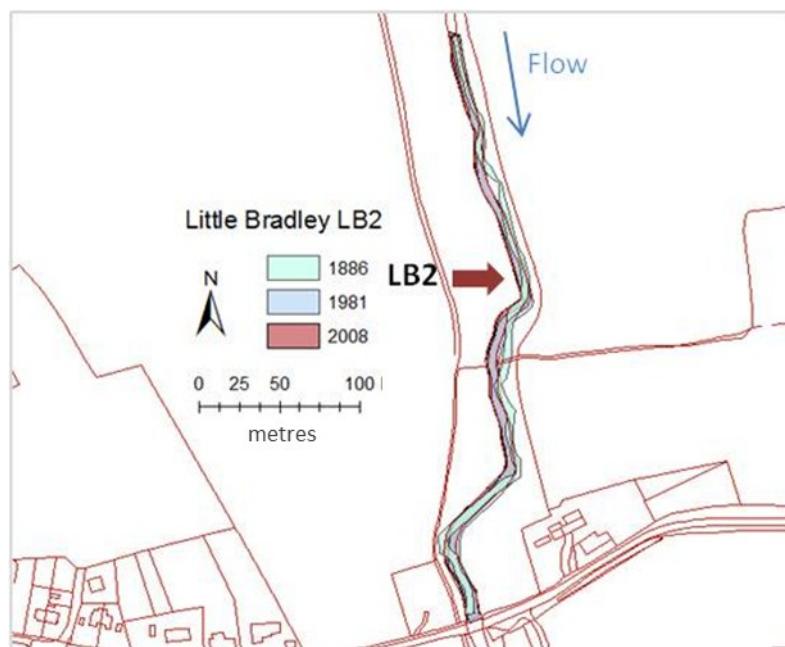
Fig. 3.3.5 The channel of the River Stour with the LB2 site in 1886, 1981 and 2008. (Base map is 2008 Mastermap © Crown Copyright/database right 2008. An Ordnance Survey/EDINA supplied service).

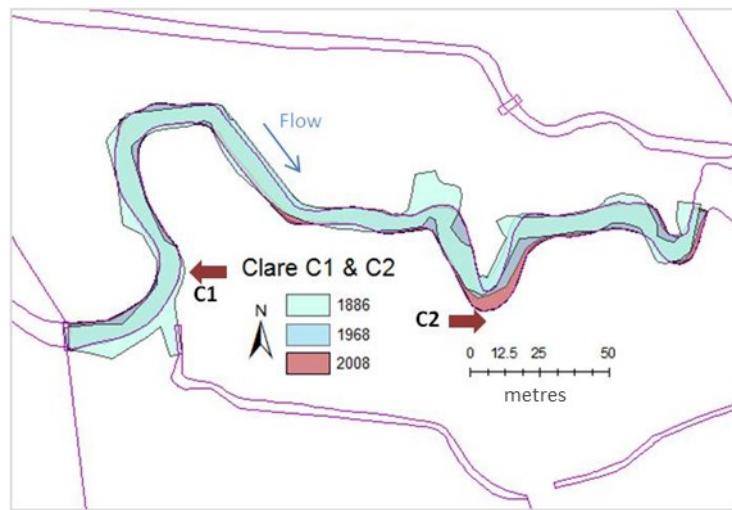
Fig. 3.3.6 The channel of the River Stour showing C1 and C2 sites in 1886, 1968 and 2008. (Base map is 2008 Mastermap © Crown Copyright/database right 2008. An Ordnance Survey/EDINA supplied service).
