River bank erosion rates and the case for willow spiling as a bank stabilisation solution

Lenka Anstead MSc

Submitted for the degree of Doctor of Philosophy

**School of Environmental Sciences
University of East Anglia, UK**

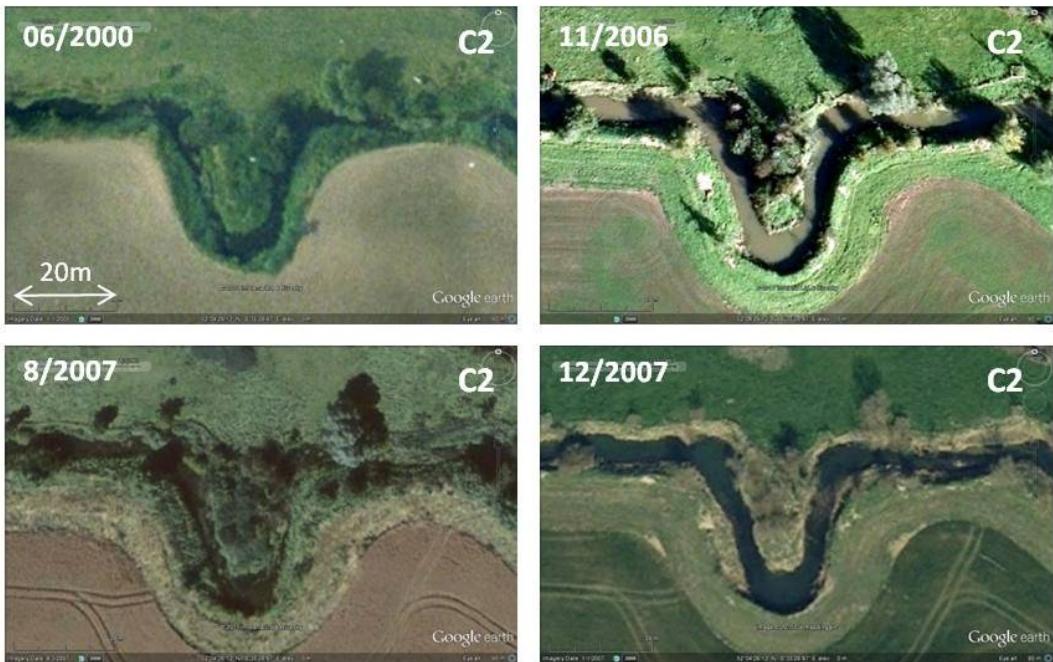
At the C2 site in Clare, the bank line is only clearly visible at the meander apex on photographs from 2006 and 2007 (taken during winter months). The low resolution of images in conjunction with the short time interval is not suitable for measuring the erosion rate although it is useful to point out larger failures or changes in longer reaches. The photographs show that land management changed some time before 2006 and there is now a 10 m wide (approximately) buffer zone on the south bank (Fig. 3.3.9).

Fig. 3.3.9 Aerial imagery sequence for the C2 field site in Clare (© Infoterra Ltd. & Bluesky, Google Earth, 2011).

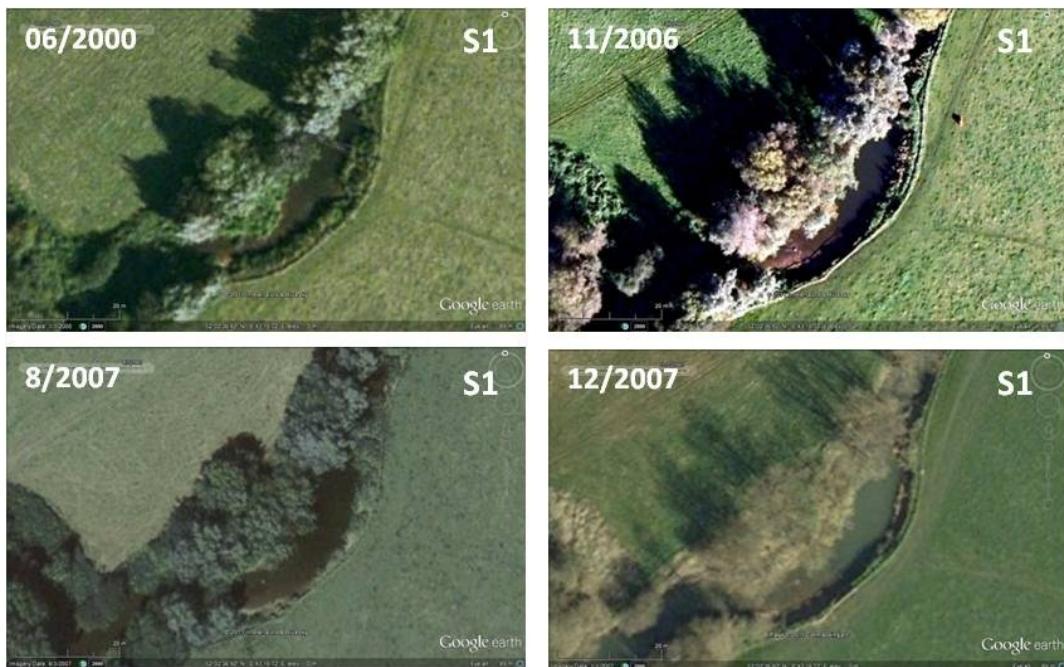
The situation is also complicated at the S1 site in Sudbury, because the bank line can be clearly identified only in the image taken in winter 2007. In 2000, more vegetation appears to be located at the bank foot. The fence is of a different shape than seen in 2006, which may indicate that it had been damaged by erosion (this was also mentioned by the landowner), (Fig. 3.3.10).

Fig. 3.3.10 Aerial imagery sequence for the S1 field site in Sudbury (© Infoterra Ltd. & Bluesky, Google Earth, 2011).

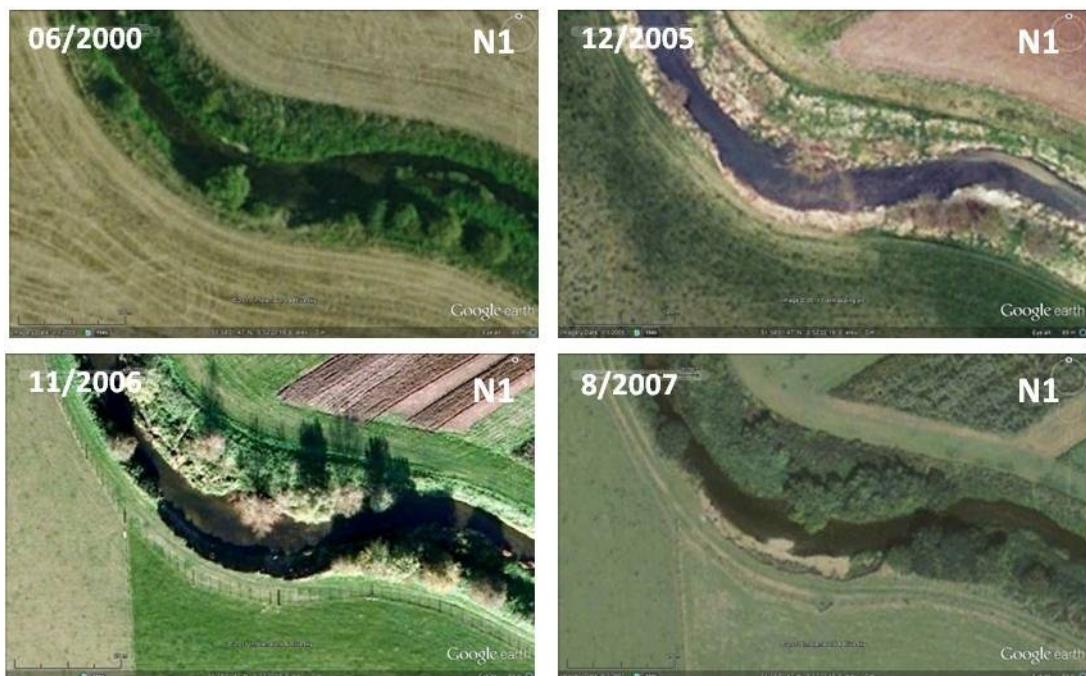
In Nayland, the N1 site shows some important changes through the sequence of pictures. The 2000 image illustrates a tree growing in the middle of the site that is missing on further images. The ownership of the land has changed since then so no information is available on whether the tree had been cut or its loss was caused by erosion. Possibly, since deflectors were installed upstream of the site, increased erosive force has undermined the tree which was sitting on loose gravel sediments. Vegetation appeared to be covering the bank face in 2000, which is now mostly bare. The 2005, 2006 and 2007 images show fast progressing erosion that is 'eating' the bank edge, and is progressing both upstream and downstream (Fig. 3.3.11).

Fig. 3.3.11 Aerial imagery sequence for the N1 field site (© Infoterra Ltd. & Bluesky, Google Earth, 2011).

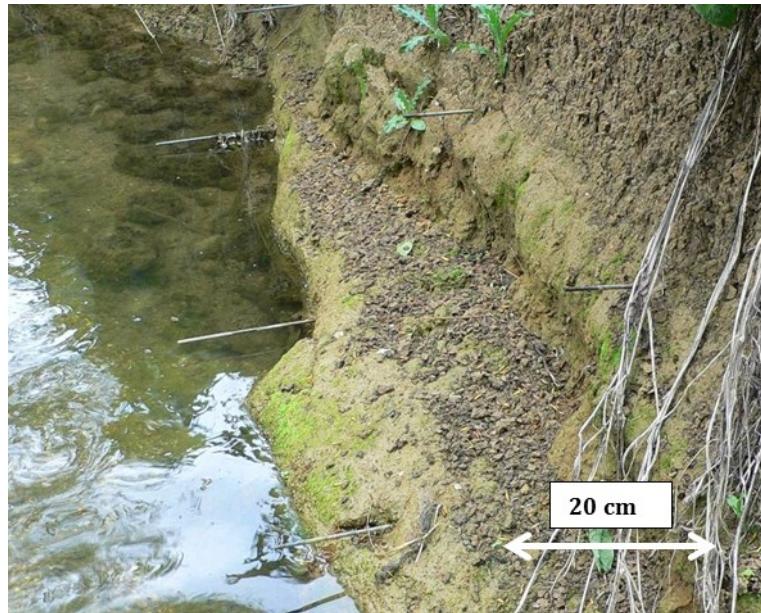
Fig. 3.4.1 Detail of erosion pins on field site LB1 in Little Bradley (see location map on Fig. 3.1.1). The flat piece of bank is possibly indicating the level of a prolonged water transfer. Erosion pins show retreat that occurred between June 2007 and May 2009 (see also Fig. 3.5.1).

In this project, 102 erosion pins were installed at eight out of the nine field sites (Table 3.4.1, Fig. 3.4.2). The pins were made of 50 cm long steel rods with a 0.5 cm diameter and

were horizontally inserted into the bank (Fig. 3.4.1) protruding by 5 cm. This starting value was the zero initial value against which all future readings were referred. If necessary, pins were adjusted back to 5 cm. This strategy limited the need for paint marks which would have been inaccurate and also limited the chance of losing the pin.

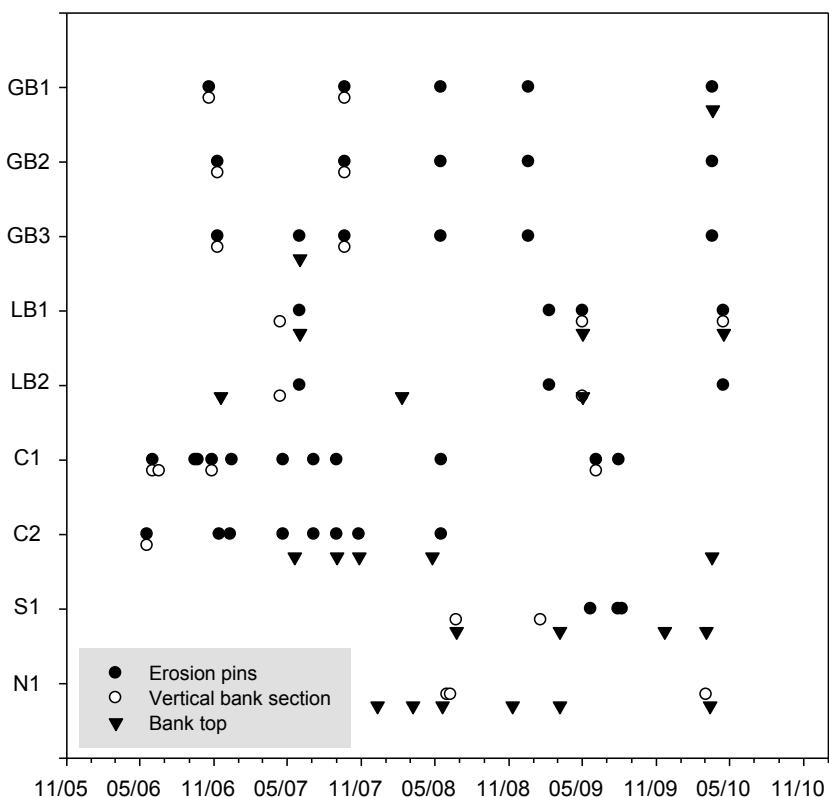
Fig. 3.4.2 Frequency and timing of field readings of erosion pins, vertical bank sections and bank edge surveys. The data presented are for each of the field sites and for the period between May 2006 and March 2010.

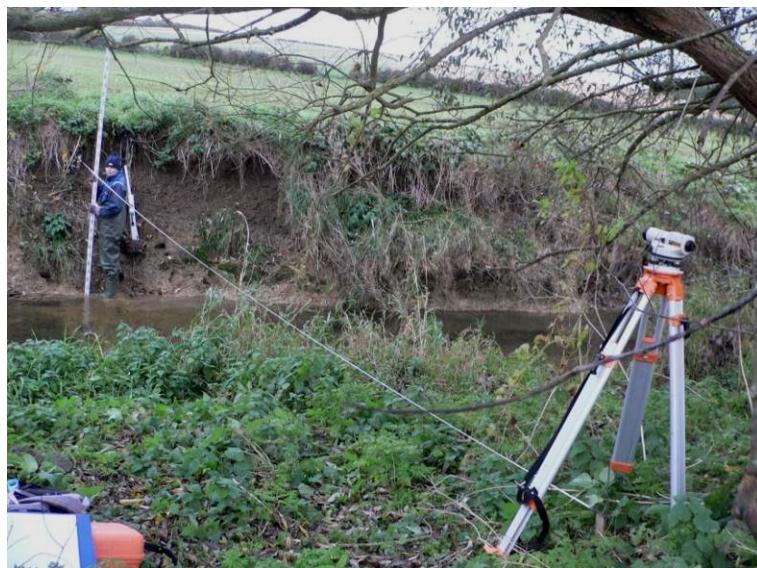
Fig. 3.4.3 Channel cross section surveying using Nikon automatic level at GB2 site in Great Bradley.

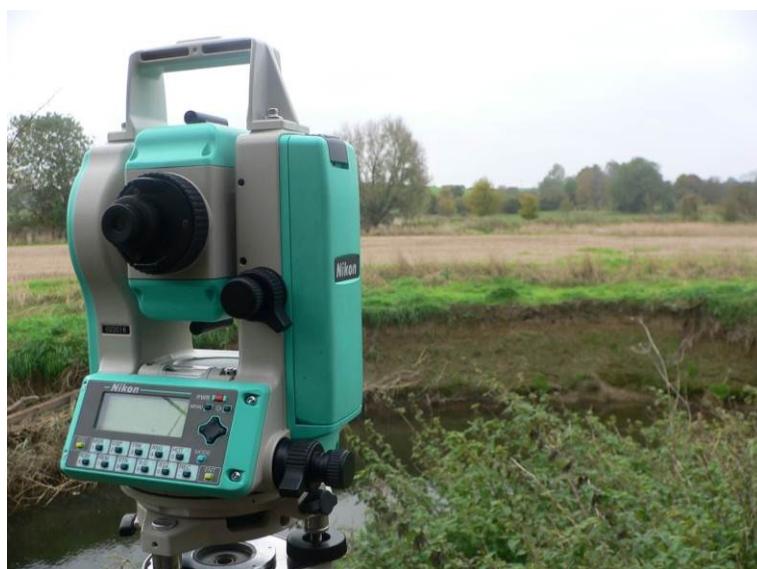
Fig. 3.4.4 Total station positioned in the centre of the meander with the surveyed bank line in the background at C2 site in Clare.

A total station (Nikon DTM 330) with a 50 mm target was used to measure the distance and angle of densely placed points along the bank edge (Fig.3.4.4). The target was placed exactly on the bank edge where soil under the vegetation prevented the target from slipping through.

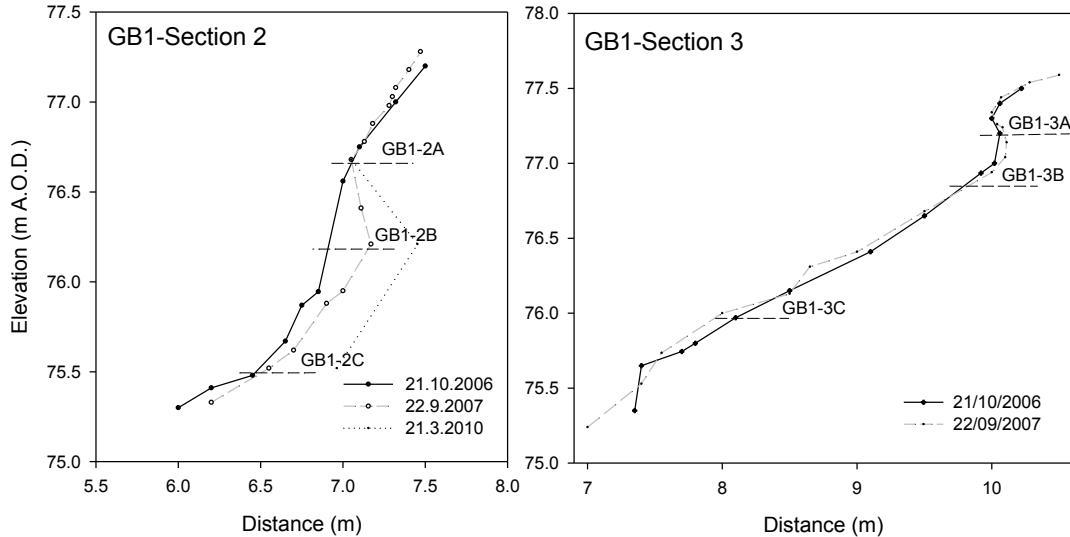
Fig. 3.4.11 Bank profiles at GB1. The dotted line in Section 2 is the magnitude or retreat recorded on pins. Dashed horizontal lines show the position of erosion pins.

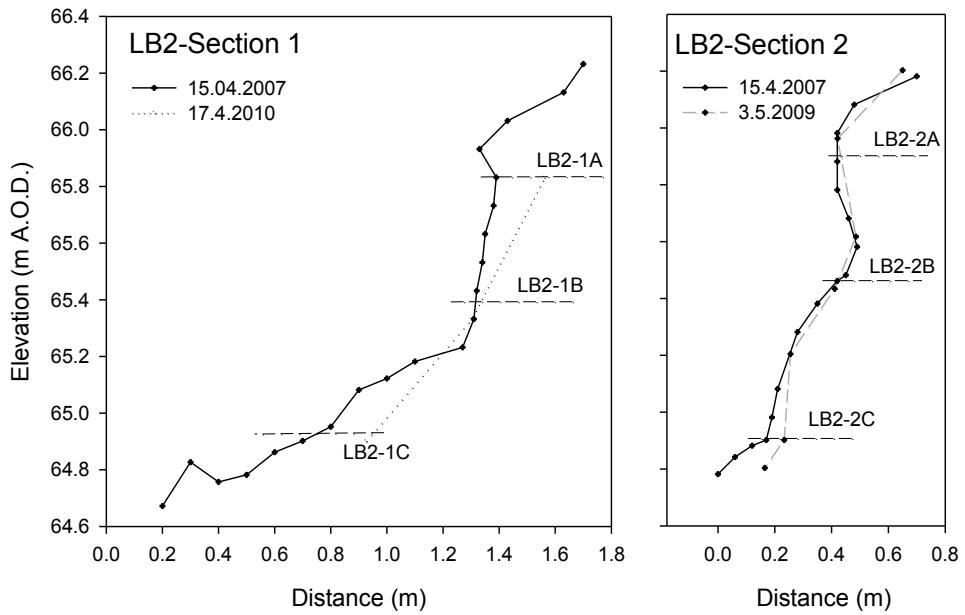
Fig. 3.4.15 Bank profiles at the LB2 sites, Sections 1-2. The horizontal lines are erosion pins with their coding.

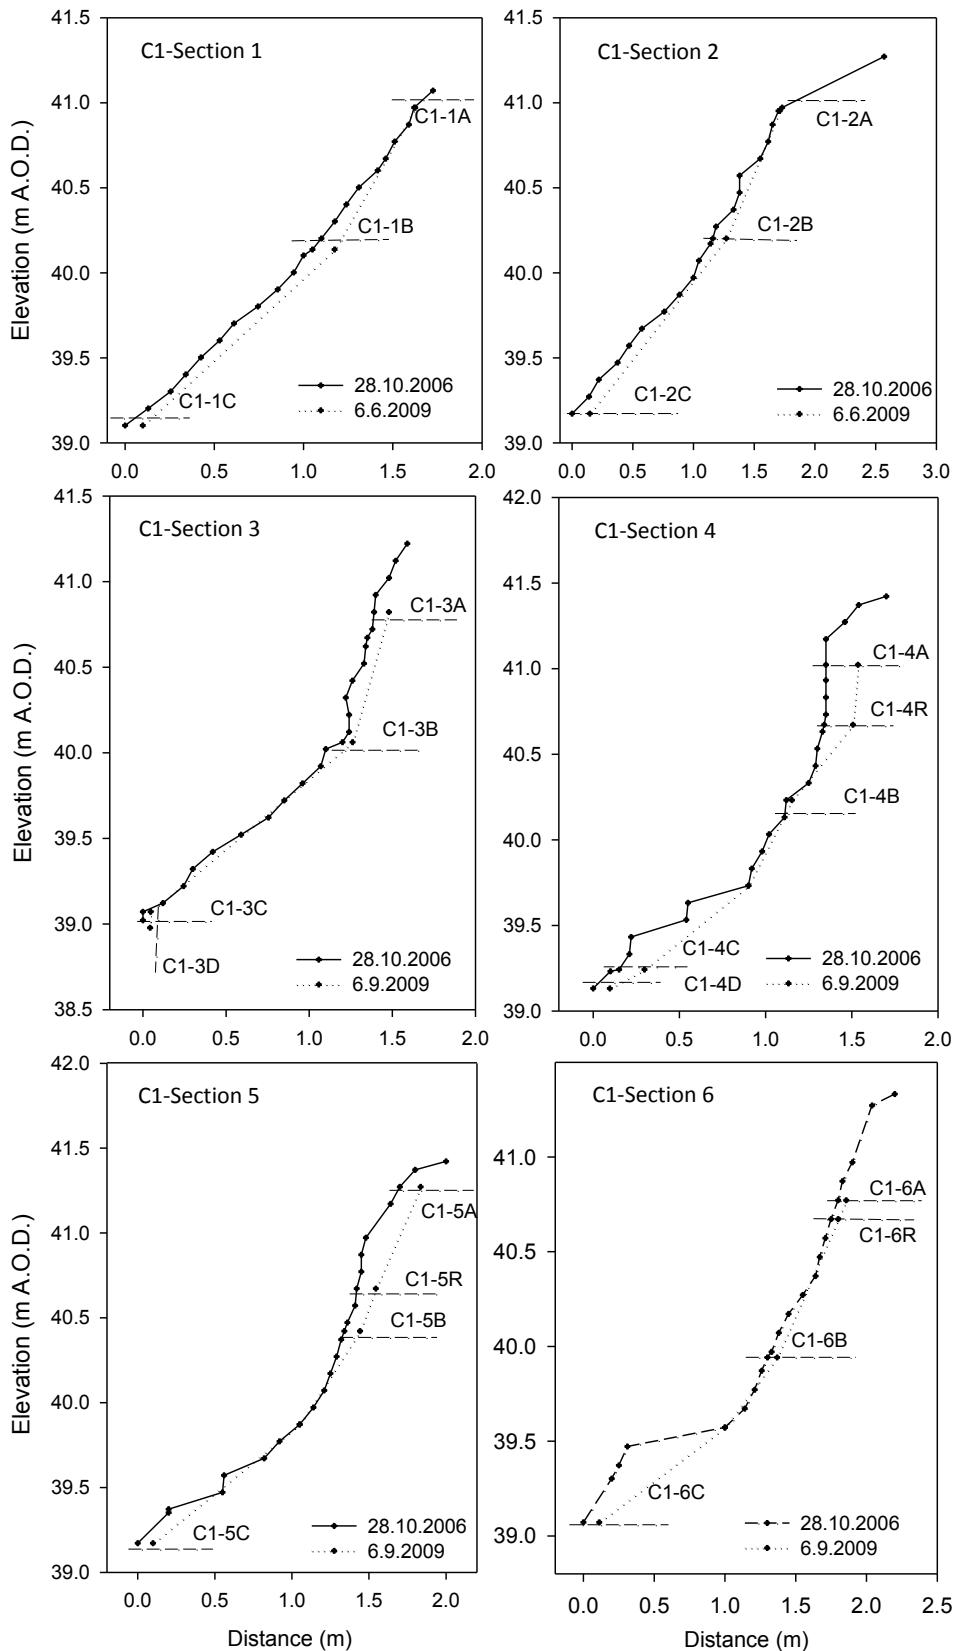
Fig. 3.4.16 Bank profiles at site C1 in Clare. The dotted lines show the hypothetical erosion based on pin readings. Dashed horizontal lines show the position of erosion pins with their coding.

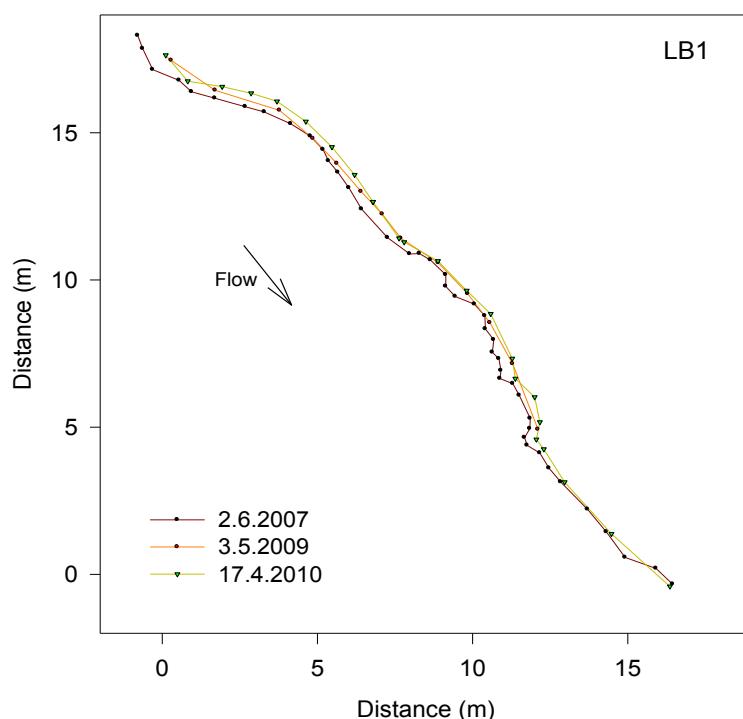
Fig. 3.4.17 Plan of bank top line at the LB1 site surveyed in 2007, 2009 and 2010. The coordinates are in m and the x axis is in the direction of downstream (indicated by the arrow).

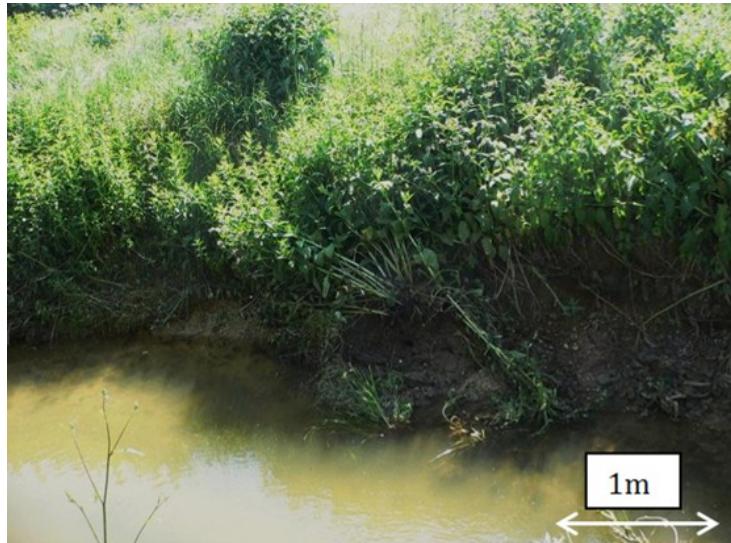
Fig. 3.4.26 Slumped piece of the right bank at GB1 site (Fig. 3.1.1) with the uprooted tall herbal vegetation, June 2007. Failed material is covering the lower pin.

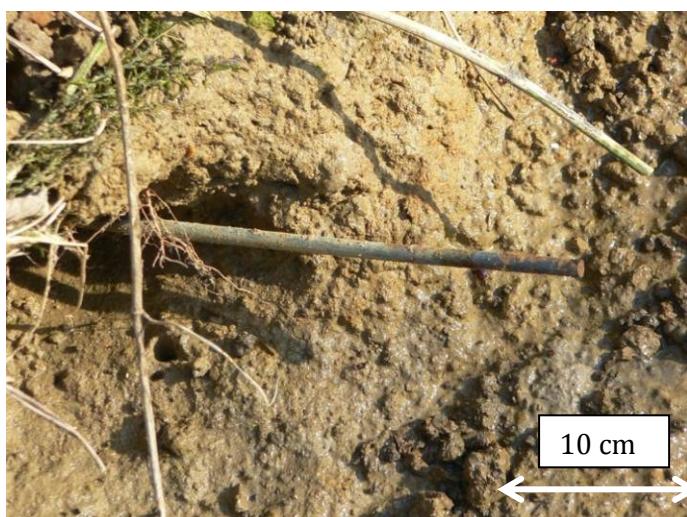
Fig. 3.4.27 A large cavity formed around the pin LB1-3B. Left bank at LB1 site near Little Bradley, January 2008 (Fig. 3.1.1).

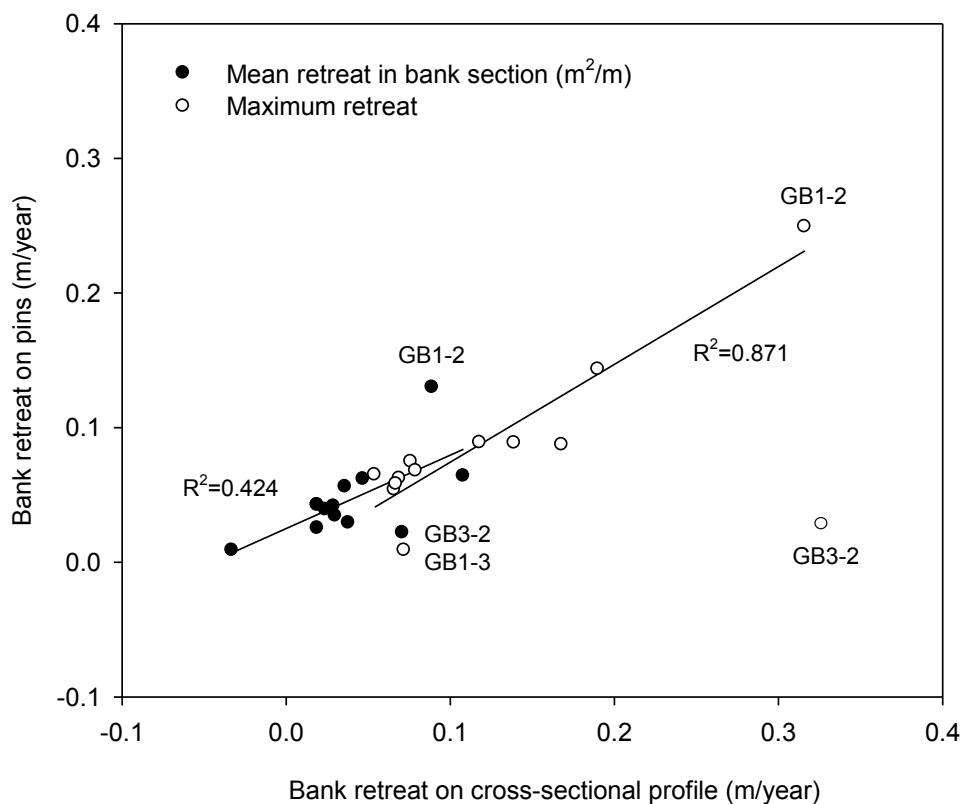
Fig. 3.4.28 Relationship between the retreat calculated from the vertical bank profiles and retreat recorded on erosion pins, for all sections listed in Table 3.4.3. The mean retreat in the bank section is expressed as $\text{m}^2/\text{m}/\text{year}$ while all other units are in m/year . All data are relative to the time factor (as years).

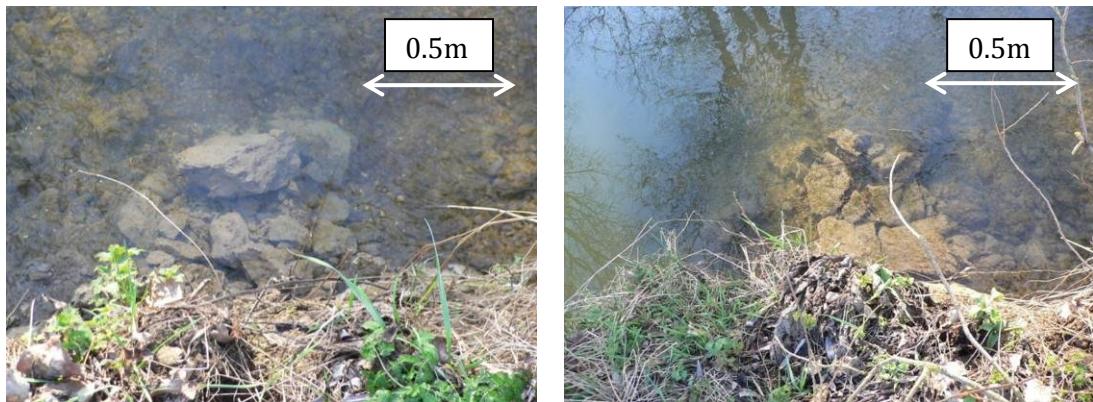
Fig. 3.4.29 Two instances of slumped bank at the upstream end of the surveyed bank at LB1 site (see Fig. 3.1.1 for a location map). Photographs were taken from the top of the bank in January 2009. The grey colour of material on the left indicates high clay content.

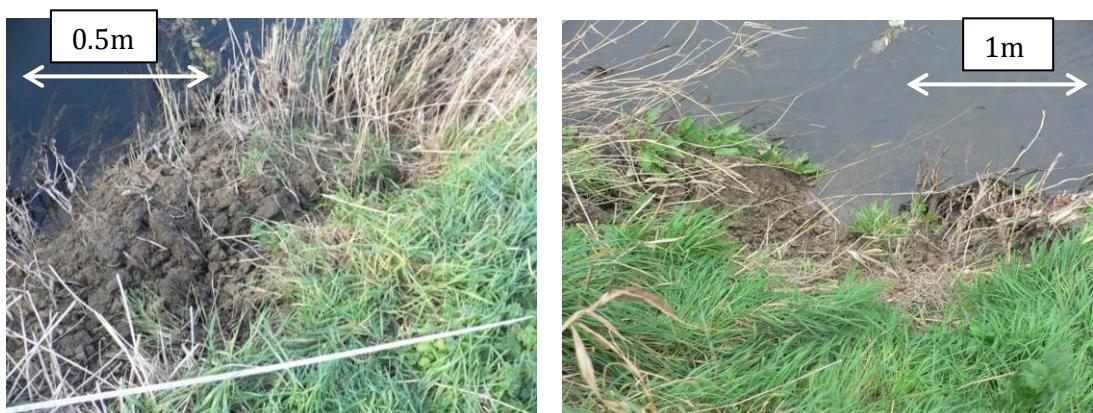
Fig. 3.4.30 Two instances of slumped bank at the downstream section of C2 site (Fig. 3.1.1) in November 2006 (left) and October 2007 (right).

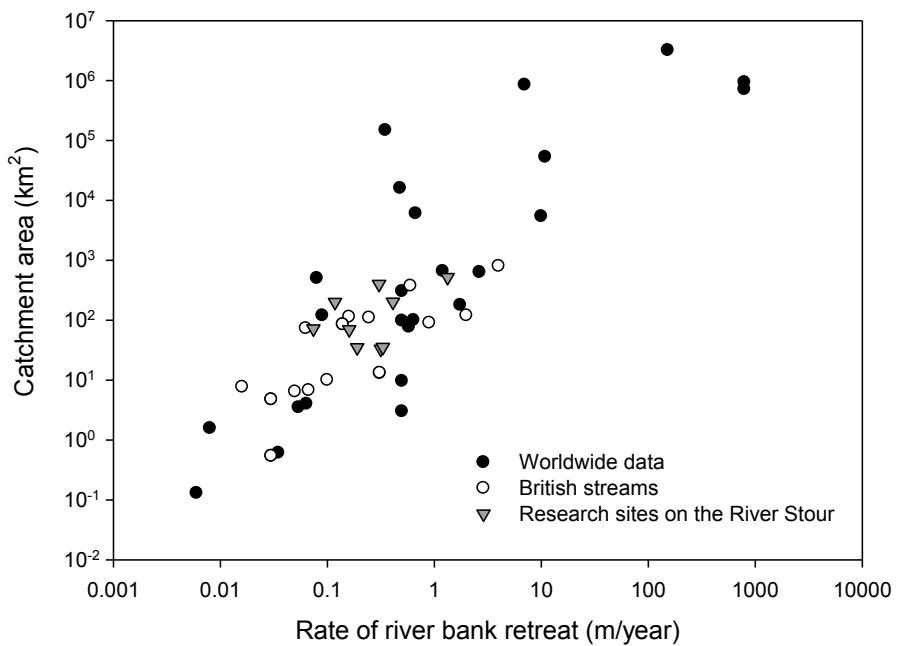
Fig. 3.4.33 Relationship between the maximum erosion rates and the catchment area on a logarithmic scale from worldwide and British rivers (data from reviews by Hooke 1980 and Lawler 1993), and from this research on the River Stour (Section 3.4.2).

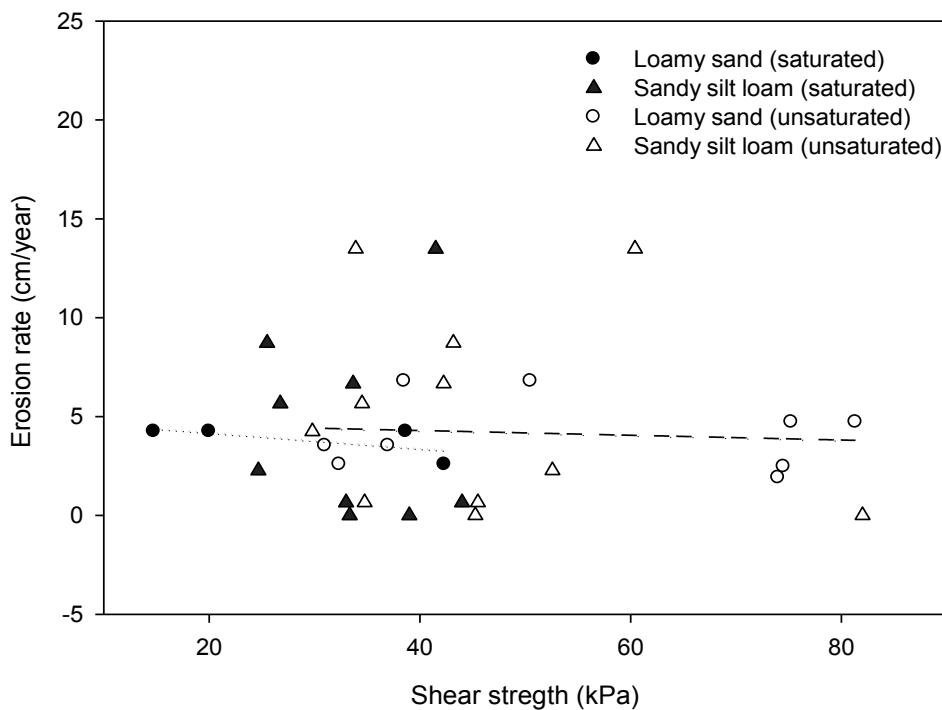
Fig. 3.5.3 Shear strength (kPa) versus erosion rate (cm/year) for loamy sand and sandy silt loam during unsaturated and saturated conditions. The lines represent an estimation of trends for loamy sand values during saturated (dotted line) and unsaturated (dashed line) conditions.

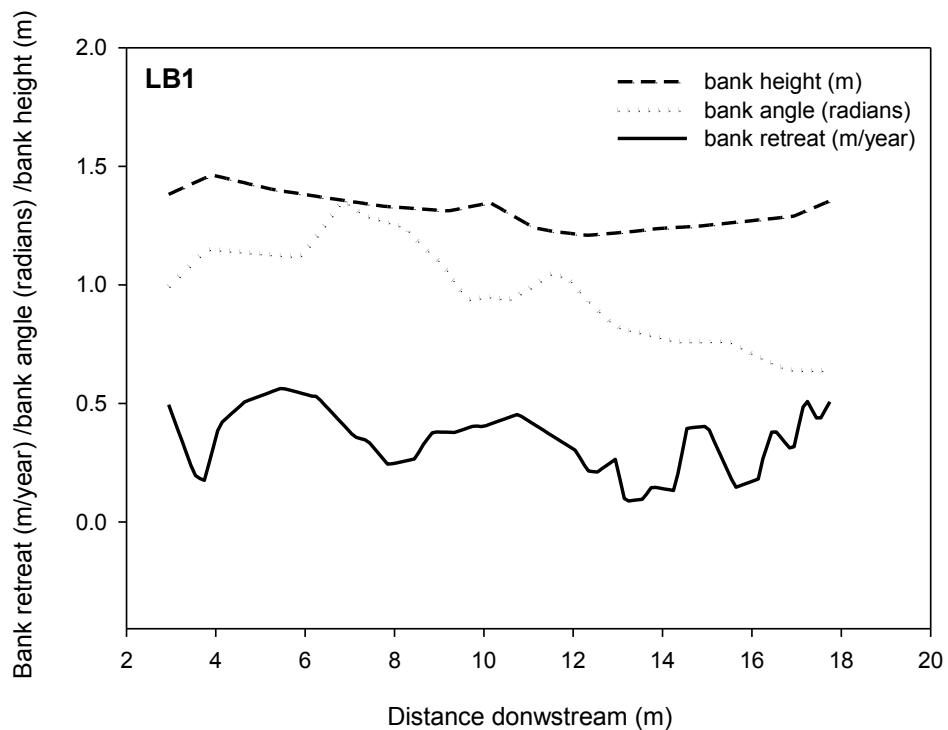
Fig. 3.5.5 Bank heights (in m) and angles (in radians) with the corresponding retreat rates (m/year) recorded between June 2007 and April 2010 at site LB1. These charts are based on extrapolated data (for each 10 cm of downstream length, section 3.4.1(C)) and are shown in relation to the distance downstream (m).

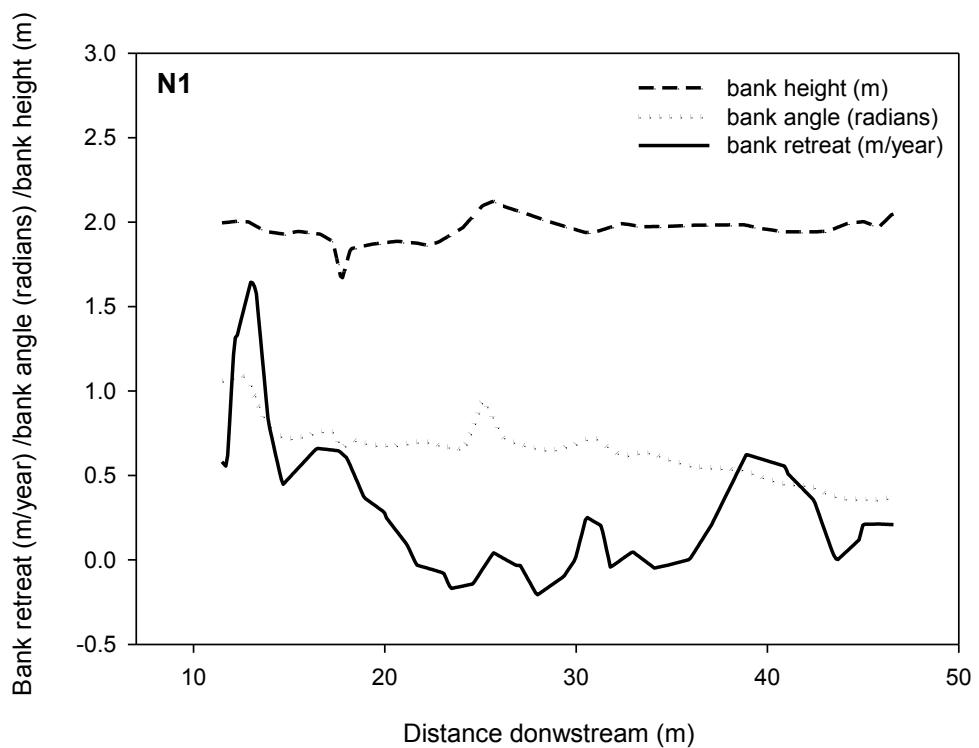
Fig. 3.5.6 Bank heights (in m) and angles (in radians) with the corresponding retreat rates (m/year) recorded between December 2007 and March 2009 at site N1. These charts are based on extrapolated data (for each 10 cm of downstream length, section 3.4.1(C)) and are shown in relation to the distance downstream (m).

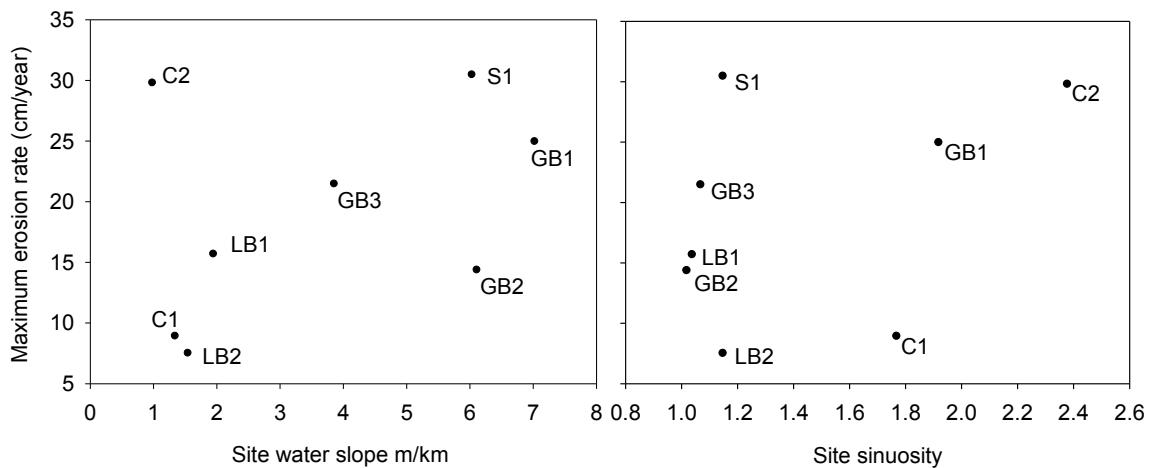
Fig. 3.5.7 Maximum erosion rate recorded on pins (cm/year) versus site water slope (left) and site sinuosity (right) at the research sites shown.

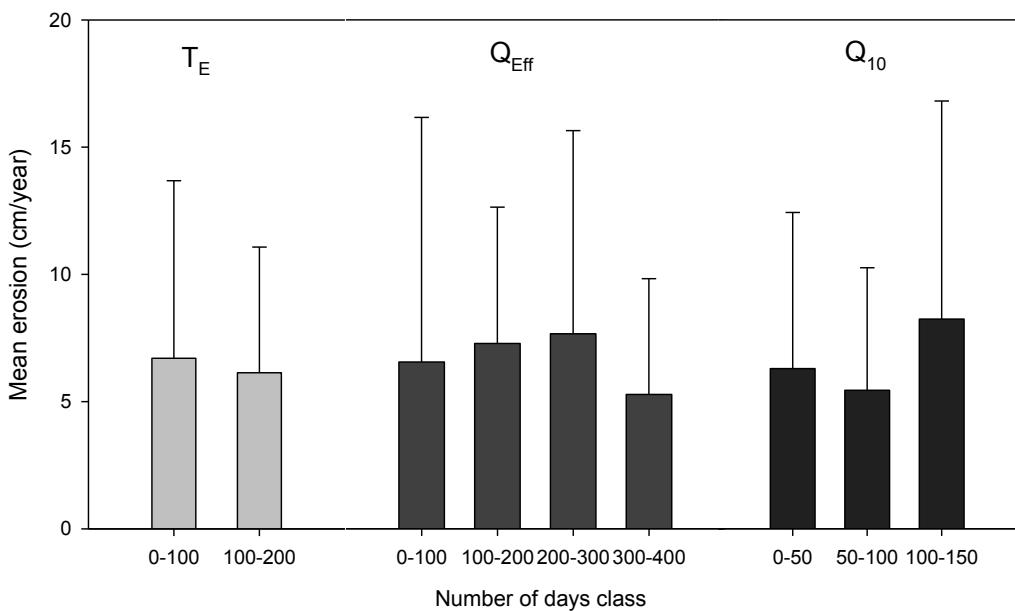
Fig. 3.5.12 Flow-specific summaries of the erosion rates: T_E is the number of days class when the water transfer was greater than 0.58 m^3 , which is the effective discharge for entrainment at GB and LB sites, Q_{Eff} is the number of days when the river flow was above the effective discharge at all sites and Q_{10} is the number of days class when the flow was above the 10% exceedance of time.

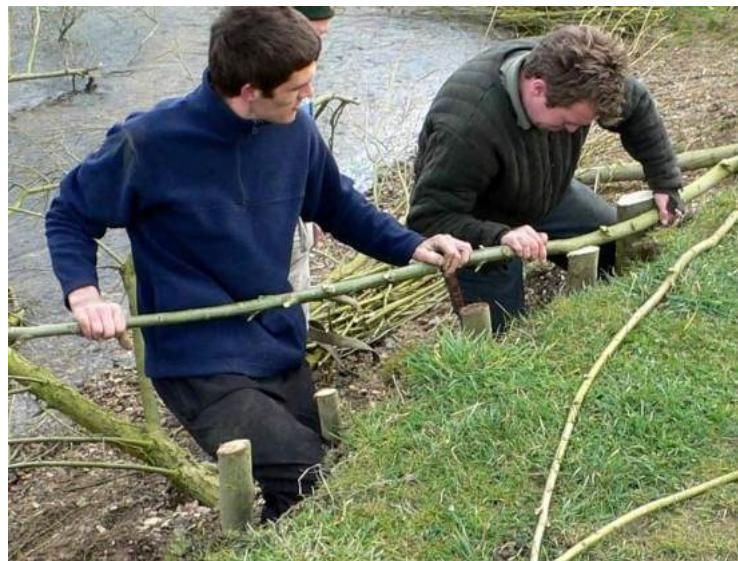
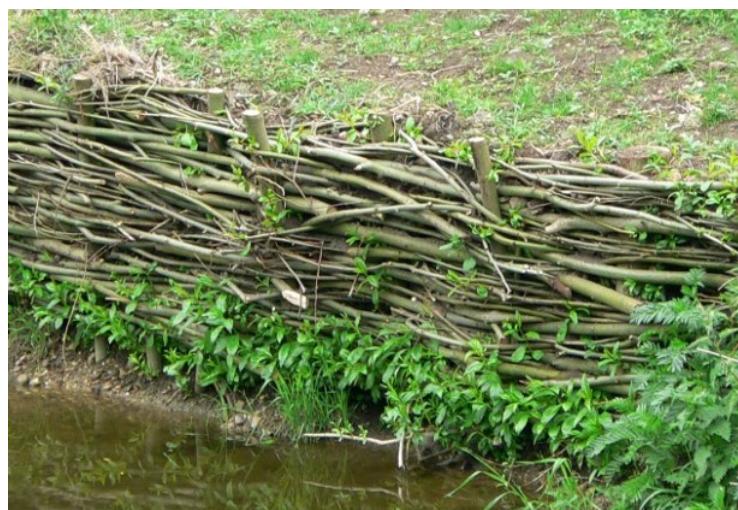
Willow spiling is made of long live willow canes interwoven tightly between live willow stakes (Fig. 4.1.1). There is no exact definition of this method and individual willow projects can vary considerably in the type of material used and ways of installing it. The most preferred option is to build a structure made of local live material that will take root and grow.

Fig. 4.1.1 Installation of willow spiling at N1 site in Nayland, March 2009 and the completed willow spiling wall with the initial growth, May 2000 (see location map on Fig. 3.1.1).

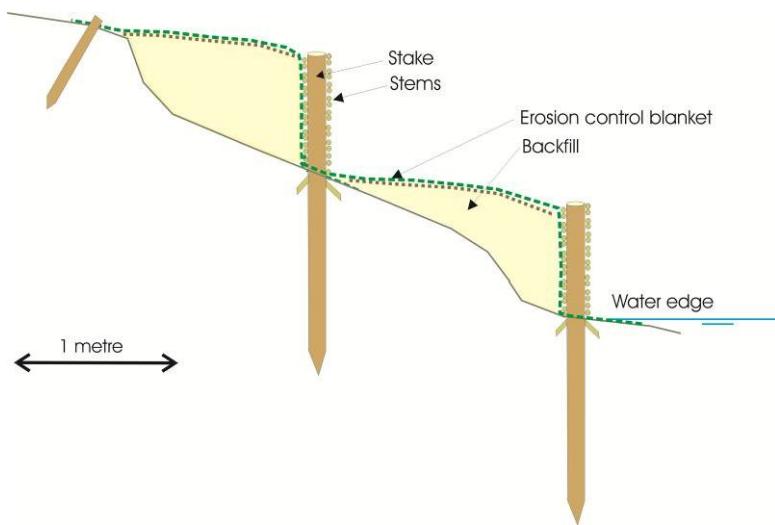
Fig. 4.1.2 Cross-sectional view of a two-staged willow spiling revetment with incorporated erosion control blanket made of coir (natural fibre extracted from the husk of coconut, (Based on Schiechtl & Stern 1996).

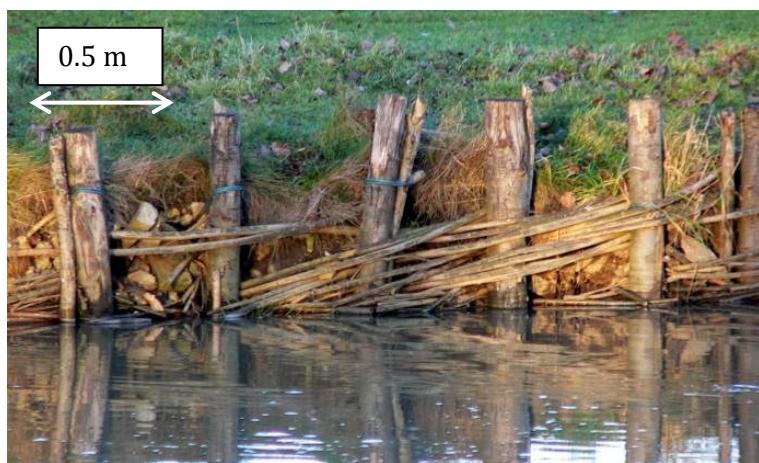
Fig. 4.1.5 Disintegrating spiling structure two years after installation on the River Great Ouse, Bedford, East Anglia.

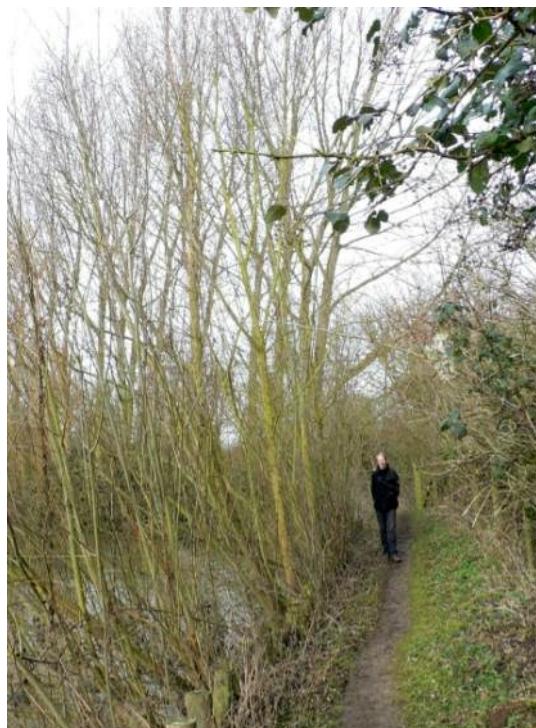
Another one-tiered, 2-m tall revetment was installed on a turbulent stretch of the River Ives in Bedfordshire, 100 m downstream of a mill weir. It was put in place in the mid 1990s and so far has been very successful. Along this 15 m spiling, ten willows have grown into mature trees of 20 cm diameter and over 10 m high. Many thicker stems and shoots have appeared along the whole length of the revetment (Fig. 4.1.6.).

Fig. 4.1.6 Successful willow spiling approximately 15 years old on the River Ives in Bedfordshire.

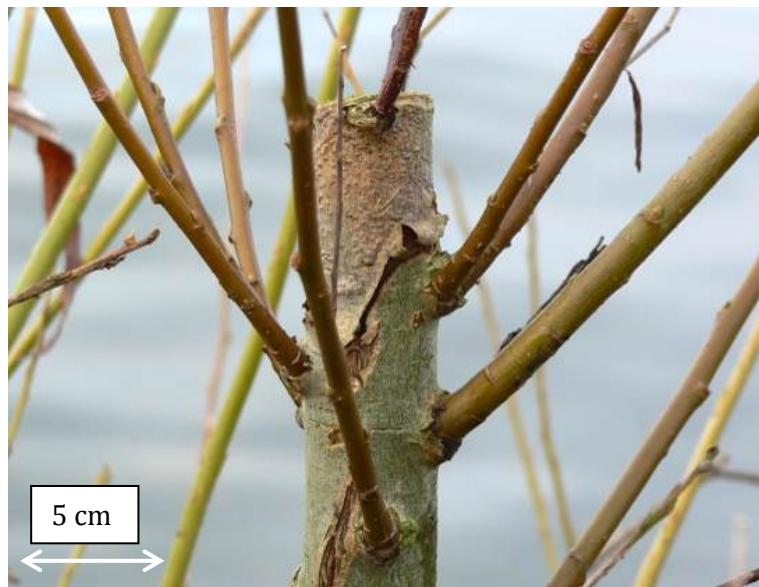
Fig. 4.1.7 Shoots growing on a willow stake installed one year ago, Bedford, East Anglia.

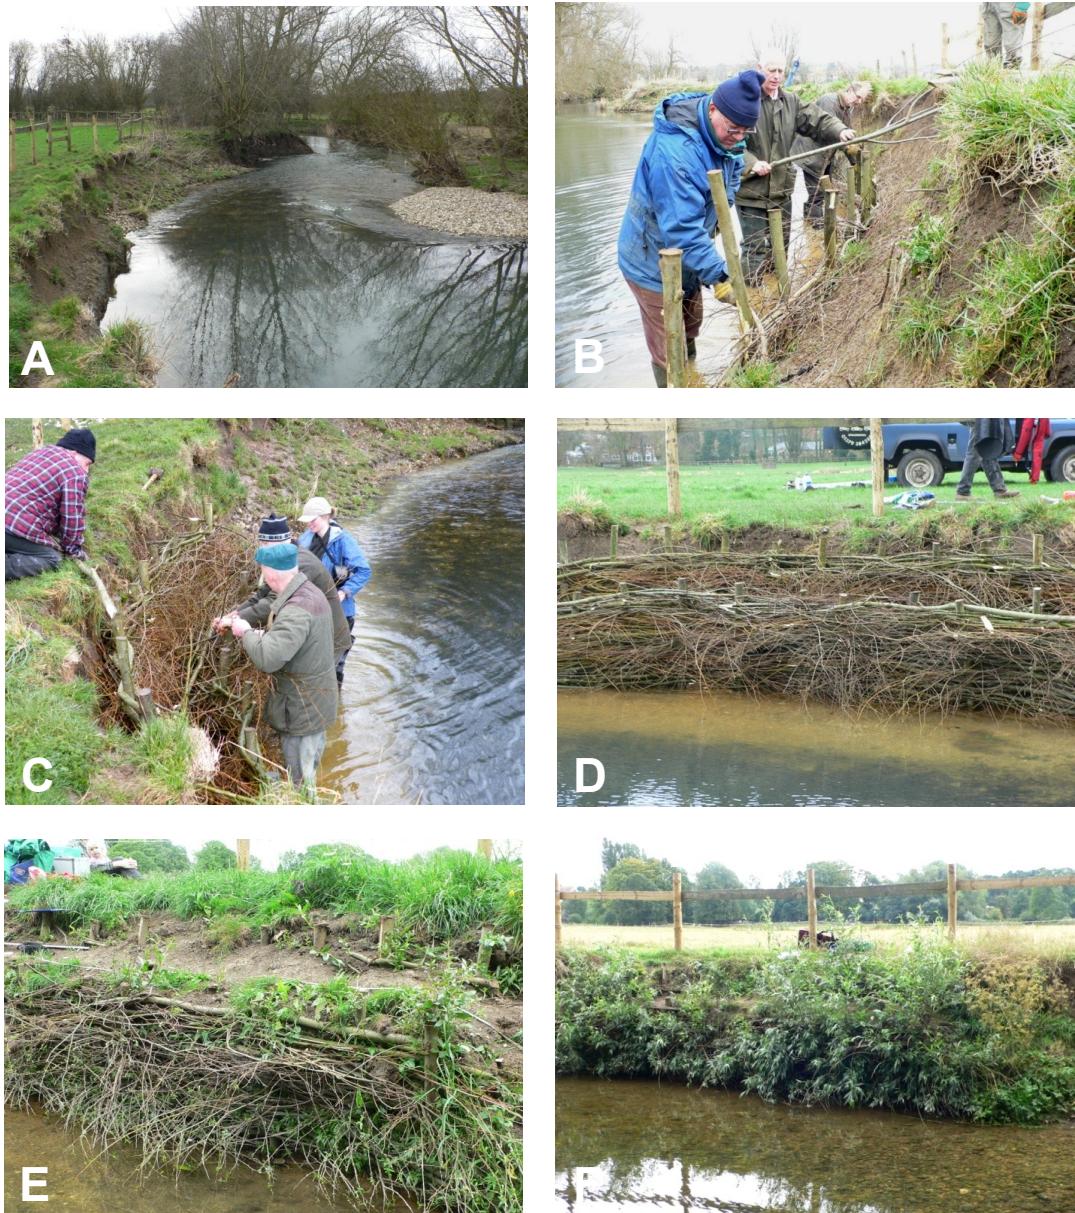
Fig. 5.2.1 Photographs from the project diary at the cohesive site in Sudbury S1: (A) site before stabilisation works, looking downstream; (B) Sudbury Common Lands volunteers weaving the lower tier; (C) finishing the weaving on both tiers; (D) completed spiling before backfill – all March 2009; (E) finished backfilled spiling with first shoots appearing – May 2009; (F) summer growth on the spiling, viewed from the right bank – August 2009.

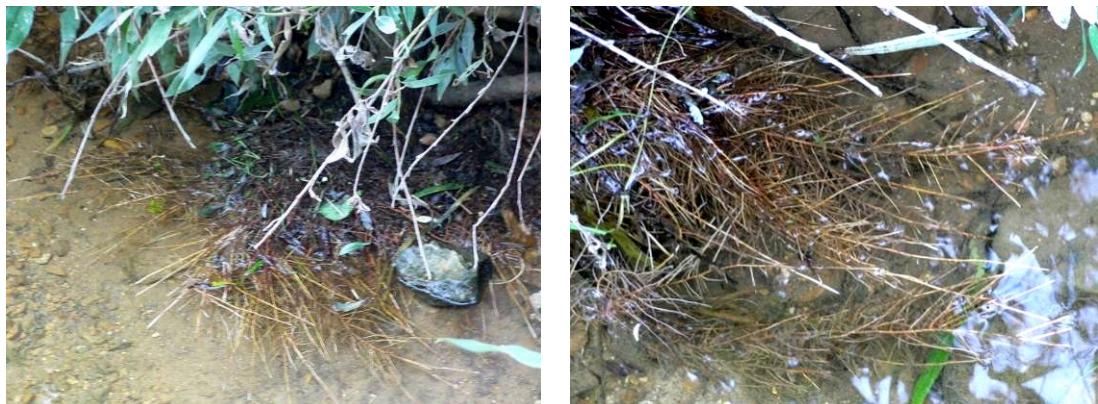
Fig. 5.3.2 *Adventitious roots growing from submerged parts of stems in the lower tier at the cohesive site S1.*

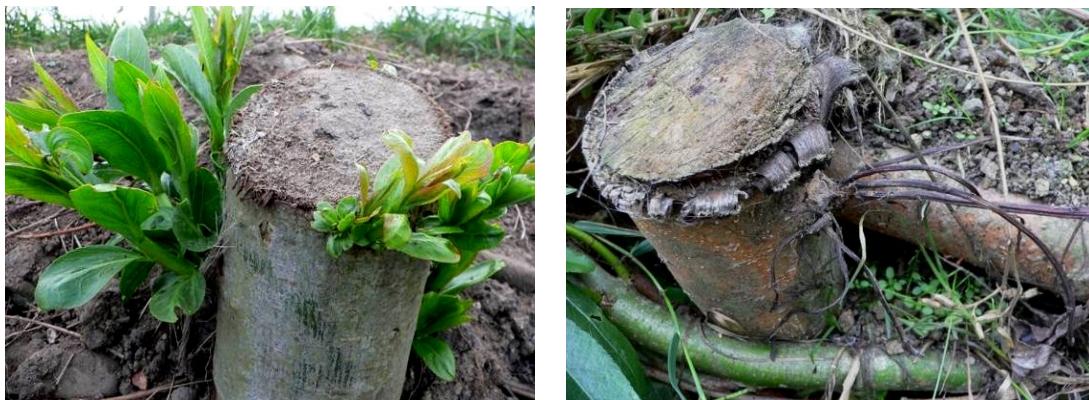
Initial sprouting on most sampled stakes was vigorous with abundant new shoots. Later in the season, the number of live shoots on the majority of stakes had decreased. Shoots located around the top of the stakes were affected the most (Fig. 5.3.6).

Fig. 5.3.6 Appearance of new shoots from a willow stake at N1-UT in May 2009 (left) and dead shoots on a stake at S1-LT in August 2009 (right).

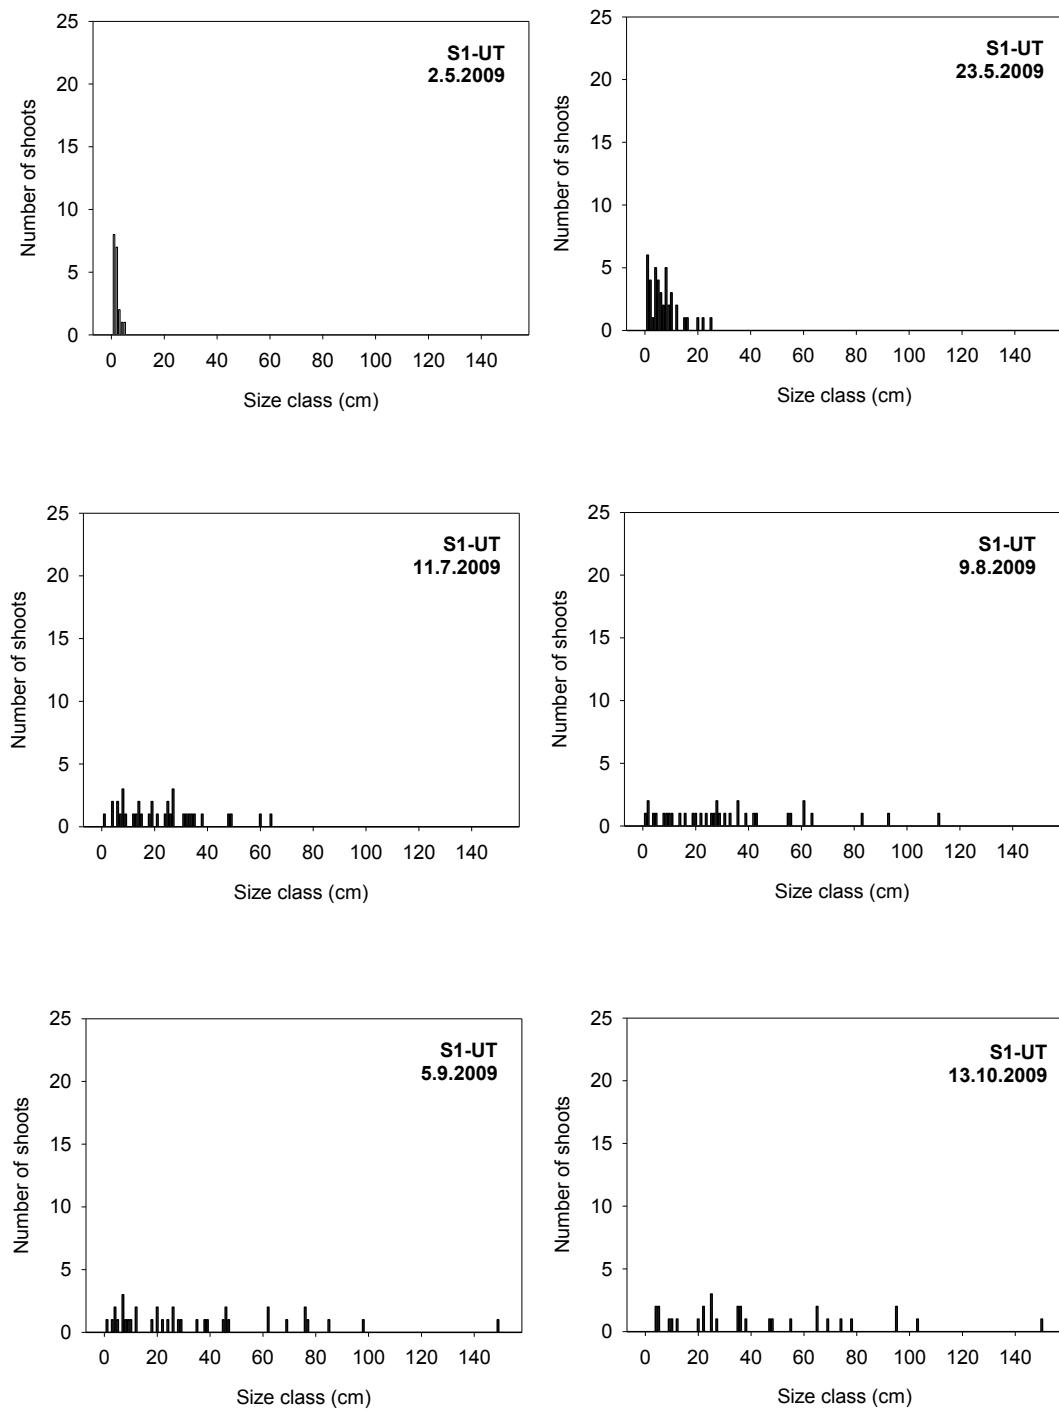
Fig. 5.3.10 Frequency distributions for the cohesive site – upper tier (S1-UT) showing shoot length size classes (cm) against number of shoots. The size class interval was 1 cm.

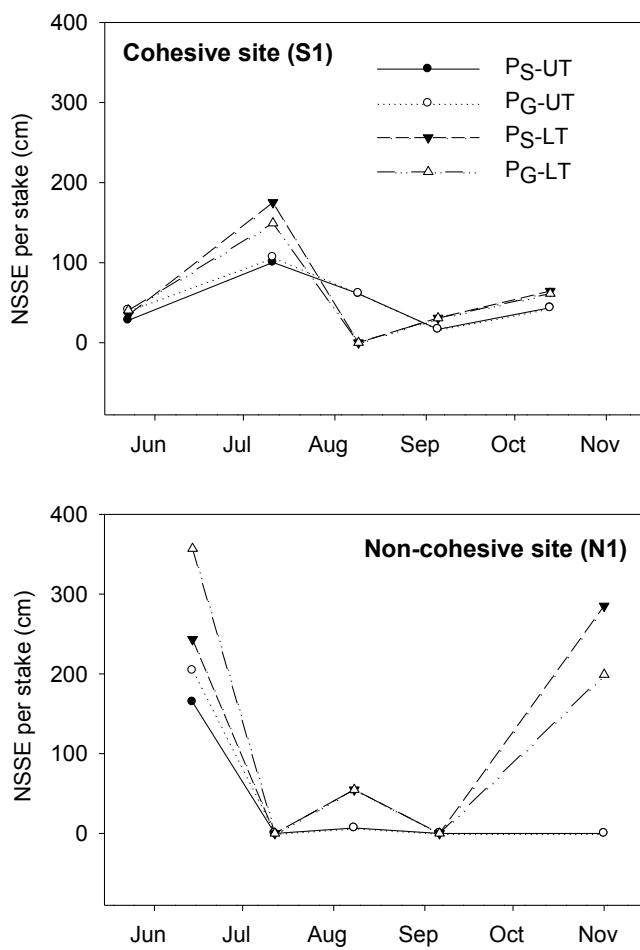
Fig. 5.3.15 Net seasonal shoot extension (NSSE) at cohesive (S1) and non-cohesive (N1) site for monthly intervals based on the two methods for production estimation: increment summation (P_s) and instantaneous growth (P_G). The production values are per stake.
