River bank erosion rates and the case for willow spiling as a bank stabilisation solution

Lenka Anstead MSc

Submitted for the degree of Doctor of Philosophy

**School of Environmental Sciences
University of East Anglia, UK**

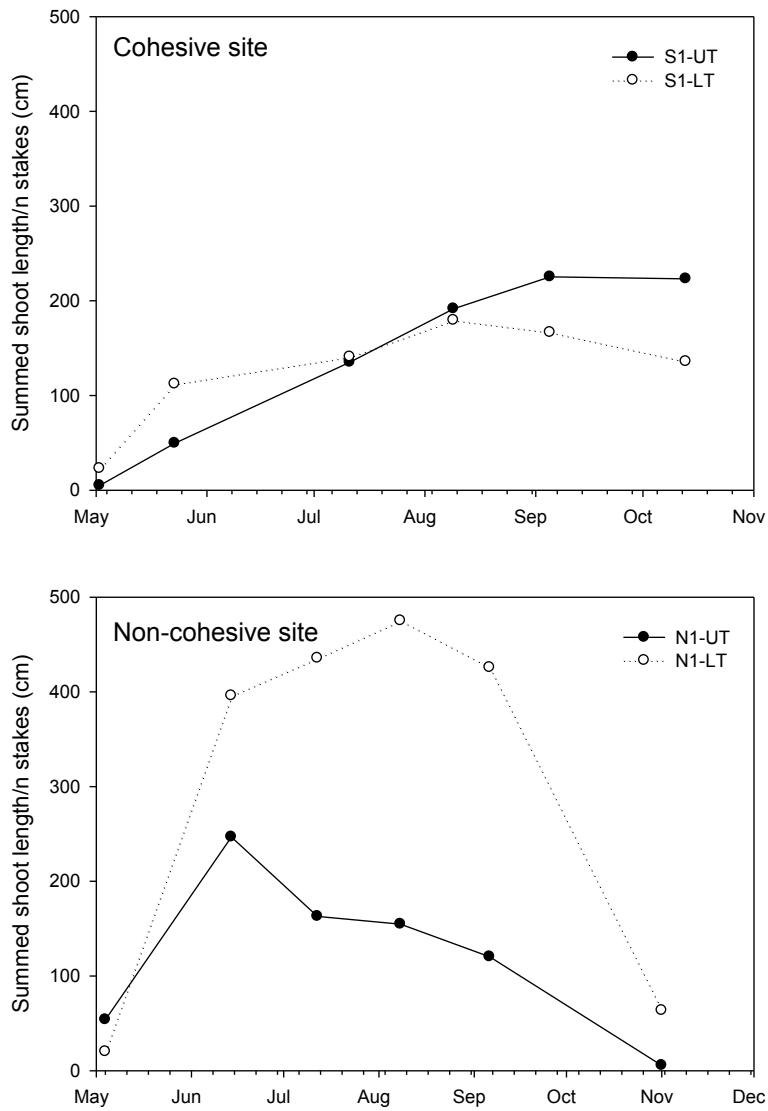
Fig. 5.3.16 Summed shoot length (cm) per stake at the sampling dates for each cohort.

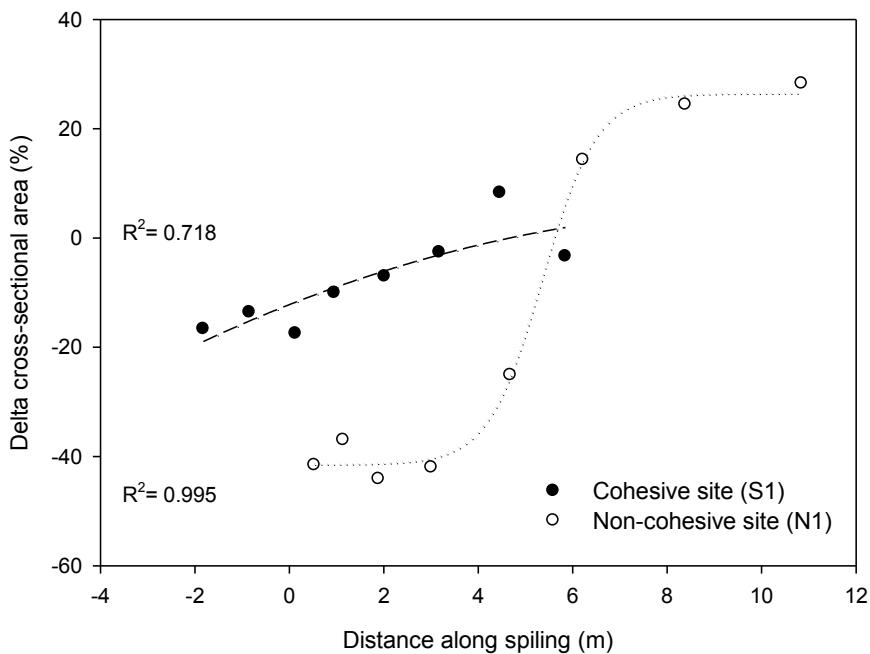
Fig. 5.4.7 Percentage difference of cross-sectional areas at the cohesive (S1) and non-cohesive (N1) site that occurred between November 2009 and March 2010.

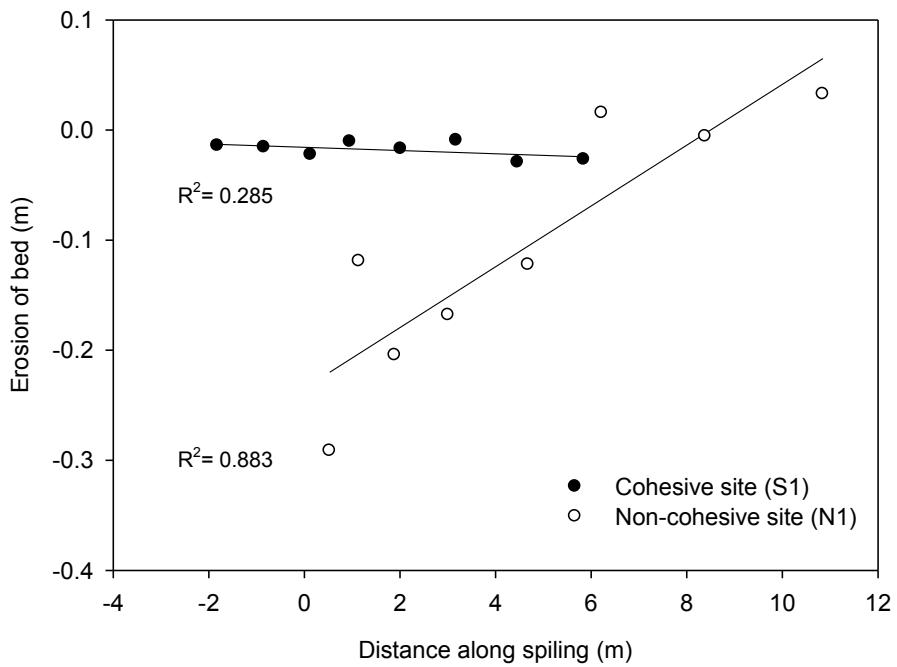
Fig. 5.4.8 Erosion of the river bed adjacent to the spiling that occurred between November 2009 and March 2010 calculated as a difference in elevation at zero cross-sectional area. The negative values on the x axis correspond with the section upstream of the spiling at the cohesive site.

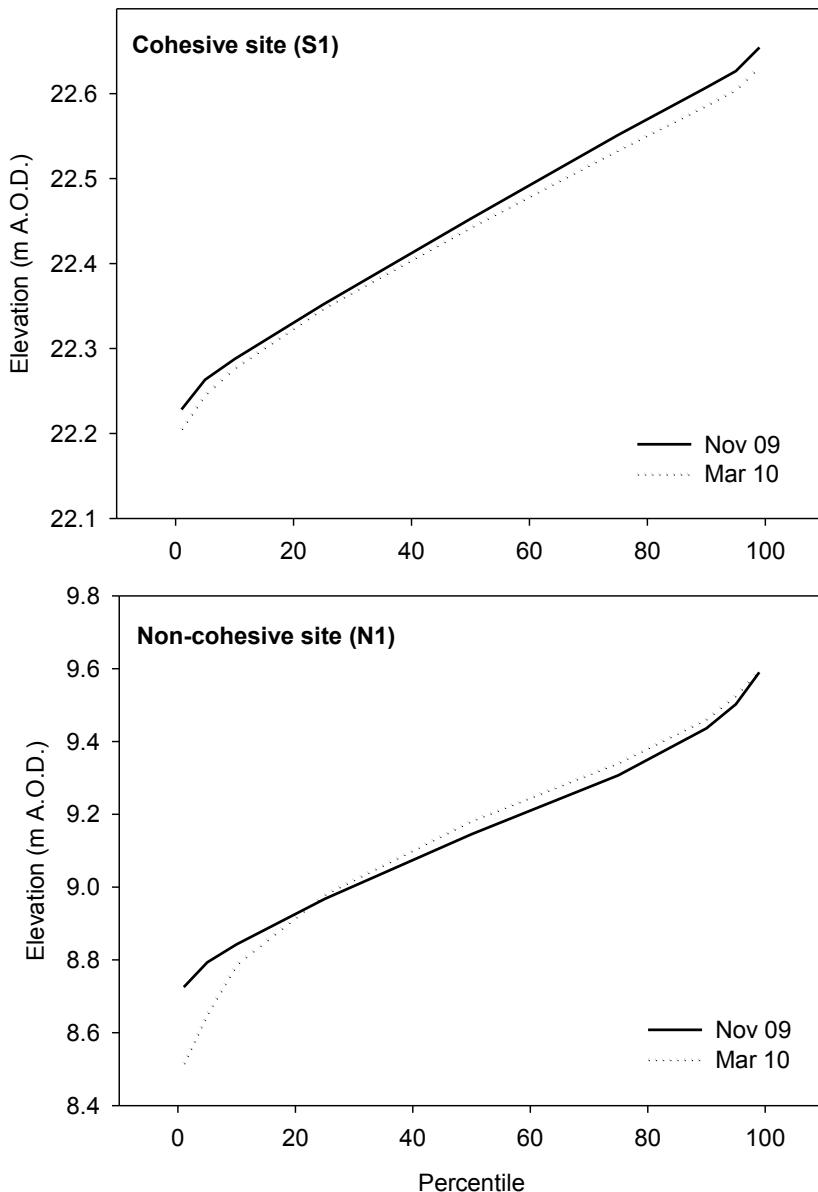
Fig. 5.4.9 Percentile distribution of elevation before and after high flow events at cohesive and non-cohesive site. The values for 1, 5, 10, 25, 50, 75, 90, 95 and 99 percentiles were plotted.

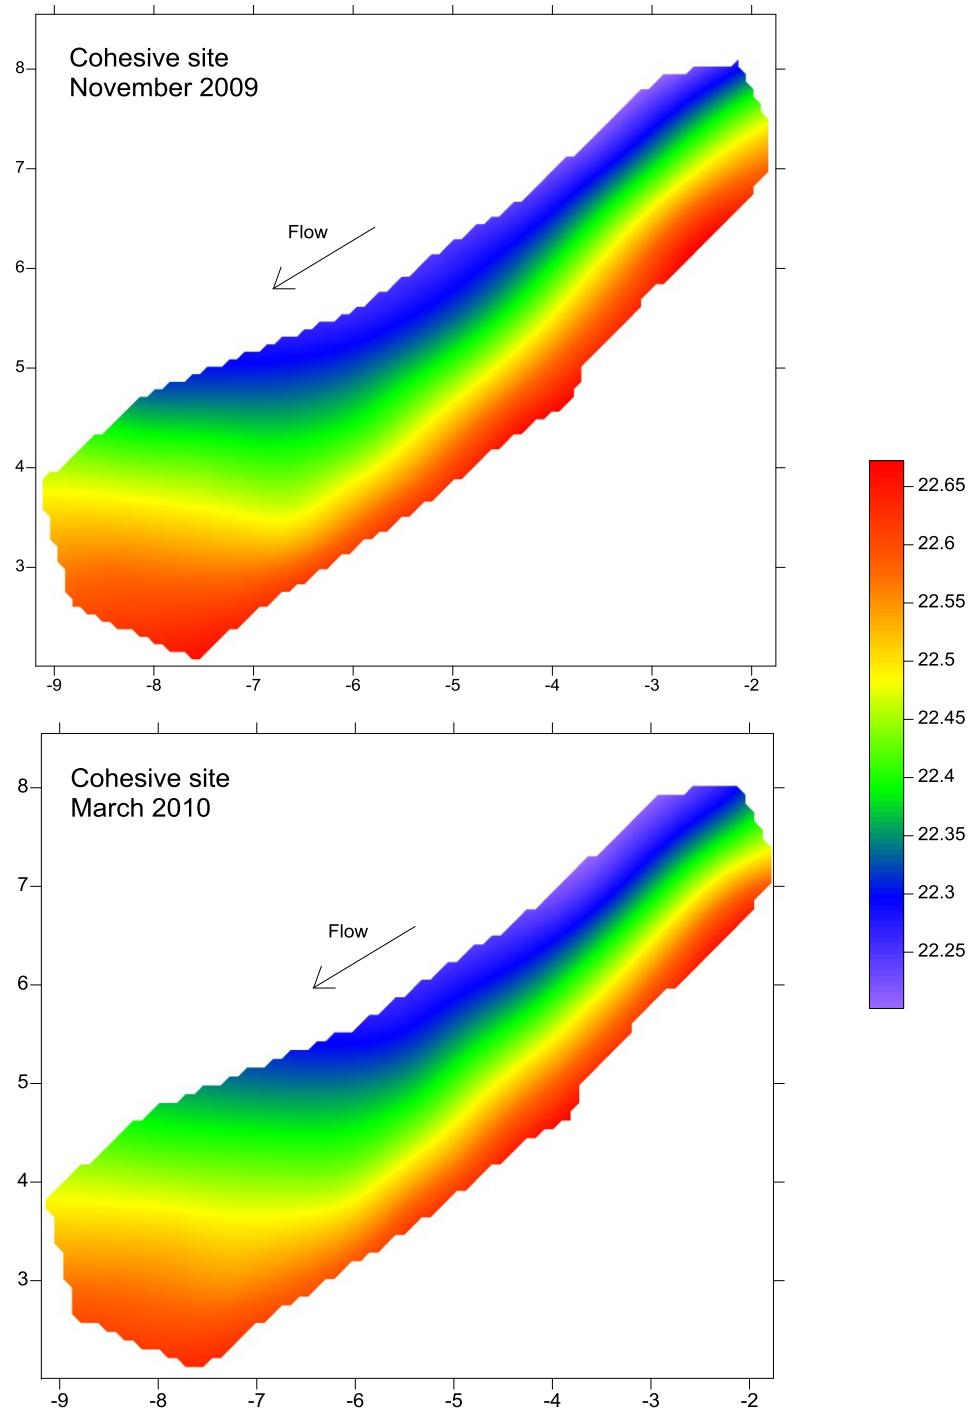
Fig. 5.4.10 Image map of the river bed at the cohesive site (S1) before and after high flow events. The shading is colour coded to represent each of the elevation values, shown by the scale on the right (as m AOD). The axes are coordinates in m.

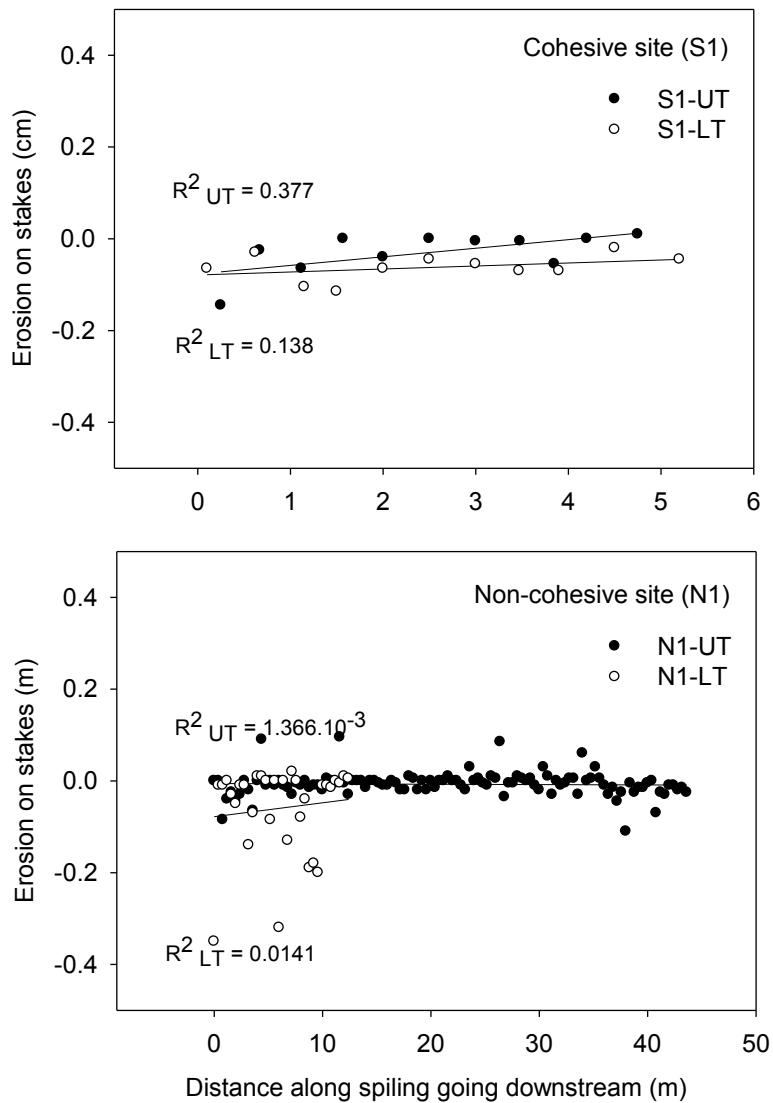
Fig. 5.4.14 Erosion on backfill that occurred on stakes in the upper (UT) and lower tiers (LT) at the cohesive (S1) and at the non-cohesive site (N1) recorded between November 2009 and January 2010.

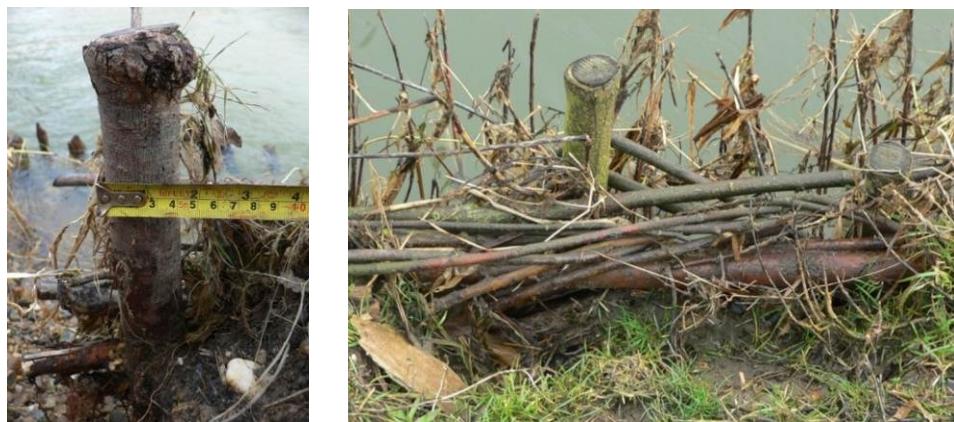
Fig. 5.4.15 Eroded backfill on the lower tier at the non-cohesive site in March 2010 with visible roots and woven part of spiling that was originally under the backfill.

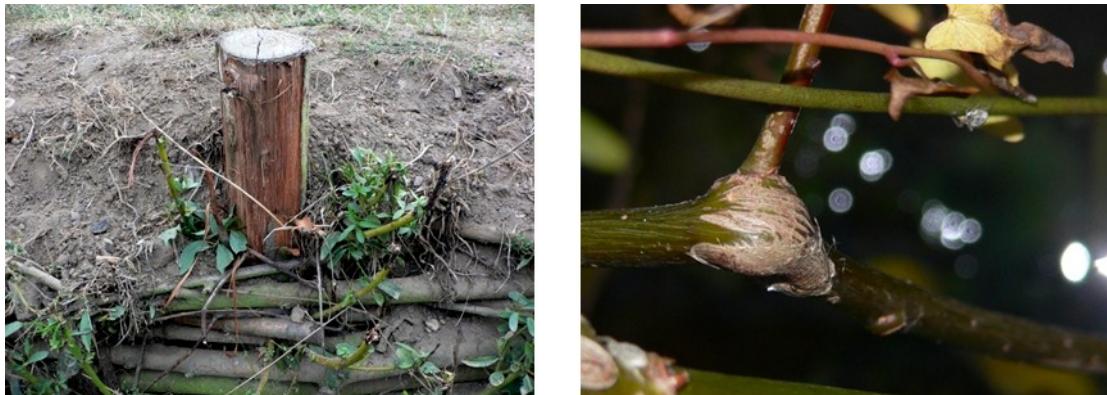
Willow stakes responded to the removal and damage to their primary shoots by producing secondary ones (called also the changing of apical dominance), comparable with pollarding and coppicing. As a response to stem damage, 'nodes' were formed where the stem was broken. In spite of the adaptations, repeated grazing and irreversible debarking (the removal of the live cambium layer) on the stakes significantly contributed to increased stake mortality during July and August 2009 because, in combination with drought, the plants were unable to regenerate (Fig. 5.5.8).

Fig. 5.5.8 Stake damaged by grazing at the gravel site (left), September 2009 and a recovery node created in the breakage zone on the stem (right).

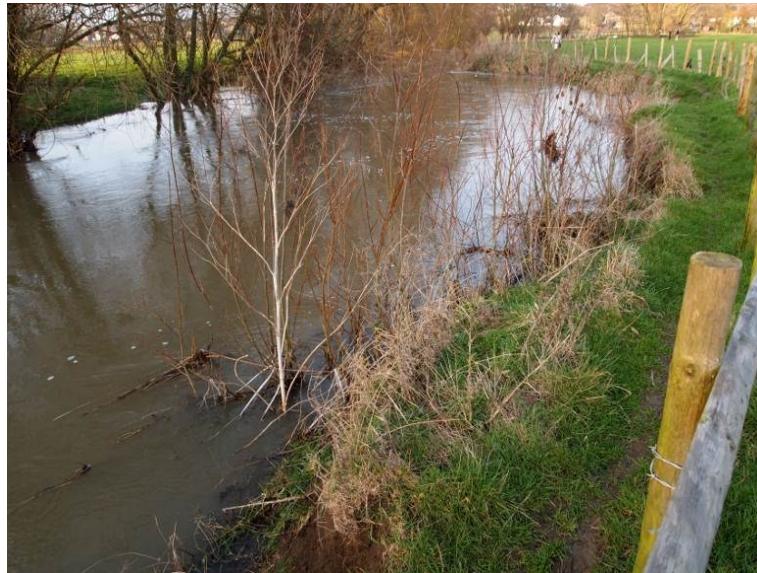
Fig. 7.1 Willow spiling in Sudbury at the S1 site on the River Stour, during a high flow event, looking upstream in March 2012. The spiling acts as a flow deflector and a trap for small floating debris and sediment.

Both willow spiling projects were visited on a few occasions after the biological and geomorphological monitoring had formally ended. The last visits took place in June 2012, over three years after both installations were established. While the revetment in Sudbury, S1 site, remained very much the same (Fig. 7.1) as three years previously, the spiling wall in Nayland, N1 site, had changed considerably (Fig. 7.2). The 50 m long eroding bank edge that was found to be retreating at a rate of up to 1.3 m per year before installing the revetment (see Chapter 3.4) has become stable, apart from two locations close to each other where the river flow reached behind the spiling and started to erode the bank edge. The total length of these failures was 4.5 m and the bank retreat rate there was 0.5 m. The upper tier on this stretch, apart from one stake, had failed to survive, the withies had dried out and disintegrated, and dead stakes had started to decompose. Without any vital root system, willow spiling is short lived (Chapter 4). Two stakes had already been removed from the revetment by the river flow. However, the lower tier had survived well, shoots were in abundance and it has been successful in protecting the bank from erosion. The shorter lower tier was expected to be undercut in the years immediately following installation (Chapter 5.4) as it was exposed to the highest flow velocities, yet this now appeared stable and well growing, with shoots around 4 m high.

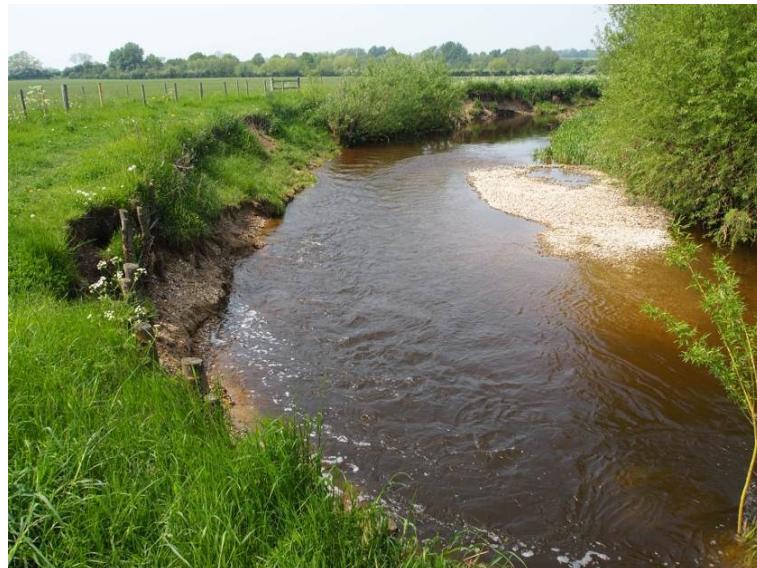
downstream section the channel bed and banks have started to erode and, over a small distance, the upper tier revetment has failed and the bank edge retreated (Fig. 7.2).

Fig. 7.2 Willow spiling at N1 site in Nayland on the River Stour in June 2012, looking upstream. Some dead stakes and scouring are visible on the left (right bank) and there is no growth from the revetment in the upper tier. On the other hand, a vigorous growth is seen from the shorter lower tier, in the top middle of the picture.

Changes to the river geomorphology at both sites were interesting and unexpected. At the Sudbury site the point gravel bar adjacent to the bank opposite to the spiling was entrained and some signs of early undercutting were noted on this bank. At the Nayland site the situation was more complex. Here, the bank was eroding upstream of the spiling and the intention had originally been to extend the revetment. This did not happen and the reed bed, which was increasing in size on the opposite bank, continued to deflect the flow to the right bank upstream of the spiling causing significant instability. The thalweg was imposed on the spiling yet the spiling itself dissipated the flow's energy but at the same time contributed to back-eddying upstream of the structure. The lower tier, that was initially expected to be undercut and fail, is now vital and is accumulating sediment. Downstream of the lower tier, the bank for a stretch of 10 metres appears relatively stable with some grass cover, but then there is another pool section that has deepened since the spiling was installed and the banks on both sides of the river have become steeper. At this
