1 **Dynamic liquefaction of shear zones in intact loess during simulated earthquake**
2 **loading**

3
4
5 **J. M. Carey¹, M. J. McSaveney¹ & D.N.Petley²**

9
10
11 **ABSTRACT**

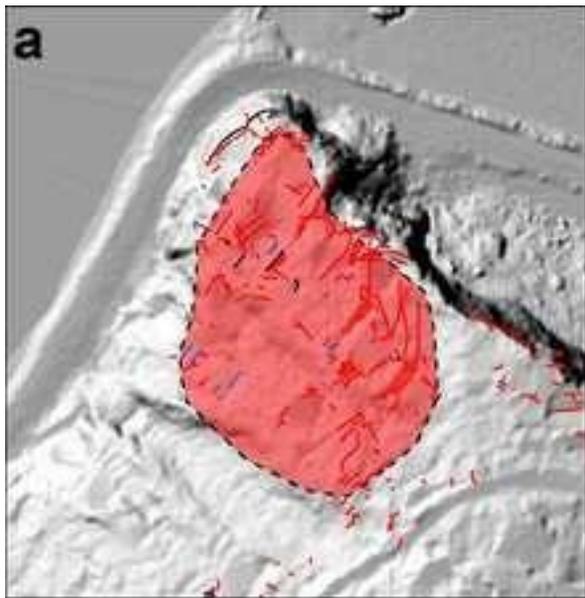
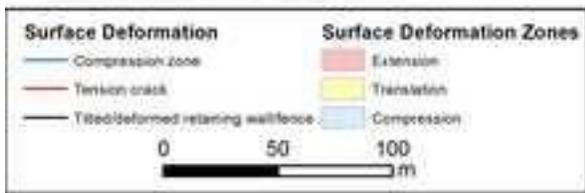
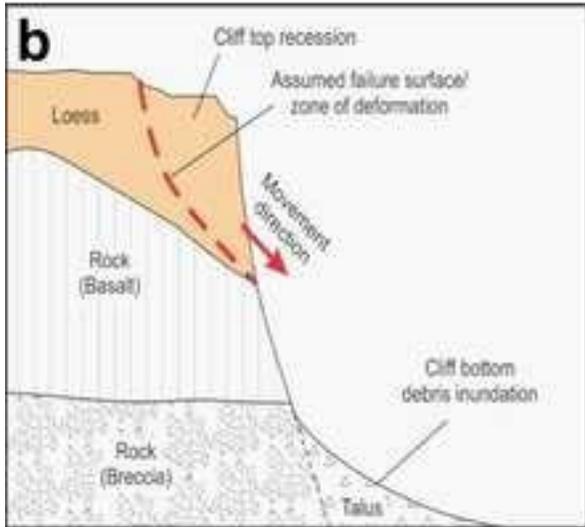
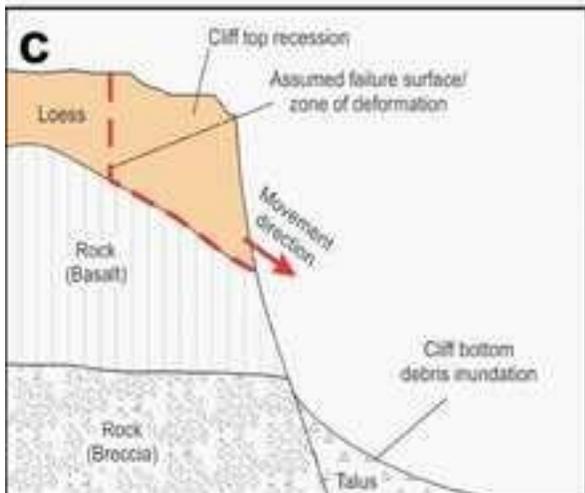
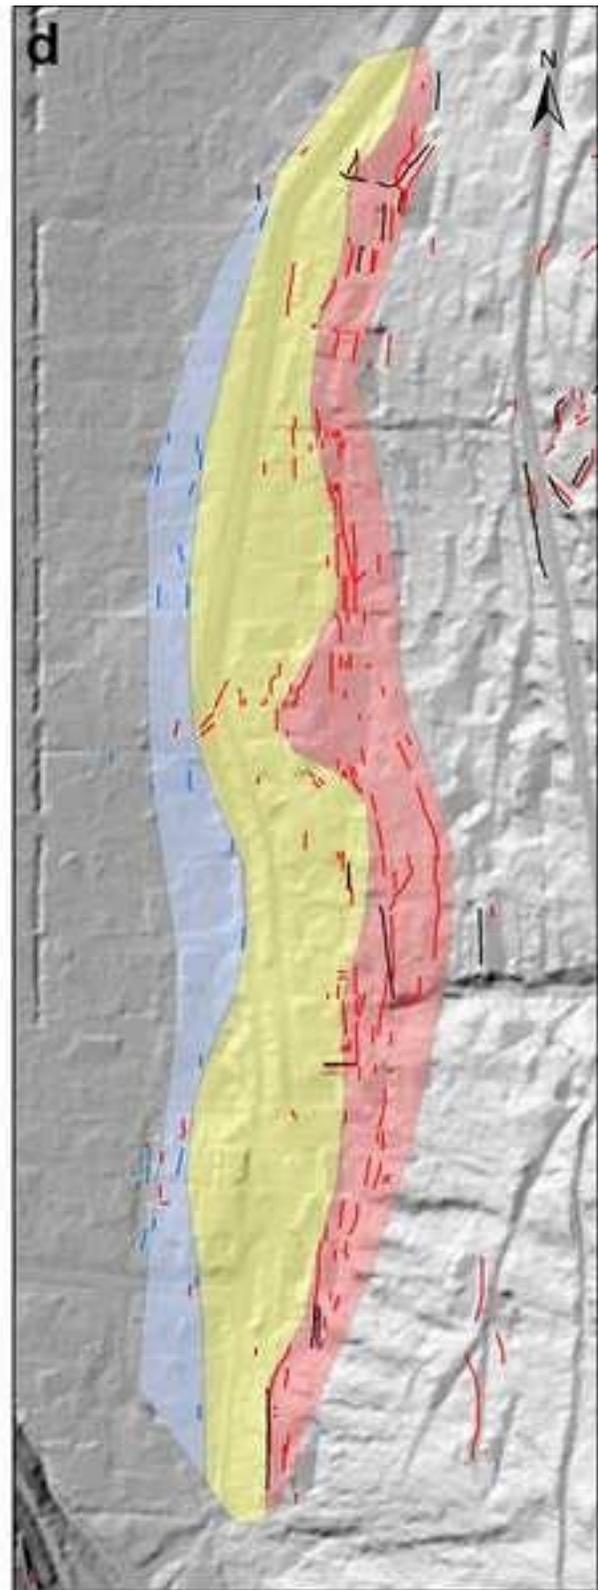
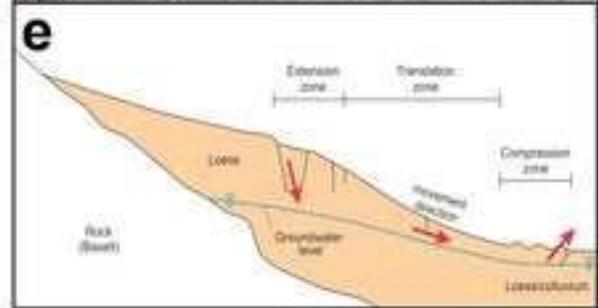
17 719 Figure 3. The Maffey's Road study site (a) Maffey's Road mass movement extent
18 based on surface deformation mapping and block sampling location (b) damage
19 720 associated with earthquake-induced ground movements at Maffey's Road and (c)
20 721 sampling of exposed loess slopes.
21 722

194 One of the many mass movement sites identified in the loess mantled slopes of the
195 Port Hills was at Maffey's Road (Fig 3). The site morphology indicated that the slope
196 formed as an embayment along a now-abandoned sea cliff, with localised evidence of
197 past landslide scars. The slopes above the cliff are, for the most part, mantled by loess.

233
234 Samples were collected as large intact blocks from the exposed loess cliffs at the
235 Maffeys Road site (Fig 3). Each block was hand excavated from the cliff to avoid
236 disturbance and, then wrapped to maintain natural moisture content before being
237 boxed to avoid damage during transport. Standard soil classification tests were
238 undertaken to establish the loess physical properties (Table 1 and Fig. 5). Particle-size
239 analyses (Fig. 5) confirms that that the loess is fine grained comprising of
240 approximately 50% Clay and 40 - 45% silt with the remaining fraction consisting
241 mostly fine and medium grained sand. The natural moisture content was measured at
242 9.1% (Table 1) and a plastic limit of 16%; a liquid limit of 25% and plasticity index
