# Landslides

## Patterns of movement in the Ventnor landslide complex, Isle of Wight, southern England

**Patterns of movement in the Ventnor landslide complex, Isle of Wight, southern England**

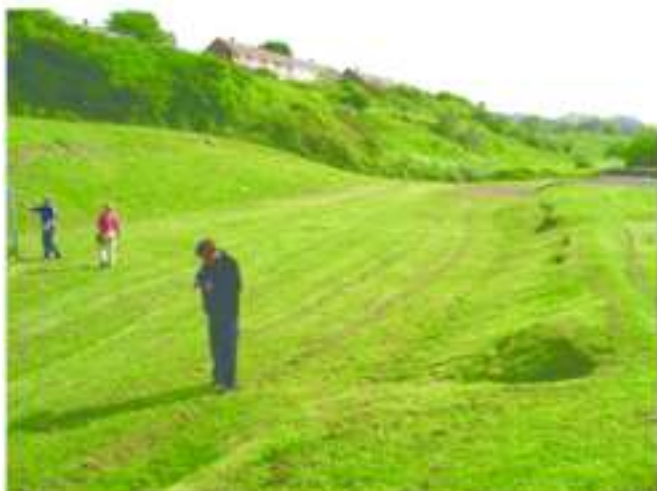
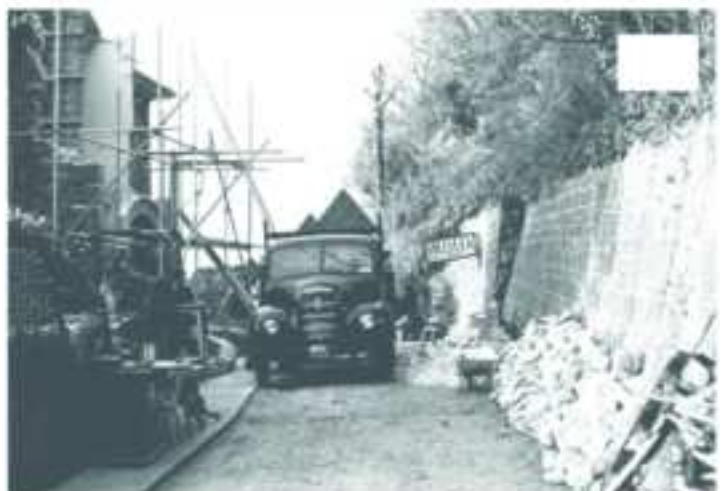
Figure 3  
[Click here to download high resolution image](#)

The key geomorphological features of the Ventnor landslide complex (Fig 3) comprise:

**Figure 3.** The spatial distribution of damage in relation to landslide geomorphology, mapped by Geomorphological Service Limited (1991) and modified from Moore et al., (2010), (P1) the Lowtherville Graben photographed in 2005, (P2) damage recorded at Bath Road during ground movement in 1960 (reproduced from Moore et al., 2007a).

The relationship between building damage and the geomorphology (Fig 3) indicates that the most severe damage in historical times has occurred within the Lowtherville Graben. This damage indicates on-going landslide displacement and has continued at the graben to the present day (Fig 3, P1).

1 Observations of ground deformation generally follow periods of prolonged rainfall (e.g. the wet winter  
2 of 2012) resulting in the need for continued maintenance of the Newport Road (Anon, 2013). The  
3 damage further shows the lateral shear between two distinct landslide units, which extends seaward  
4 from the graben in upper Ventnor to the west of Bath Road (Fig 3, P2). Less severe damage is  
5 concentrated along the edges of separate landslide blocks in upper Ventnor and along Ventnor Park  
6 Road in Lower Ventnor (Fig 3).  
7  
8  
9
