Does bone debris in anterior cruciate ligament reconstruction really matter? A cohort study of a protocol for bone debris debridement

Abstract – Background: The purpose of the current study was to determine whether a systematic five-step protocol for debridement and evacuation of bone debris during anterior cruciate ligament reconstruction (ACLR) reduces the presence of such debris on post-operative radiographs.

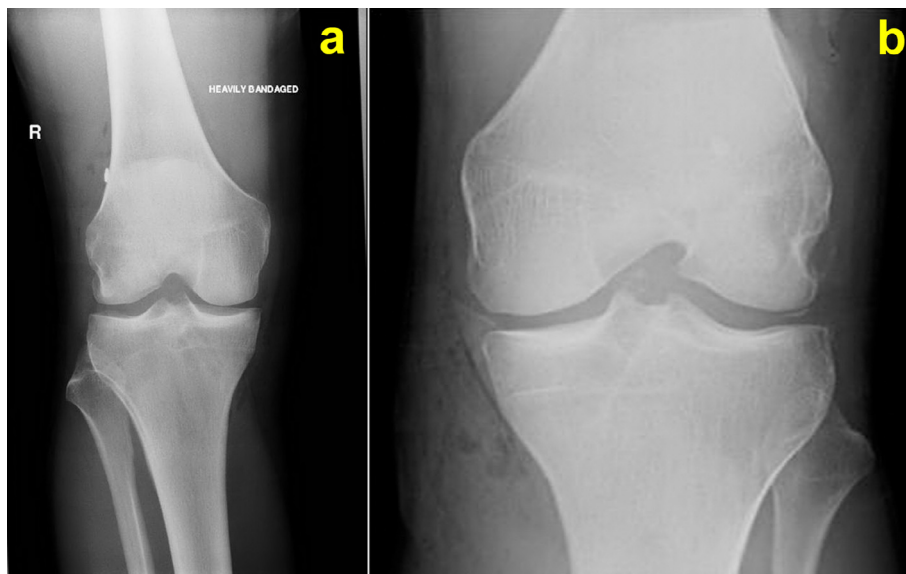
Figure 1. (a) Post-operative anteroposterior view of a right knee after ACLR showing no debris, (b) post-operative anteroposterior view of a left knee after ACLR showing debris.

The pre- and post-operative radiographs of all patients were reviewed and evaluated by one blinded expert in musculoskeletal radiology for the presence of debris to assess the effectiveness of the proposed protocol (Figures 1a and 1b).

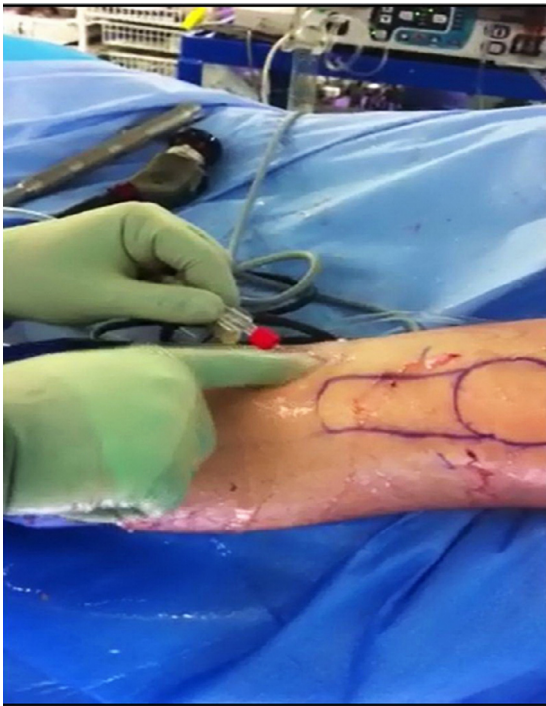
Figure 6. Debriding the tibial tunnel opening at the end of operation.

Prior to closure, the donor site is washed thoroughly to clean it from all debris (which might have accumulated after tibial drill bit retrieval) using the irrigation fluid (Figure 6).
