THE KASHMIR, PAKISTAN
EARTHQUAKE OF 8 OCTOBER 2005
A FIELD REPORT BY EEFIT

A FIELD REPORT BY EEFIT

Dr Navin Peiris
Dr Tiziana Rossetto
Dr Paul Burton
Mr Suqlain Mahmood

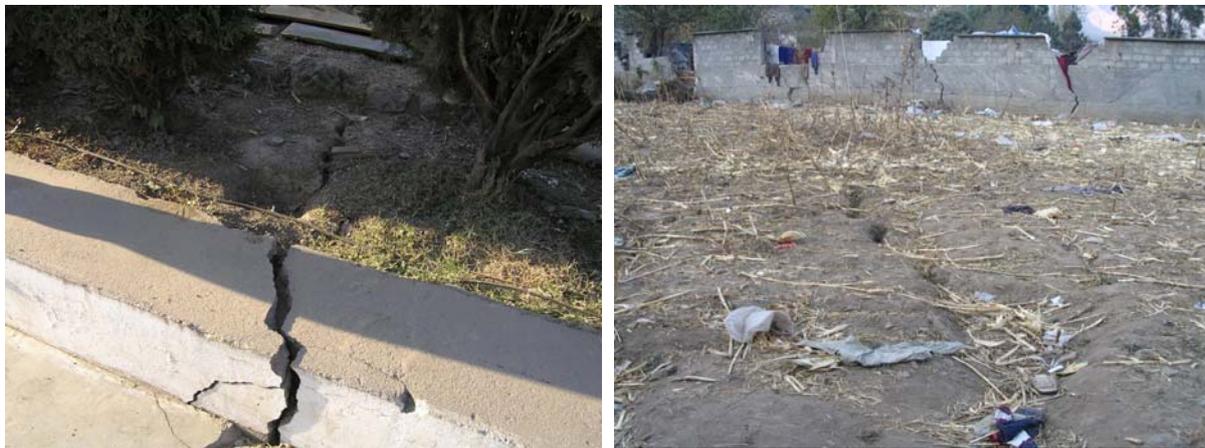
The surface trace of the causative fault as interpreted from the map of ground displacements from radar amplitude measurements (COMET, 2005) approximately coincides with that predicted by Bilham (2005) from observation of the location and orientation of large landslides resulting from the event. The majority of the landslides were indeed observed by Bilham (2005) and by EEFIT to extend from Balakot to a few kilometers SE of Muzaffarabad. An extension of this line of landslides was also observed by EEFIT together with Dr Bijan Kazai of the EERI team to coincide with a series of ground cracks running for 200-300 m through the town of Balakot (see Figure 3.2 for location). These were not associated with any direct land sliding and might be a further surface expression of the fault movement below the earth's surface or simply one of local slumping (Figure 2.8). The two black dots plotted on Figure 2.6 show some of the GPS readings taken of the crack trace. These dots are seen to lie almost directly over the fault line location prediction made by COMET (2005). However, this is a preliminary observation and more detailed follow up work on our observations is required before anything may be concluded. It is likely that fault rupture on the Muzaffarabad fault was mostly "blind" since there are many blind thrust faults in the region (MonaLisa, 2005).

Figure 2.8: Photos of ground cracks observed by EEFIT and Dr Bijan Kazai (of Columbia University, New York, and member of EERI team) to run through Balakot in a NNW-SSE direction

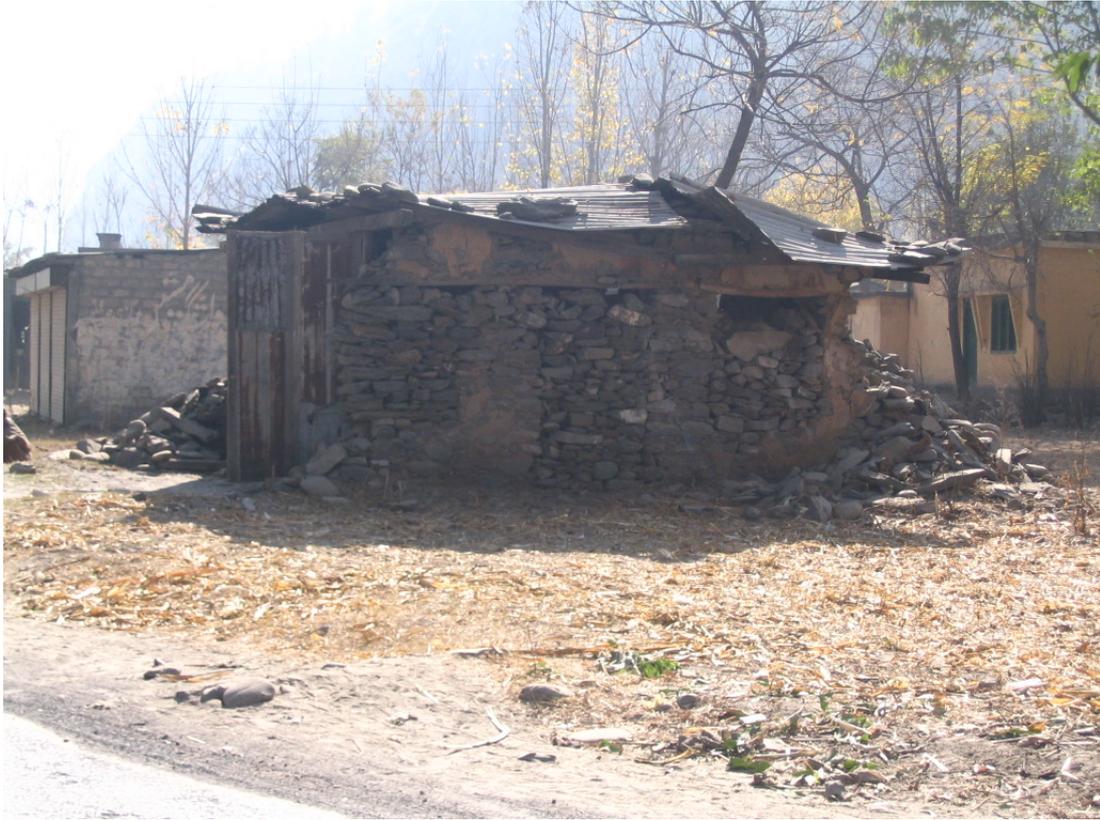
Figure 3.1: Typical unreinforced stone masonry wall house (Katcha house)

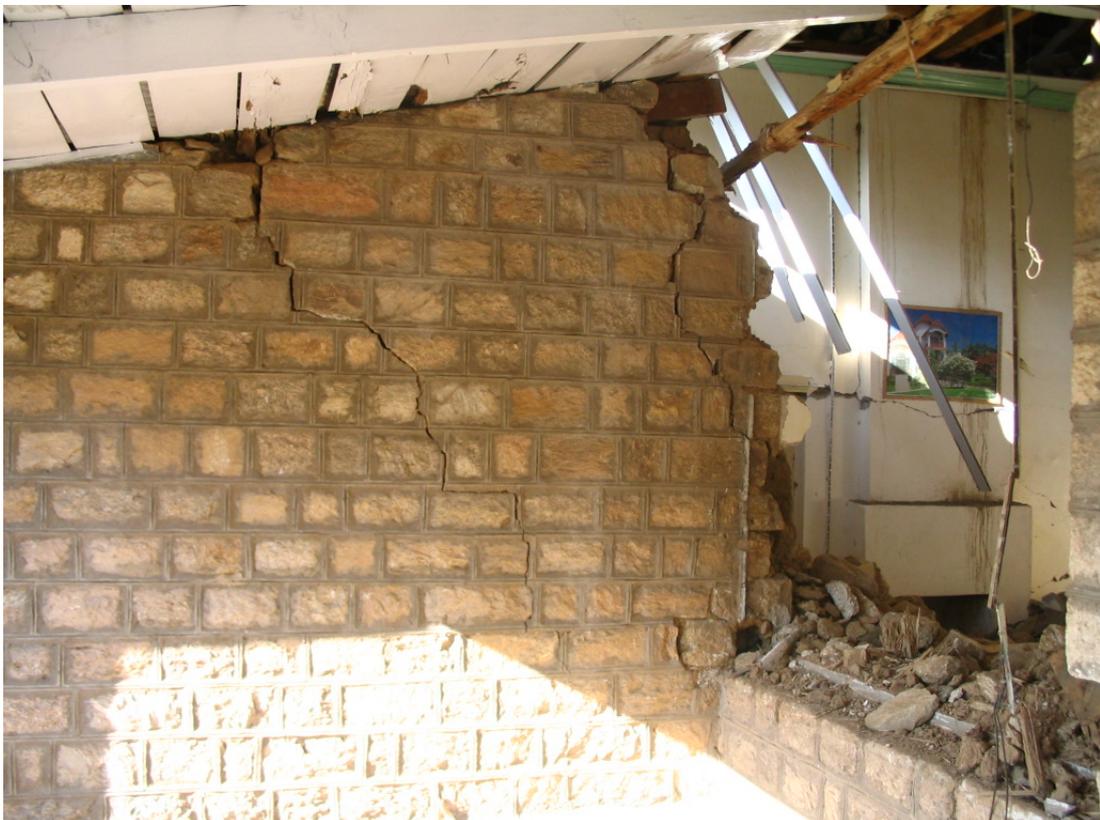
These buildings consist of walls made of stone (mostly rounded) irregularly laid in a cement, sand mud mortar or in some cases dry stacked. The roof is either a flat thatch/mud roof supported on wood beams or irregularly placed corrugated galvanized iron (GI) sheets. Figure 3.1 shows a typical unreinforced stone masonry building used for residential purpose. These types of houses locally known as “Katcha” or non-permanent houses are very common in rural or village areas rather than in the cities. Stone masonry buildings used for government or official buildings have stones that are cut and laid regularly using cement sand and mud mixtures with lintel beams above openings. Figure 3.2 shows the cracked walls of a government agricultural research office building north of Mansehra.

Figure 3.2: Typical unreinforced stone masonry government or official building

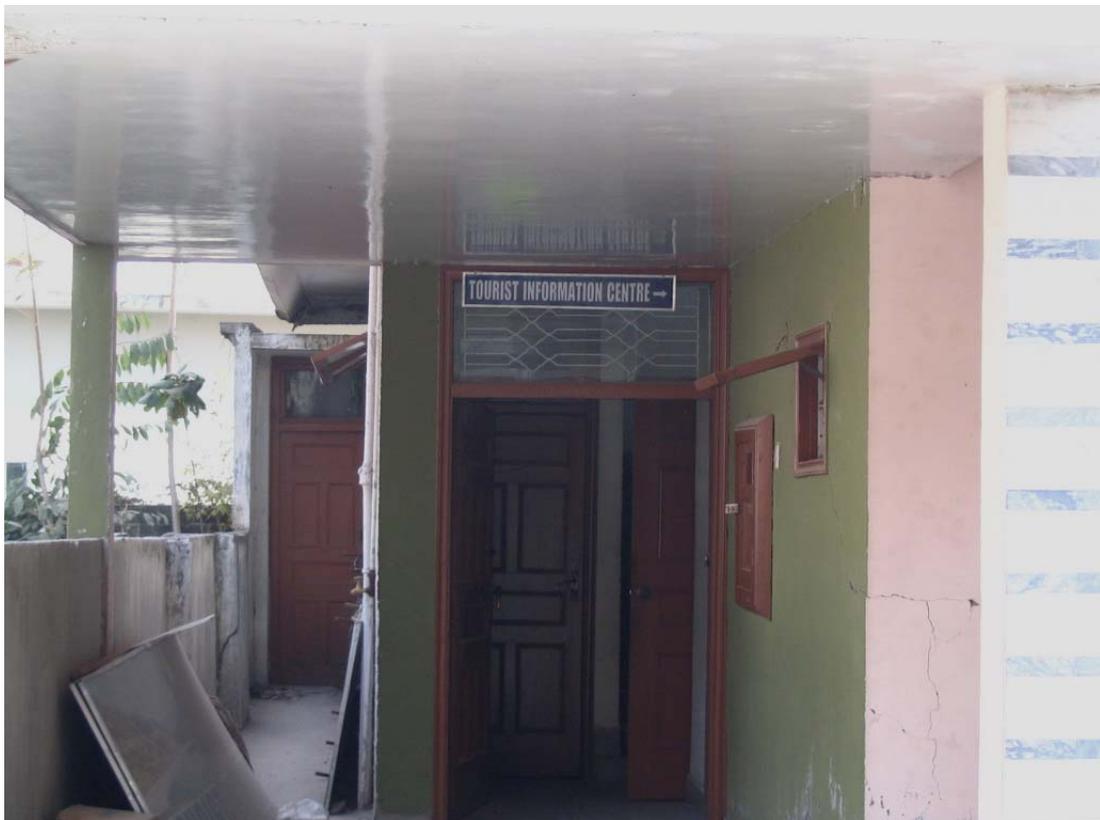
Figure 3.6: Unreinforced brick masonry government building in Muzaffarabad

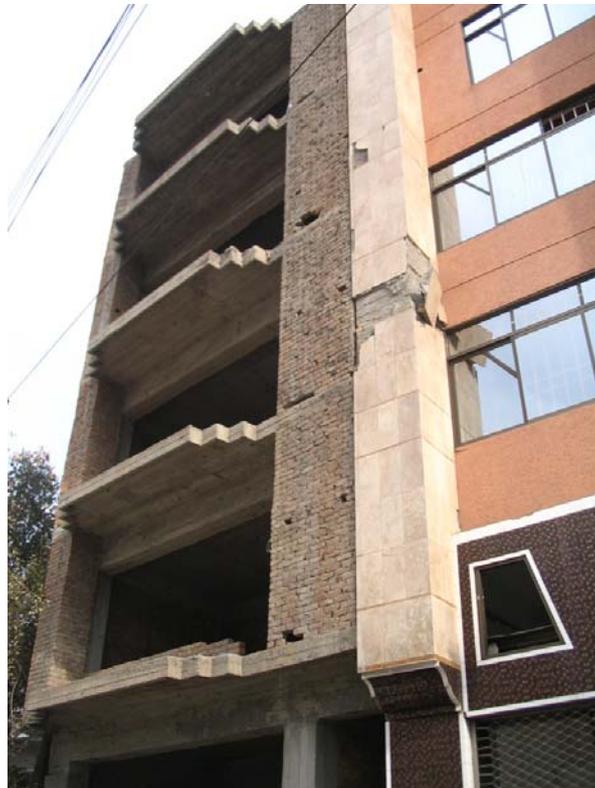
Figure 3.8: Multi-storey RC building under construction adjacent to an existing office building in Muzaffarabad

Reinforced Concrete (RC) construction is primarily used for commercial and retail buildings. The configuration consists of an RC frame with masonry infill. Figure 3.7 shows a typical RC frame commercial building, which was moderately damaged during the earthquake. Multi-storey RC structures have a composite RC frame and slab structure which extends to the roof level often used for housing services such as water tanks, air conditioning units etc. Figure 3.8 shows a multi-storey building in Muzaffarabad under construction adjacent to an existing multi-storey building used for office and retail.

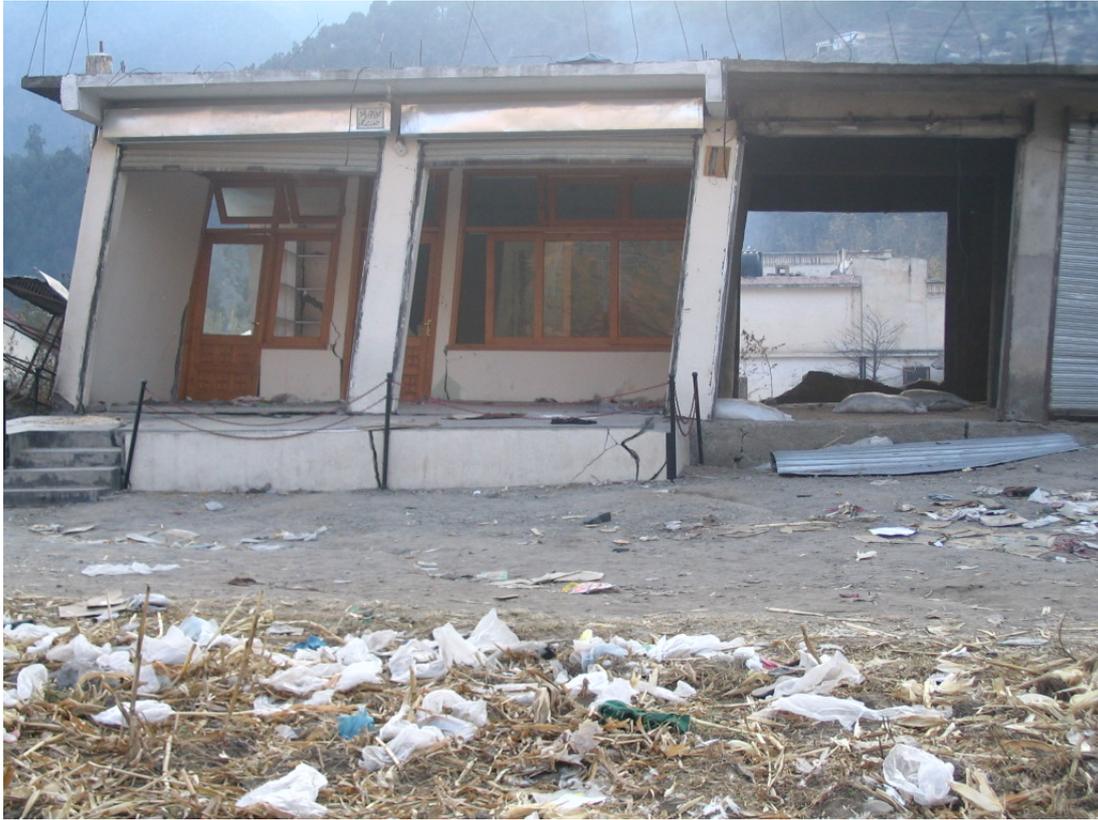
Figure 3.18: Deformed RC frame structure with rotation at the column/slab connection

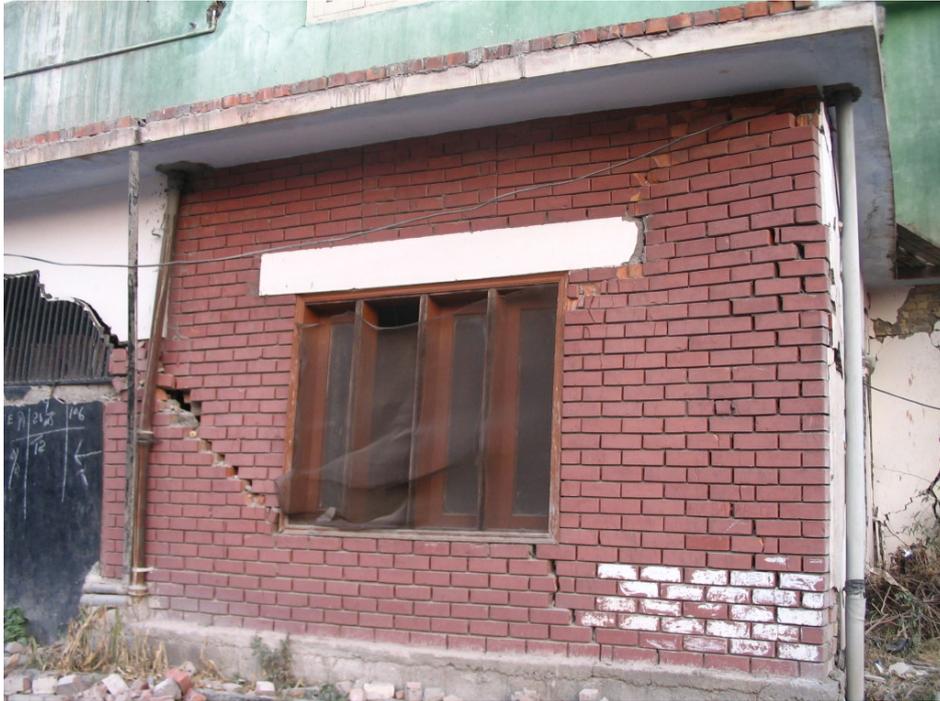
Figure 3.21: Diagonal shear cracks through window on a brick URM residential building, moderate damage, Muzaffarabad

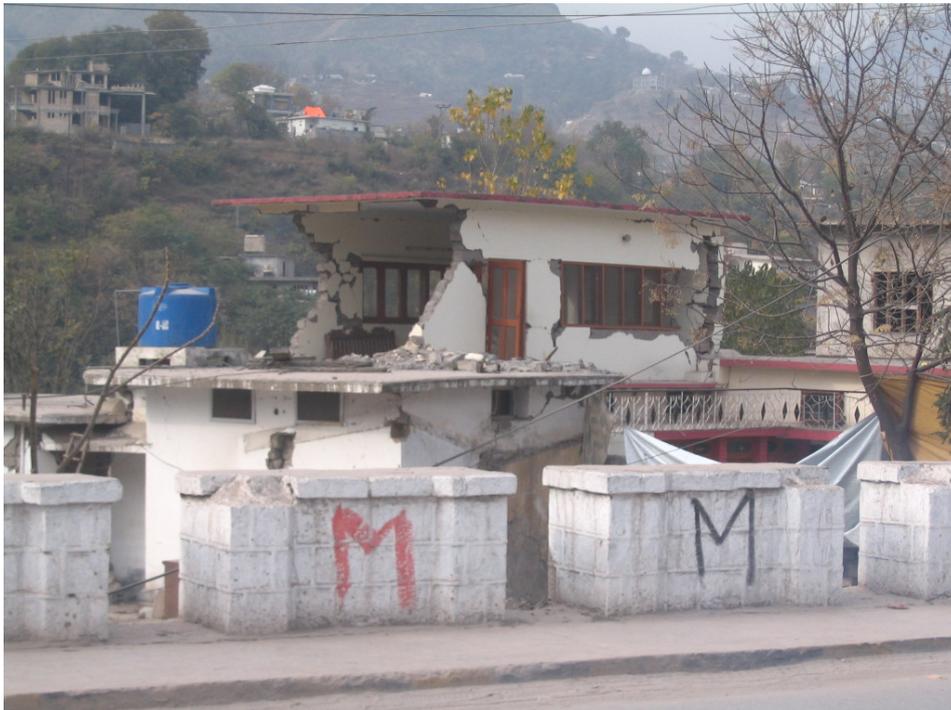
Figure 3.22: Partially collapsed upper floor walls of a 2-storey concrete block URM residential building with RC slab floors and roof. Shear and out-of-plane failure of concrete block bearing walls, Muzaffarabad

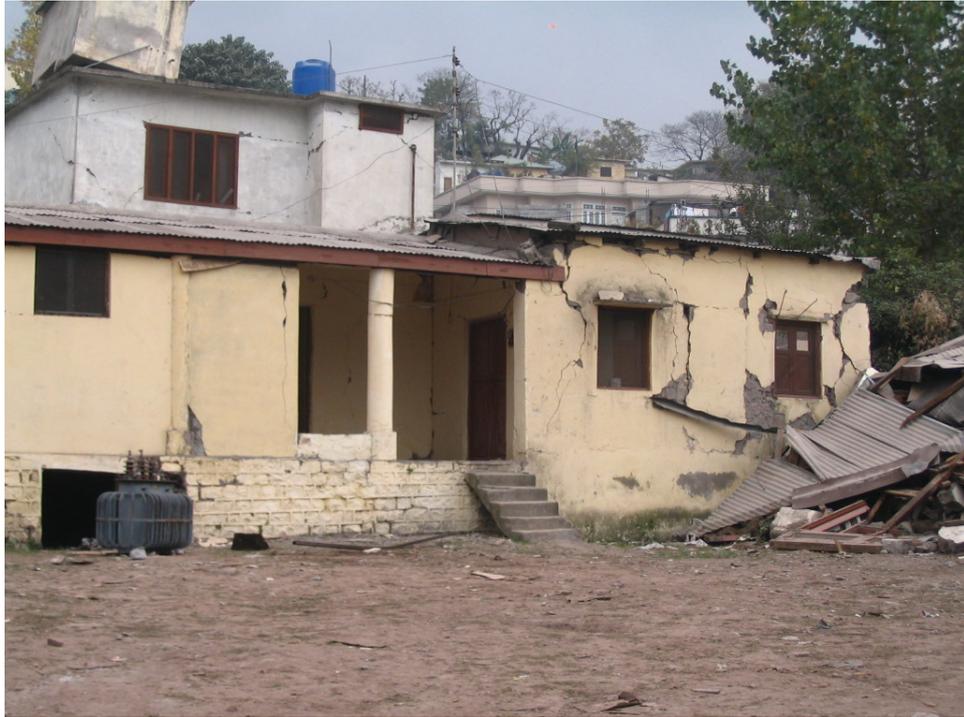
Figure 3.23: Shear cracks through the concrete block masonry wall of a residential building, moderate damage, Muzaffarabad

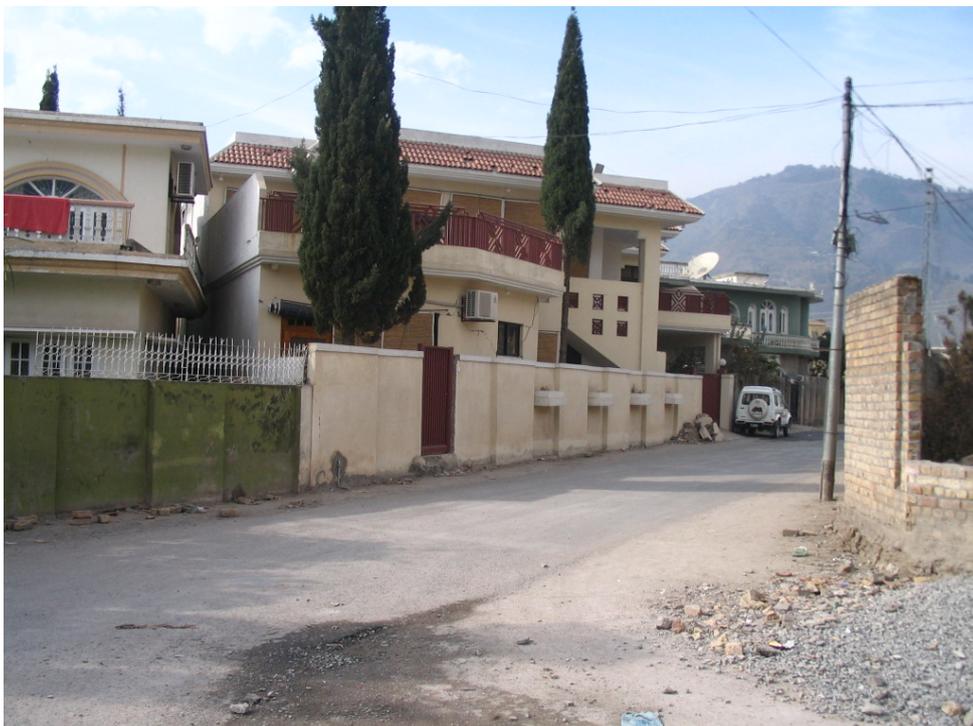
Figure 3.24: Undamaged RC frame and slab residential building with concrete block masonry infill walls, Muzaffarabad

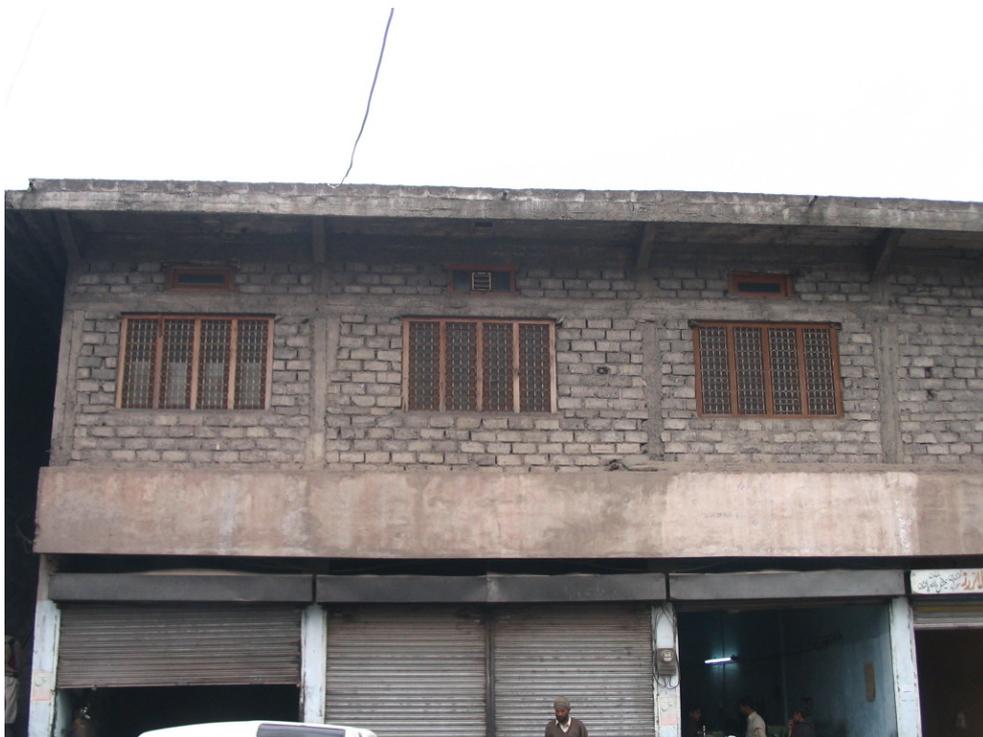
Figure 3.28: Undamaged RC frame and slab commercial building with concrete block masonry infill walls. RC lintel beam continuous over the structure perimeter, Muzaffarabad

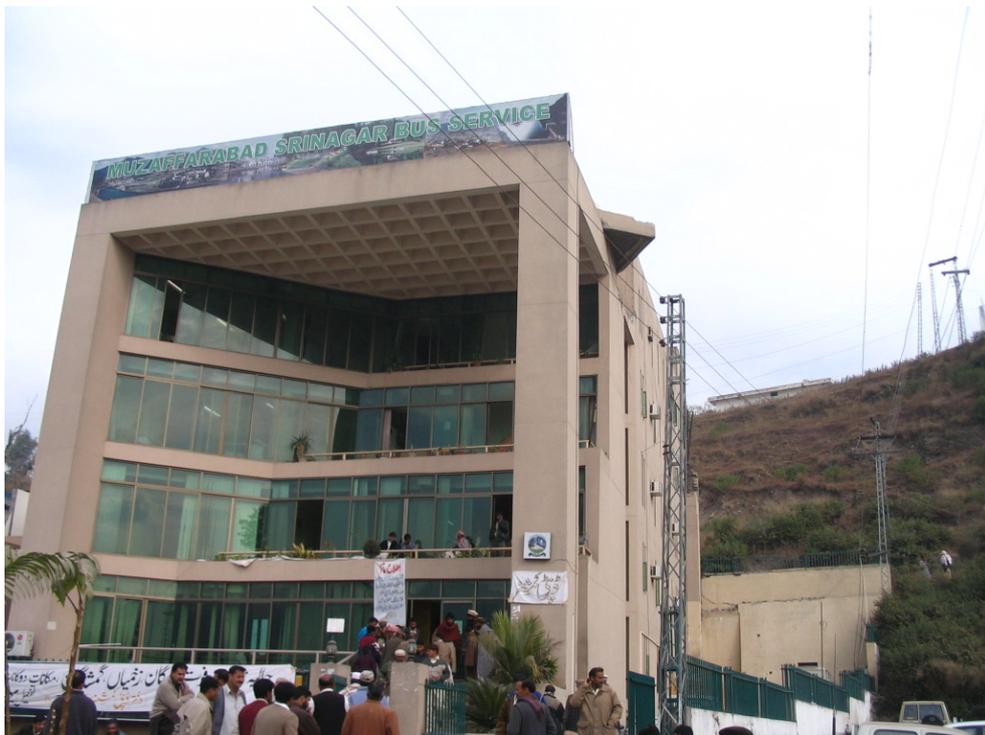
Figure 3.34: Undamaged RC frame and slab commercial building, Muzaffarabad

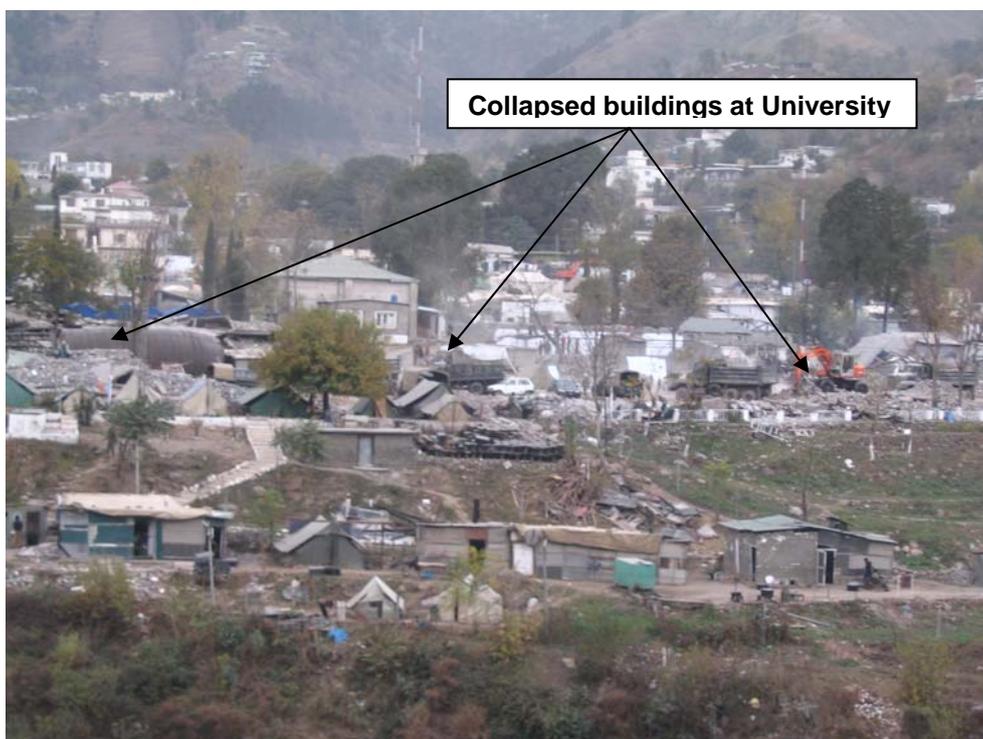
Figure 3.42: Collapsed concrete block URM buildings of the University of AJK, Muzaffarabad

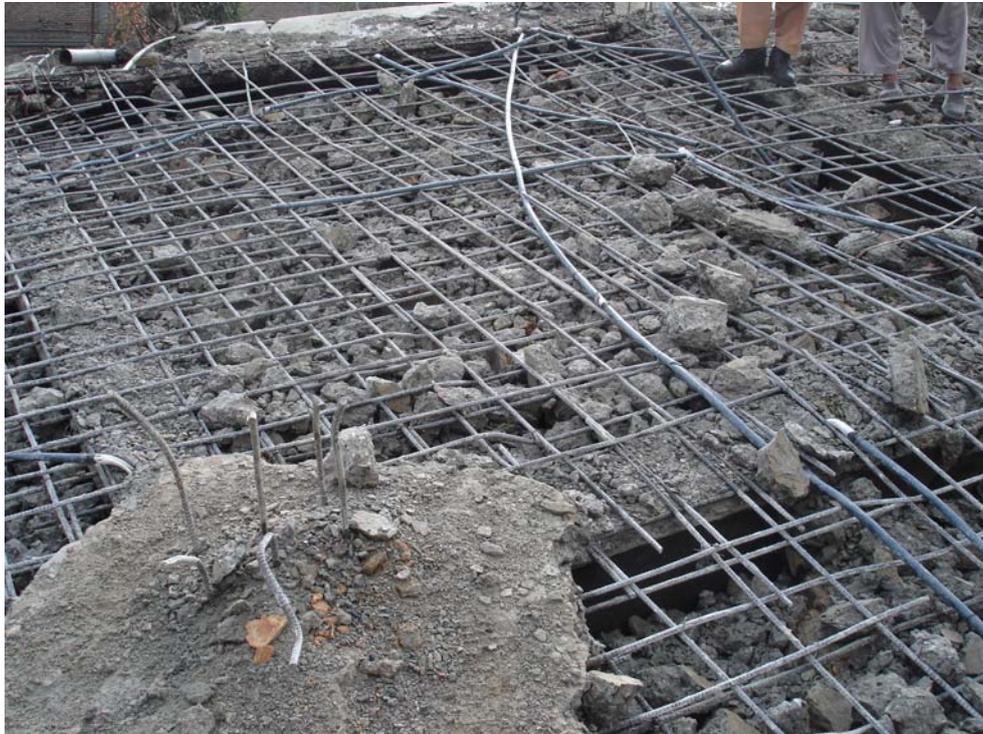
Figure 3.45: Reinforcement layout of a collapsed slab revealed after removing the concrete

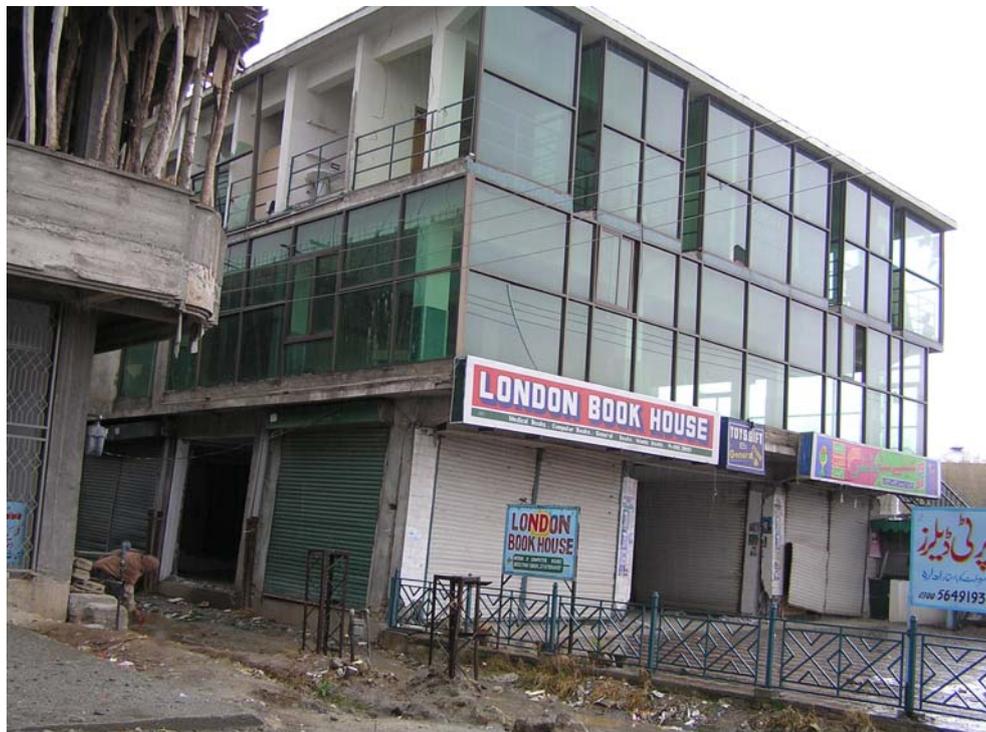
Figure 3.49: Permanent drift at ground floor due to soft-storey in RC frame and slab 3-storey commercial structure, Abbottabad. The ground floor drift prevented large deformation at upper floors, hence glass frontage was intact

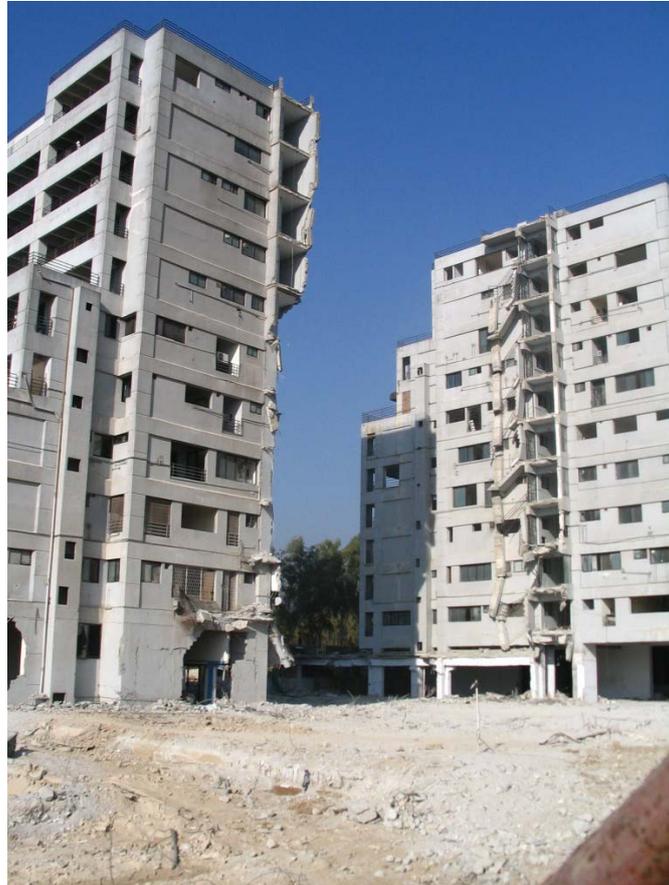
Islamabad is located about 100km southwest of the epicentre and experienced moderate ground shaking from the earthquake. The only major collapse reported was one of the 11-storey residential apartment buildings in the Margala Towers complex constructed just over 10 years ago. Figure 3.50 shows the site after clearance where the adjacent buildings were unoccupied at the time of the survey.

Figure 3.50: Margalla Towers and the site of the collapsed building in Islamabad

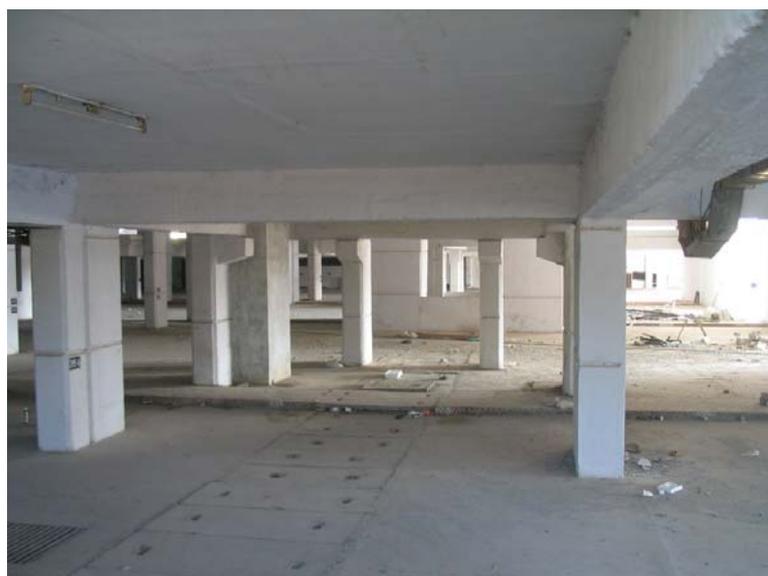
Figure 3.51: Soft-storey basement in a building adjacent to the collapsed building at Margalla Towers

About 100 people died during the building collapse, however there were no reported secondary damage or casualties due to fires. Inspection of adjacent buildings gave clues on the nature of the construction of the collapsed building. The floors of the building are reinforced concrete slabs supported on reinforced concrete beams and columns founded on probably a raft foundation. Each building has a basement and therefore the basement floor is a soft storey as shown in Figure 3.51. The adjacent buildings do not indicate damage to the reinforced concrete elements except spalling of concrete at the movement joints between adjacent buildings due to pounding during the earthquake. The masonry walls acting as partition walls for the apartments show in-plane and out-of-plane shear cracks. The building that collapsed was the last to be constructed in the complex. The fact that adjacent buildings did not suffer major damage to the structural load bearing elements suggests that the collapsed building may have been defective, for it to suffer a major collapse due to the ground motion 100km from the epicentre.

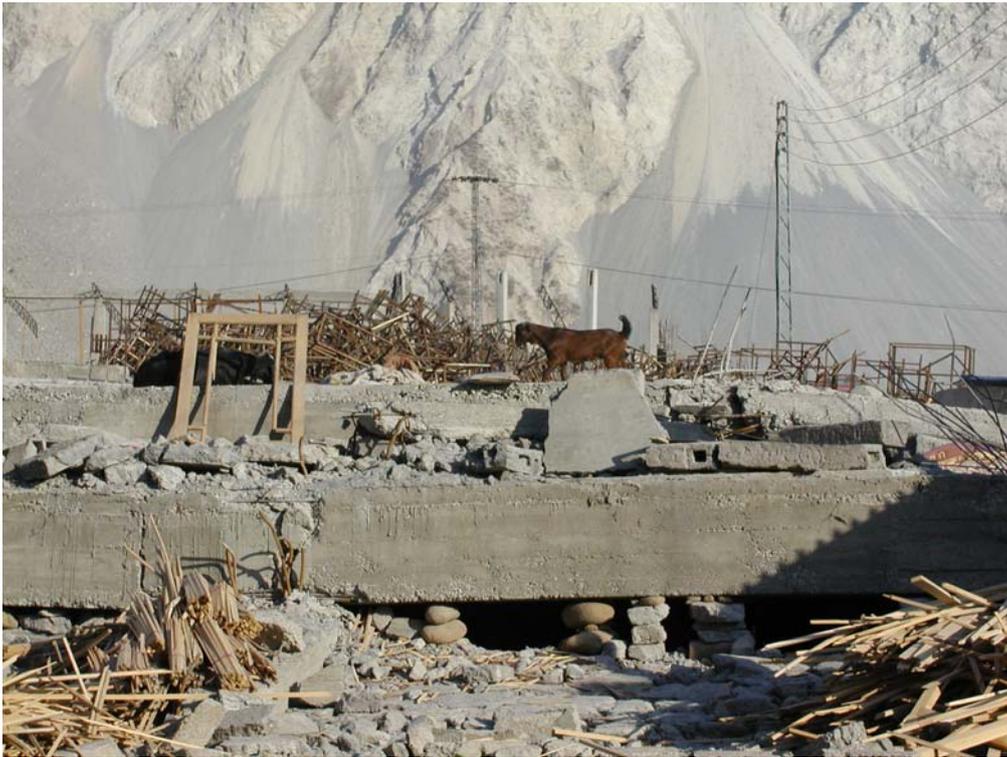
The Chela Bandi, Muzaffarabad landslide is viewed in Figures 4.4 and 4.5 along the eastward pointing arrow indicated in the satellite imagery of Figure 4.6. This landslide temporarily blocked the Nilam River which can be seen in the satellite image (Fig. 4.6) flowing N to S and around the city of Muzaffarabad, but this blockage was quickly breached. This impressive landslide, although deep cutting, is largely surficial. Most of the debris detached from the dolomite limestone mountain side is shale and dolomite. Its extent is about $1.5 \times 0.5 \text{ km}^2$ and probably has volume close to 10^6 m^3 . Other landslides are visible in this image to the E of Muzaffarabad and elsewhere. The fault (Balakot-Murree-Muzaffarabad) probably lies at the foot of the landslide in these photographs and satellite image. The main face of this mountainside and landslide runs NNW-SSE and faces WSW and the hanging wall along the Balakot-Murree-Muzaffarabad Fault underwent elastic rebound of at least 3 m horizontally to the SW accompanied by 4-5 m uplift (Figure 4.2). An additional but vital point is that the Muzaffarabad landslide at A in Figure 4.7 is adjacent to the maximum coseismic slip in the major asperity on the fault plane model between Balakot and Muzaffarabad.

Figure 4.4: Kashmir earthquake October 8, 2005. Landslide in dolomite mountainside just north of Muzaffarabad at Chela Bandi

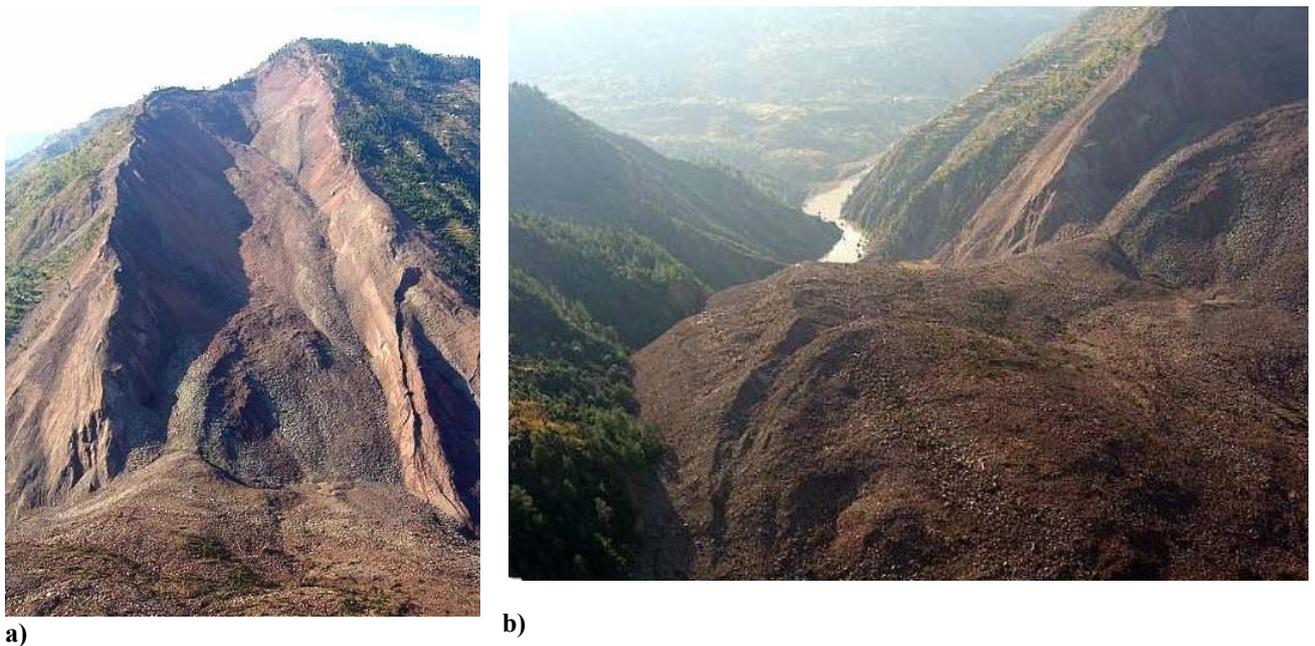
The second deep cutting landslide to be considered is the most significant; this is the Hattian slide (according to Schneider, 2006, also referred to as the Chikar slide, the Dana slide, or the Dandbeh slide,) and this occurred at location “slide B” in Fig. 4.2 displacement map, which is just south of the township of Bhagsar and the Jhelum River in the Pir Punjal Mountains. Schneider (2006) places the origin of this slide on Dana Hill (2080 m above sea level at 34° 09' N, 73° 43' E) and its run (Fig. 4.8a-b) buried the village of Dandbeh. The extent of the slide from origin scarp to toe indicated by arrow in the photograph Fig. 4.9 is about 2,850 m long (C. Scawthorn, personal communication) with volume in the range 1-6 10^6 m³. The run down reported by Schneider was a drop of 1,000 m and distance of 2.75 km covering an area of 5 km² within half a minute. The slide then ran up the far side of the valley, overtopping the crest and into the next valley. It dammed two tributaries of the Jhelum River and so also formed a tertiary hazard of future flooding from two dammed lakes, the larger being in the first valley crossed and the second smaller dam and lake being in the second valley. There is evidence of an earlier slide at this locality, overridden by the Hattian slide and perhaps associated with an earthquake in 1955 (Schneider, 2006). The Hattian slide is also very visible in satellite imagery Fig. 4.10. The Hattian slide is again on the hanging wall of the fault located at “slide B” in the Muzaffarabad-Bagh segment of the fault. Although this location is associated with high uplifts of 4-5 m in the displacement map (Fig. 4.2) it was not subjected to the very large 3 m SW horizontal elastic rebounds that occurred in the thrusting along the Balakot-Murree-Muzaffarabad segment. Instead, just W of the Hattian slide location the pure thrust mechanism changes to include a significant component of right lateral strike-slip motion in the remainder of the Muzaffarabad-Bagh segment. At B in Fig. 4.7 the Hattian slide is also adjacent to significant coseismic slip in the lesser asperity on the fault plane model that exists in the SE part of the Muzaffarabad-Bagh fault segment.

Figure 4.8: The Hattian slide, Pir Punjal Mountains: the major landslide in the Kashmir 2005 earthquake. a) the source and high energy channel of the slide b) landslide material resulting in damming of two tributaries of the Jhelum River (photos by Charles Scawthorn)

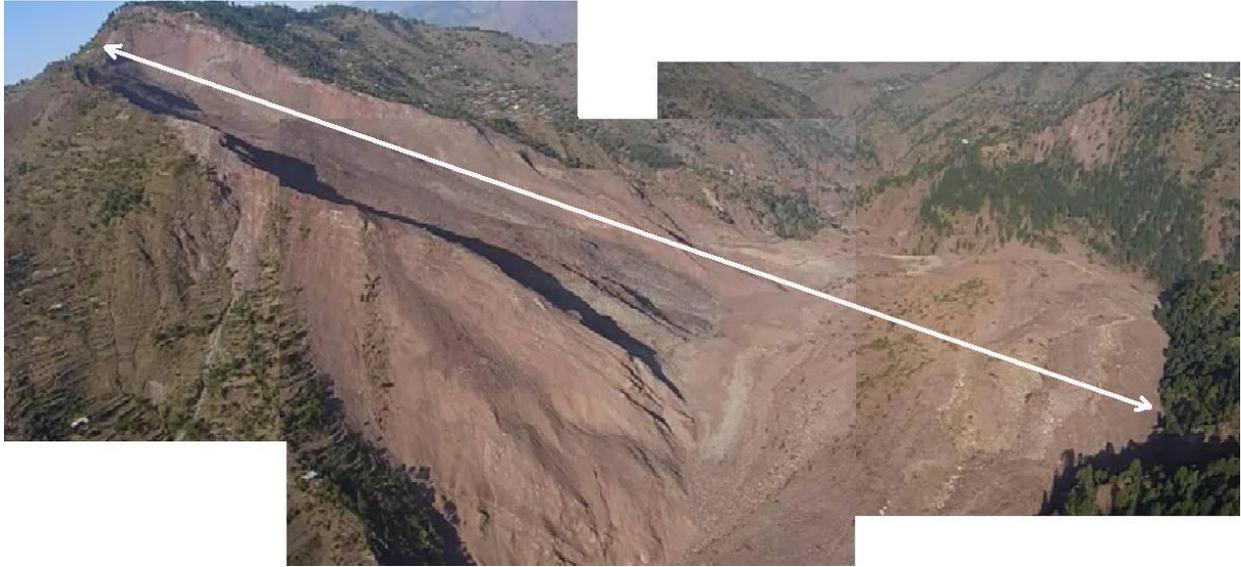
Figure 4.9: The Hattian slide, Pir Punjal Mountains: the major landslide in the Kashmir 2005 earthquake. This deep cutting landslide from source scarp to toe (white arrow) stretches over approximately 2,850 m (photo collage by Charles Scawthorn)

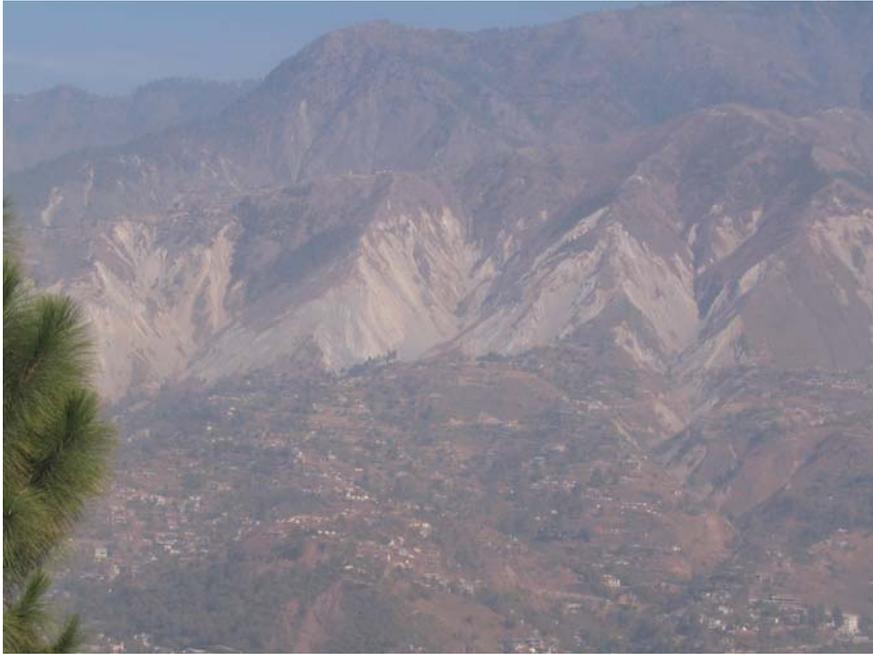
Figure 4.13: Large shallow depth landslides east of Nelum River in Muzaffarabad

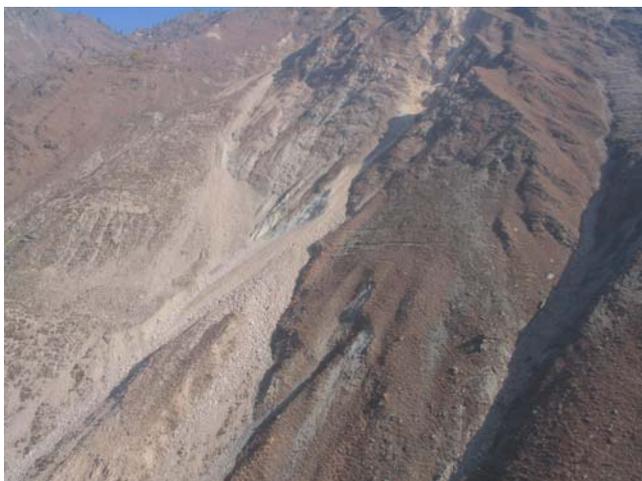
- c) Shallow landslides and flows into gullies (Muzaffarabad-Nausari),
- d) Shallow landslide blocking a road and exposing the foundations of a building above. Other slope failures blocking the same road (Muzaffarabad-Nausari),

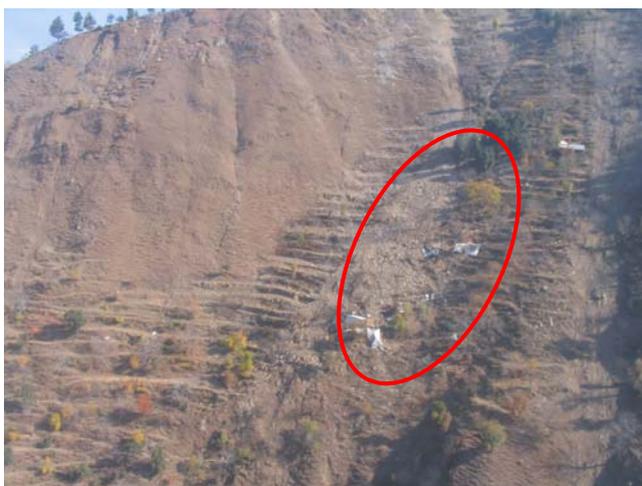
- e) Collapse of buildings on a shallow landslide (Muzaffarabad-Nausari),
- f) Large shallow depth landslide and a disrupted landslide evident from the scarp and cracks outlining the displaced volume (Muzaffarabad-Ghari),

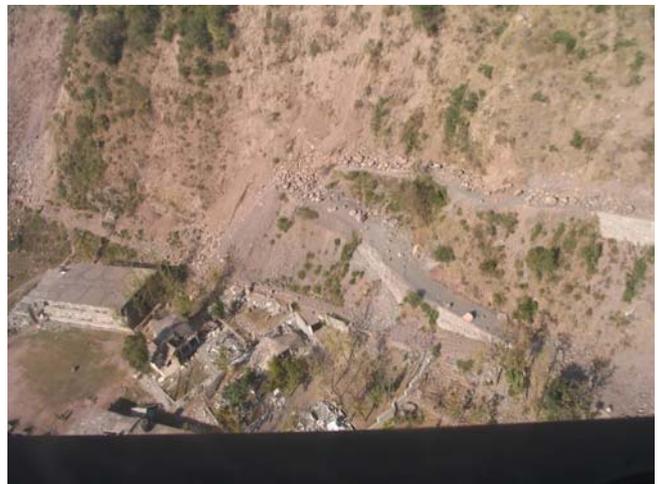
- j) Shallow landslides and rock falls blocking the road (Muzaffarabad-Ghari),
- k) Terraces and damaged buildings (Muzaffarabad-Conoko),
- l) Two river side landslides (Islamabad-Dhanni Nelam),

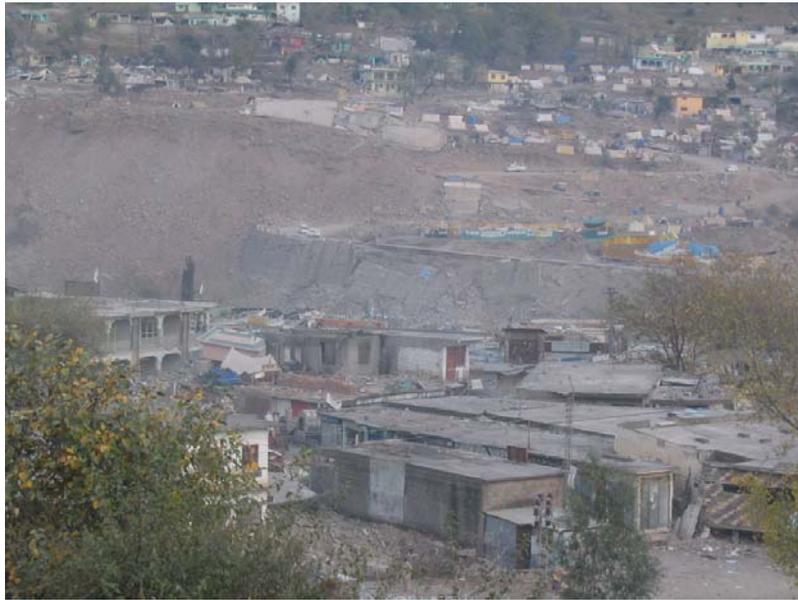
There were several geotechnical structures that performed badly during the Kashmir Earthquake. These primarily impacted the roads and adjacent structures and lifelines, and many of these were either retaining structures or structures providing facing protection to slopes. Figure 4.20 shows a collapsed concrete retaining wall and facing structure below a road descending into Balakot from the north (see also Figure 4.14). The damaged retaining wall does not appear to have any anchoring to provide sufficient support to the road above. The damage to the retaining structures poses a danger to the road above as it is exposed from slope failure or erosion from rain. A concrete gravity retaining wall by the Kunhar River in Balakot appears to have displaced toward the river as shown in Figure 4.21. However, there is no evidence of any impact on the retained side from this movement.

Figure 4.20: Collapsed retaining wall and concrete facing structures in Balakot

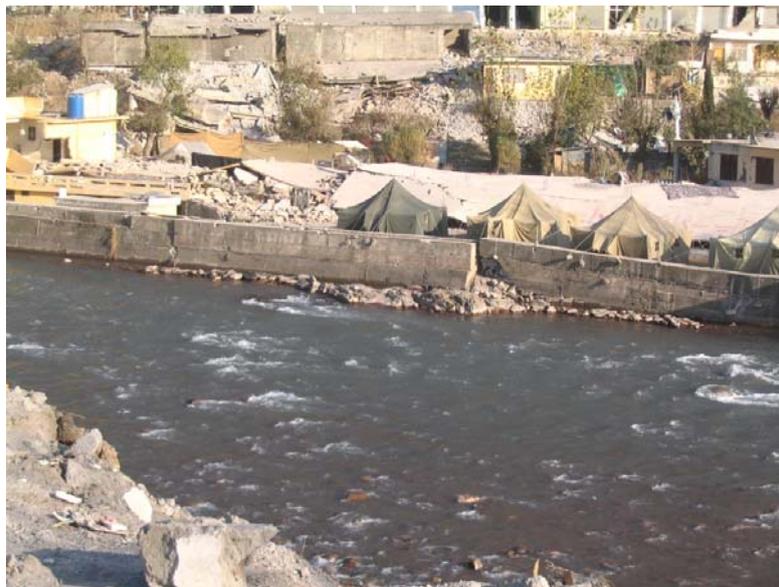
Figure 4.21: Displaced concrete gravity retaining wall by Kunhar River in Balakot

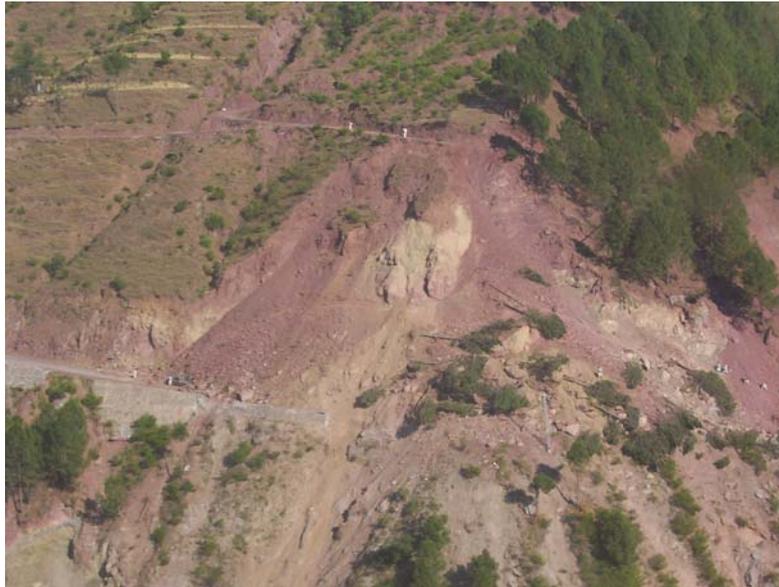
The nature of the mountainous terrain and topography meant that the road network or system was heavily exposed. Figure 4.22 shows a shallow depth landslide in Balakot, where the northern access road to the city was blocked. Figure 4.23 shows another landslide on the same route where there was a combination of rock falls and soil flow. The landslide here exposed the underlying rock that makes up the mountains in this region. Although the landslides in Figures 4.22 and 4.23 are local events, impact of such local events is broader as they degrade the road network by temporarily blocking the road, and thus removing a link from the network.

Figure 4.22: Shallow depth landslide and slumping of soils blocking an access road to Balakot City, NWFP (photo by Kathrin Renner (Arup) and US Army)

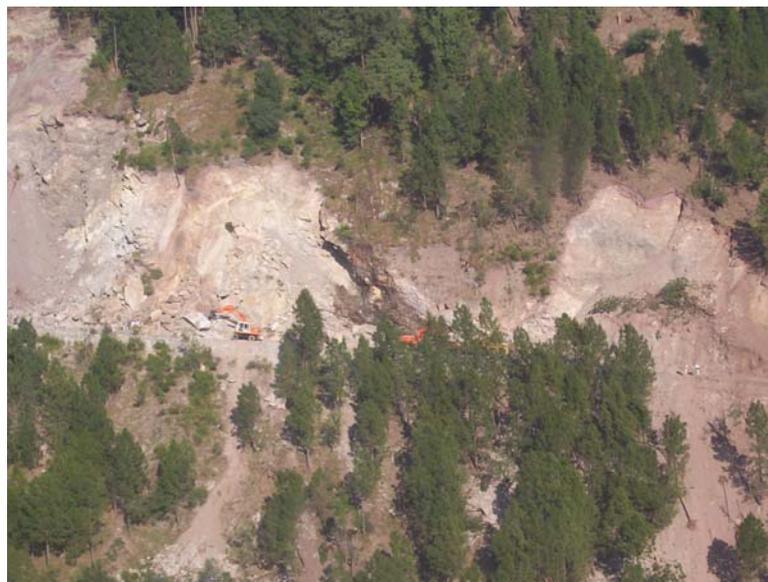
Figure 4.23: Shallow depth landslide exposing the underlying rock. Mixture of rock fall and soil flow block the northern access road to Balakot City, NWFP (photo by Kathrin Renner (Arup) and US Army)

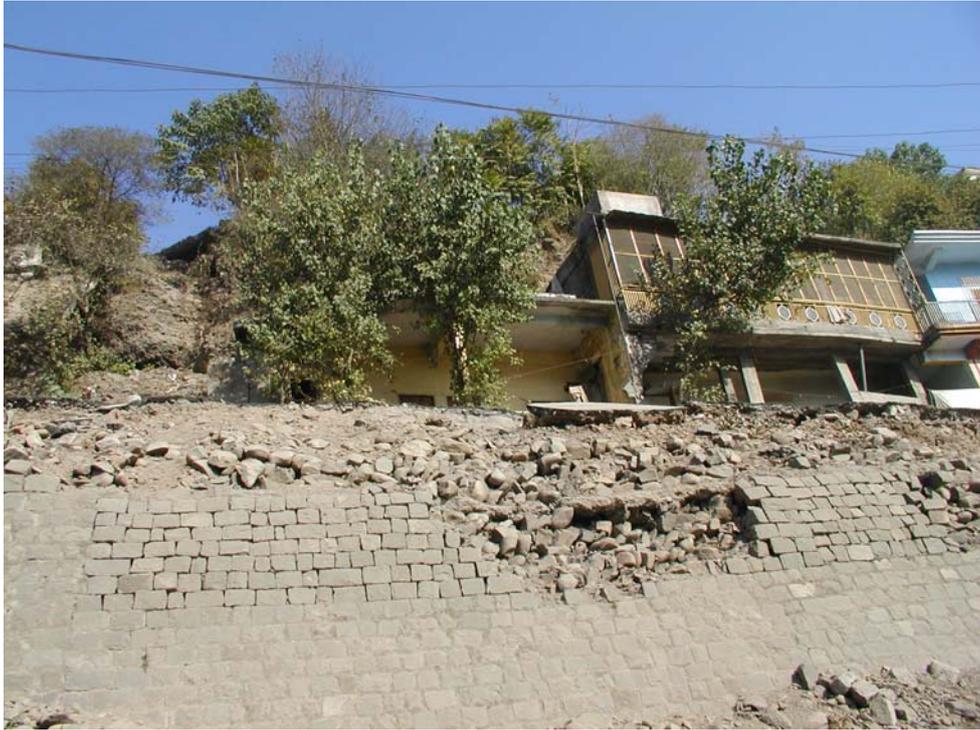
Figure 4.24 shows a distant view of collapsed concrete retaining wall section below a major route in Muzaffarabad City that runs just above the Nelum River. This collapse is similar to that in Balakot in Figure 4.20 where there appears to be no anchoring in the retaining wall system. The collapsed section leaves the road vulnerable to further damage from slope failures or erosion from rain. A few hundred metres further along this route to the north (leftwards in Figure 4.24), a stone masonry built retaining wall had failed and slipped slightly down slope. It was not keyed in to the slope it was intended to maintain. Slippage of this gravity retaining wall undercut buildings as seen in Figure 4.25.

Figure 4.25: Stone block masonry retaining wall in Muzaffarabad: slippage and collapse of this wall undermined buildings
