THE KASHMIR, PAKISTAN
EARTHQUAKE OF 8 OCTOBER 2005
A FIELD REPORT BY EEFIT

A FIELD REPORT BY EEFIT

Dr Navin Peiris
Dr Tiziana Rossetto
Dr Paul Burton
Mr Suqlain Mahmood

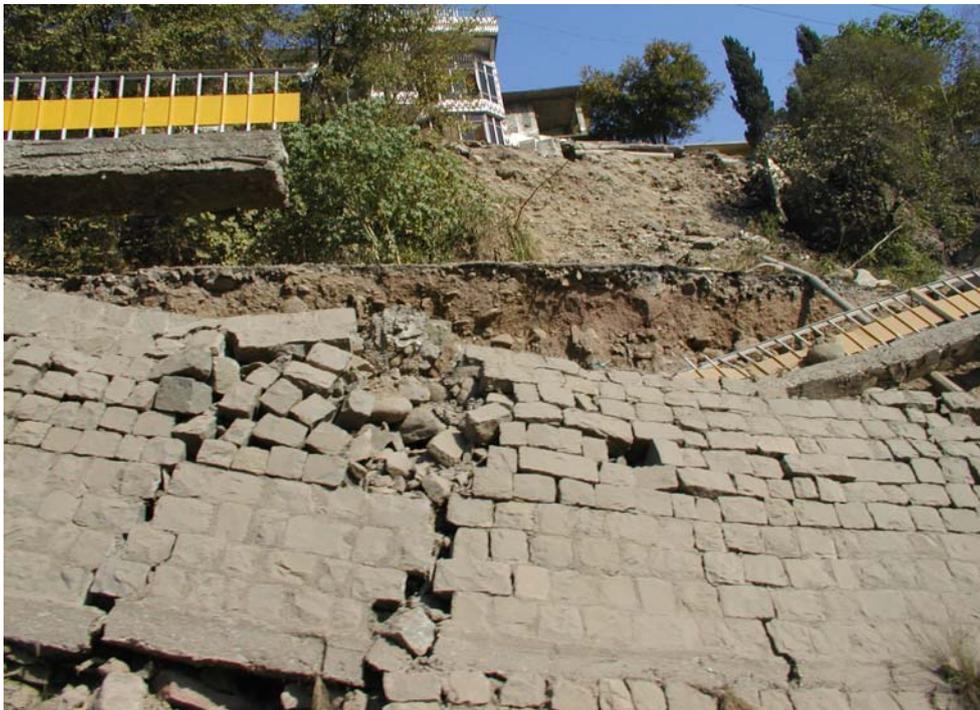
Such gravity retaining walls often supplied only superficial facing support against a slope. The same wall when it slipped not only undercut housing, but also roads and pavements as shown in Figure 4.26. In this photograph in Muzaffarabad the stone block wall has slipped and cracked; the yellow ochre band top-left is a surviving length of safety railing along a pavement behind which the road itself has also slipped away down slope.

Figure 4.26: Stone block masonry retaining wall in Muzaffarabad, just to the right of Figure 4.25: slippage and collapse of this wall also undermined pavement and road

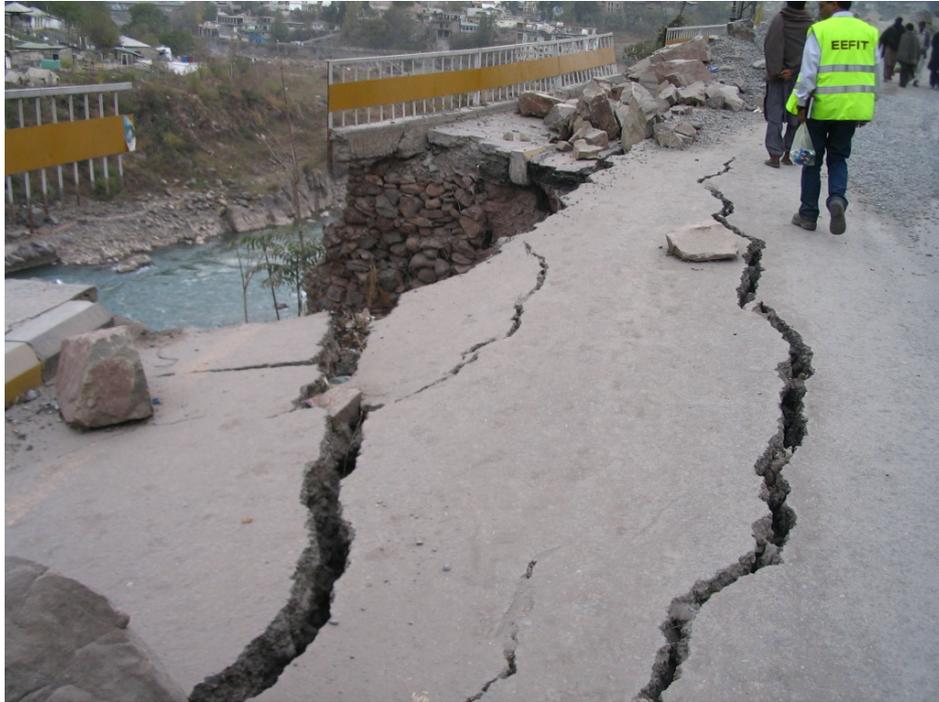
The road above the retaining wall of Figures 4.25 and 4.26 is illustrated in Figures 4.27 and 4.28. Figure 4.27 shows a collapsed section of this major route through Muzaffarabad city. The collapse of the retaining wall led to the collapse of a section of the road and the pavement and cracks to appear on the road surface. Similar cracking was also observed further along the same route as shown in Figure 4.28. The cracked road sections are exposed to likely further damage unless the collapsed retaining wall sections are quickly repaired to prevent further slope failure or soil erosion.

Figure 4.27: Retaining wall collapse leading to unstable pavement and road sections on a major route through Muzaffarabad

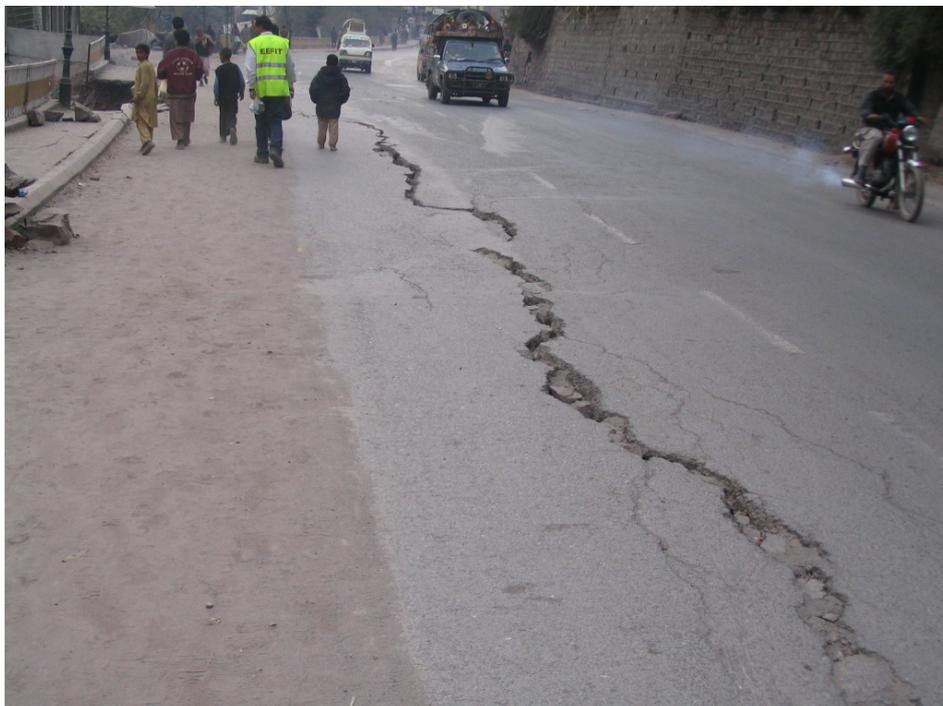
Figure 4.28: Cracks through a major route through Muzaffarabad due to collapsed retaining wall section

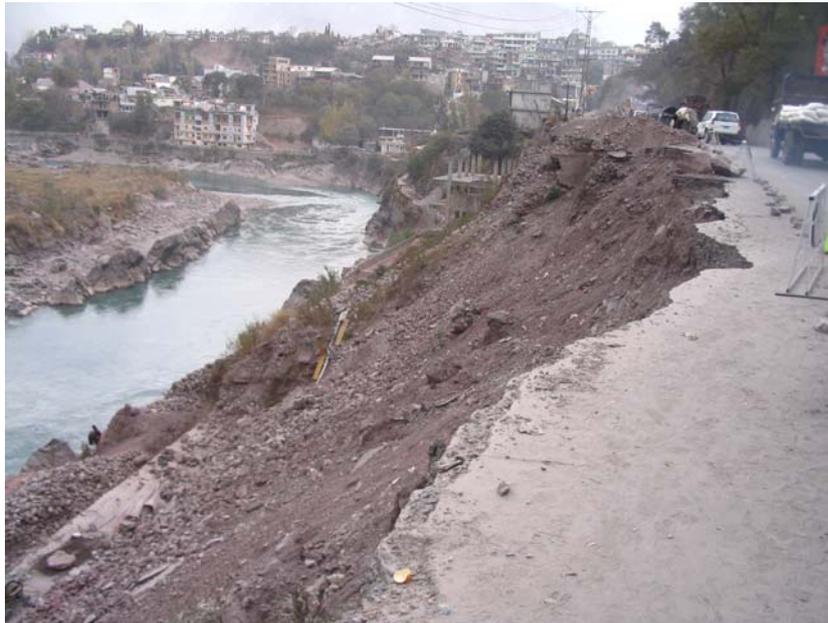
The danger of further undercutting and erosion to road surfaces was a common problem in Muzaffarabad. Figure 4.29 shows an unstable slope cutting back through a road in Muzaffarabad.

Figure 4.29: Slope failure adjacent to a major route through Muzaffarabad City, danger of further erosion of the road surface

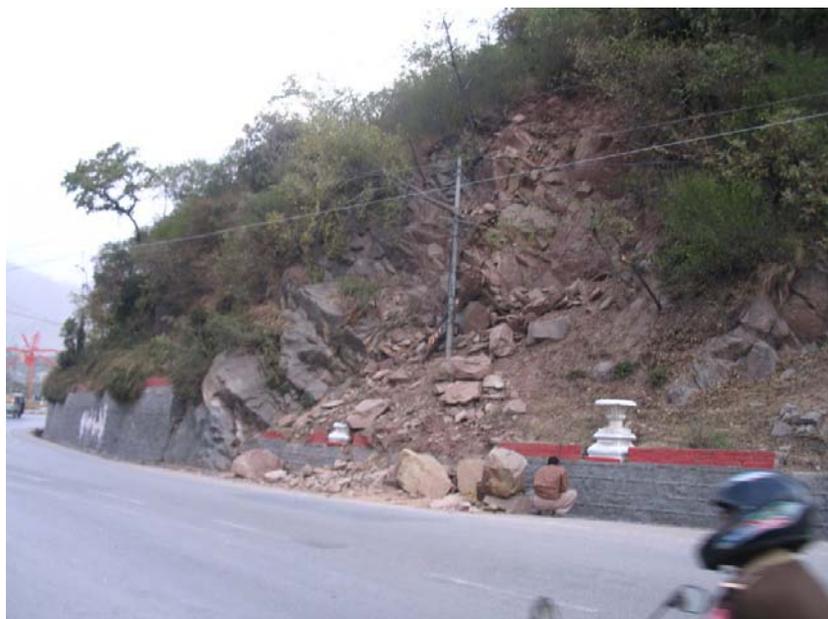
In addition to these containment and continued erosion problems, there had been severe rock falls and showers during the earthquake. A minor rock fall that had been partially cleared is shown in Figure 4.30. The slope material seen behind the skeletal building in Figure 4.31 lies directly behind the road edge seen in Figure 4.5. Road cracking is clear in Figure 4.5. In addition, at the time of the earthquake, it was reported that the cobble and boulder material that constitutes the slope in Figure 4.31 showered down on to vehicles on the road below causing fatalities.

Figure 4.30: Minor rock fall onto a main route through Muzaffarabad City

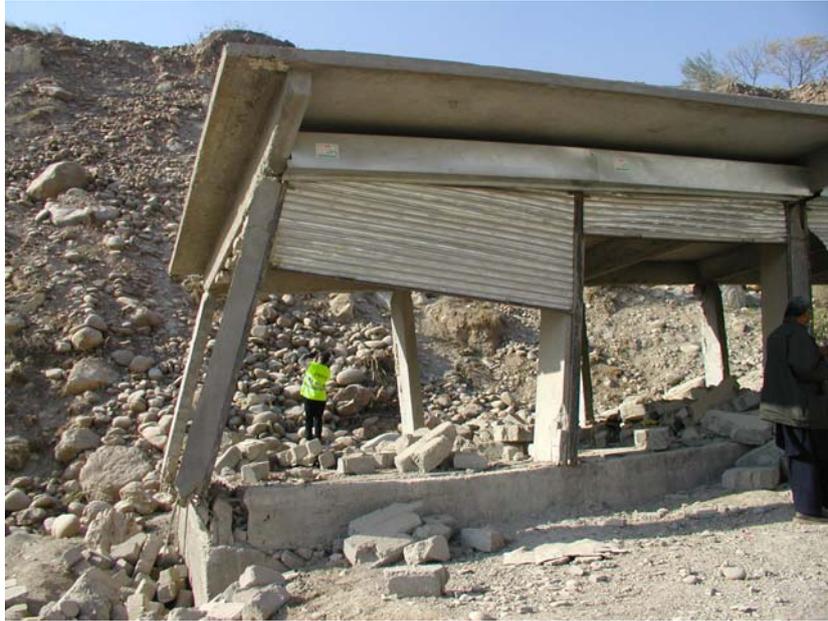
Figure 4.31: Rock falls and showers. Cobble and boulder material on slopes showered down on road transport during the earthquake. This site in Muzaffarabad City is above and behind the cracked road edge visible in Figure 4.5

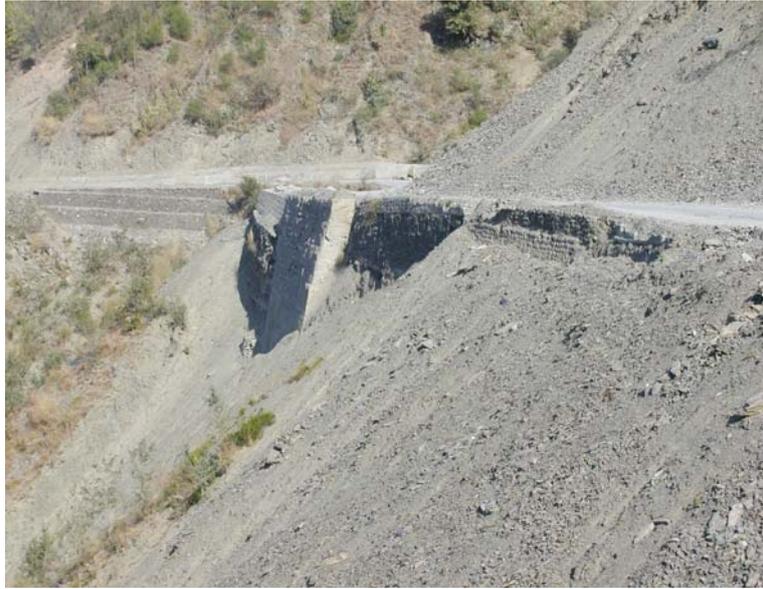
The nature of the mountainous terrain and topography meant that the road lifeline system was heavily exposed. It remains so. Roads of necessity either contour along river valley sides or hair-pin bend their way up hillsides; the photograph Figure 4.32 illustrates the Balakot-Muzaffarabad valley road south of the Masher junction. Photograph Figure 4.33 is from the same point; this road was cut by landslide reactivation of the scree slope during the earthquake. Undercutting of the abutment is also apparent as an ongoing problem. Incipient landslides also pose a further ongoing problem.

Figure 4.33: Road network and topography: reactivated landslide blocked this road for about 24 hours and has started to undercut the abutment. View from the same position as Figure 4.32

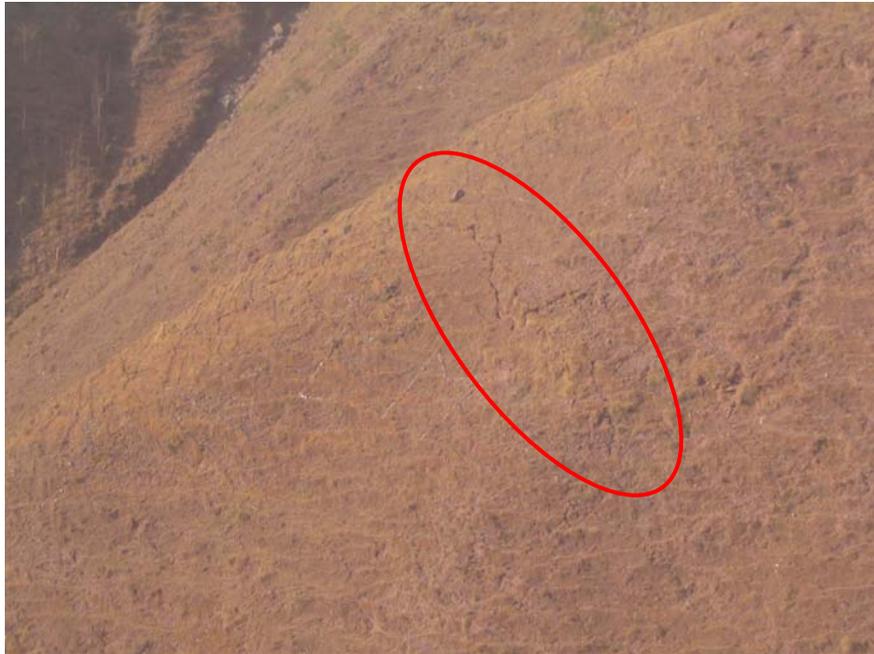
Not all visible ground cracks and potential slides had reached maturity as full landslides, several preserved a threat for the futurity. Figure 4.35 shows a mountain side viewed during a relief flight Muzaffarabad-Ghari in which ground cracks are visible. A more extreme example is apparent in Figure 4.36 in which the upper extension crack of an incipient landslide is visible. This incipient landslide has cracked through the road in two places.

Figure 4.35: Ground cracks indicating a possible disrupted landslide

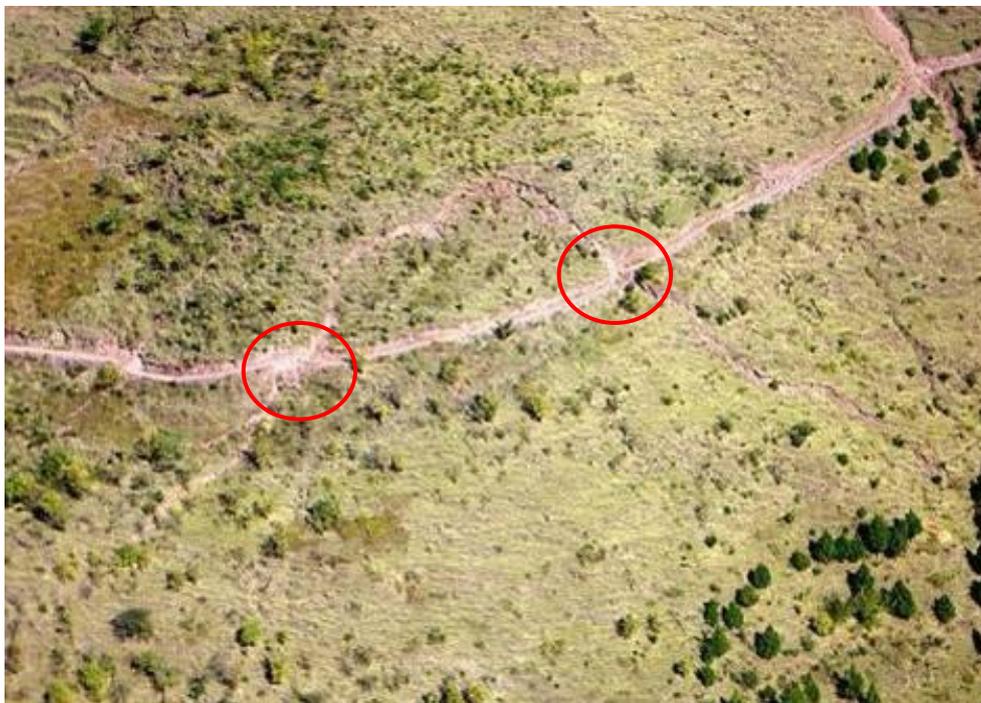
Figure 4.36: Incipient landslide threat to road: the road is cut in two places by cracking (photo by Charles Scawthorn)

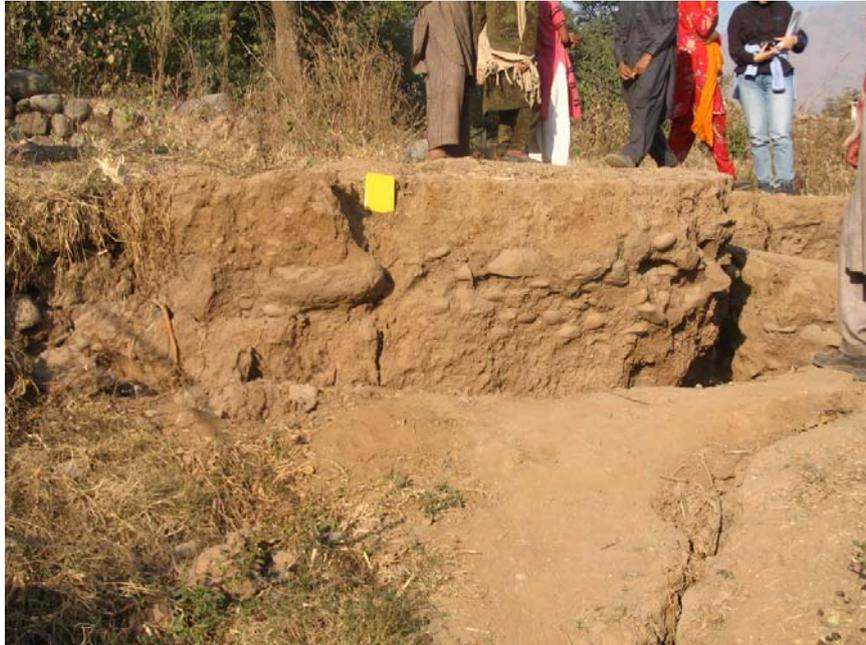
In addition to the incipient landslides on mountainside there was also observation of disrupted slides in soil. Figure 4.37 shows a scarp of one disrupted slide, near Muzaffarabad, and the ground cracks that were extending from the scarp are shown in Figure 4.38. These ground cracks extended almost parallel to the slope and some of the cracks had resulted in damage to buildings due to foundation differential settlement. These disrupted landslides also pose a danger to the people living on the landslide, as well as those in the area downhill, since the disrupted slide could eventually flow due to the weight of water from a heavy rainfall or snow melt following the winter, or through disturbance in a future earthquake.

Figure 4.37: Scarp of a disrupted landslide west of Nelum River, Muzaffarabad

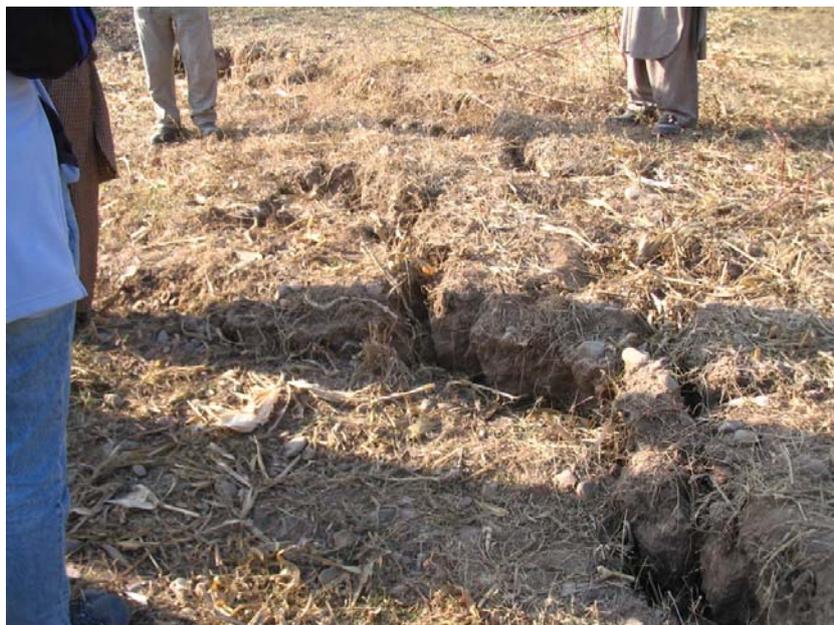
Figure 4.38: Ground cracks, an extension of the scarp of the disrupted landslide west of Nelum River shown in Figure 4.8

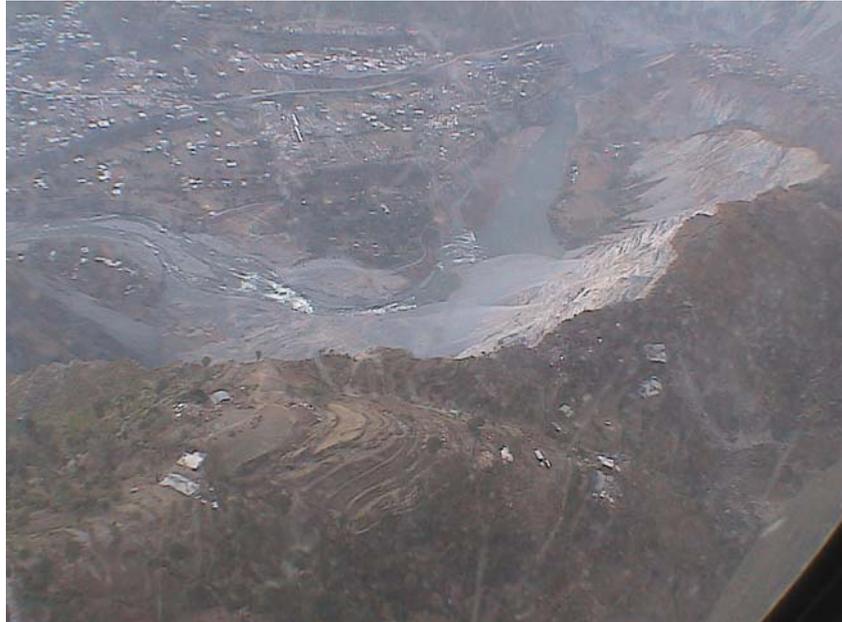
The landslides also created impacts on a traditional way of life in the mountains that is endemic. Agriculture in these hills is linked to preservation and tending of terraces on steep slopes. Evidence of such terracing is visible in Figure 4.40 on the hill tops even above the large landslide at Chela Bandi (see Figures 4.4-4.6) north of Muzaffarabad City overlooking Nilam River. This type of agricultural terracing is a characteristic of the region. A typical mountain rural view is shown in Fig. 4.41. In this example the terracing extends down a spur of a hill on which some buildings are visibly damaged and some have collapsed. Relief shelters are also visible. In some cases agricultural terraces were simply truncated by steep landslide as in Figure 4.42. Others, on a typical hill side in the upper part of Figure 4.43, have been partly truncated by a reactivated slide and slipped, while in the foreground the valley-side road is also threatened.

Figure 4.40: Agricultural terraces disturbed above the Chela Bandi landslide of Figure 4.5

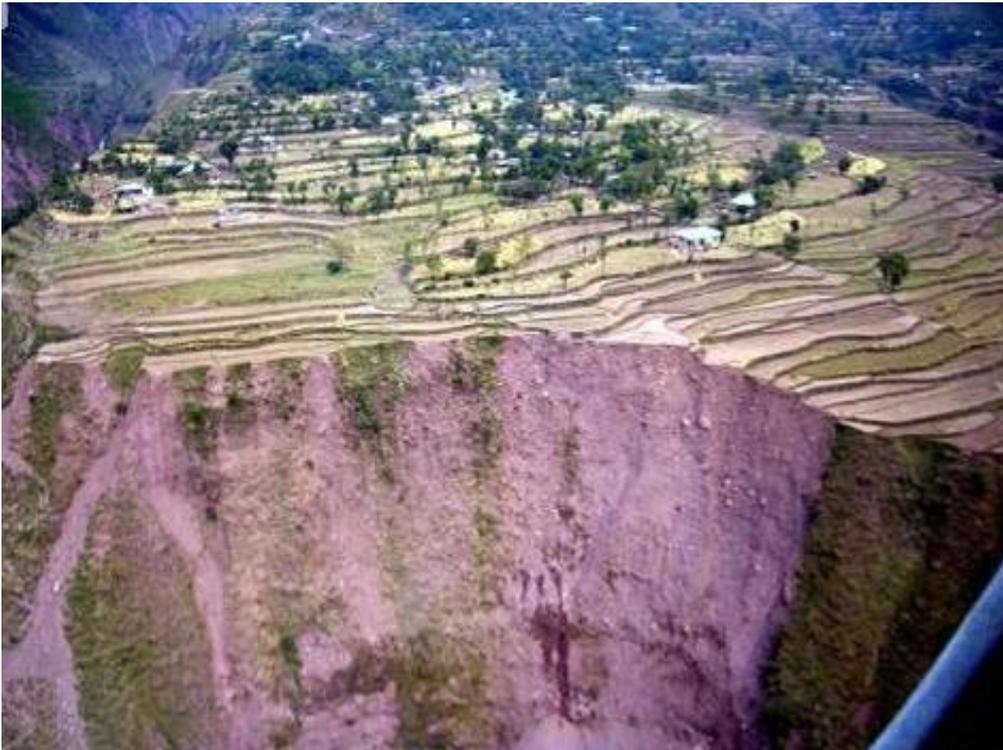
Figure 4.42: Agricultural terraces simply truncated by a steep landslide (photo by Charles Scawthorn)

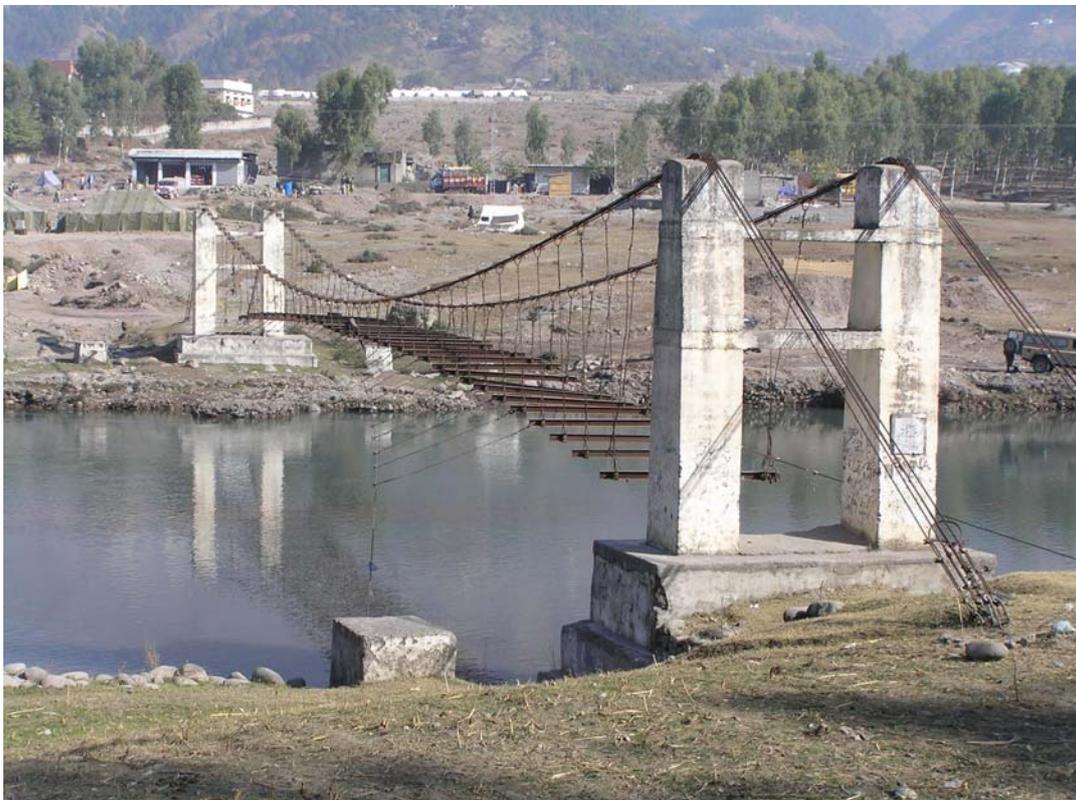
Figures 5.3 and 5.4 show two undamaged pedestrian footbridges of similar construction. However, the bridge in Figure 5.4 shows missing timber deck elements, which may or may not have been removed following the earthquake. Figure 5.5 shows undamaged bridges in Muzaffarabad. The pedestrian bridge shown in Figure 5.8 has a visible crack running through one of its masonry abutments (see Figure 5.9). Again, this bridge was fully functional at the time of the survey.

Figure 5.4: Undamaged pedestrian footbridge in Ghari Habibullah, near the NWFP/AJK border

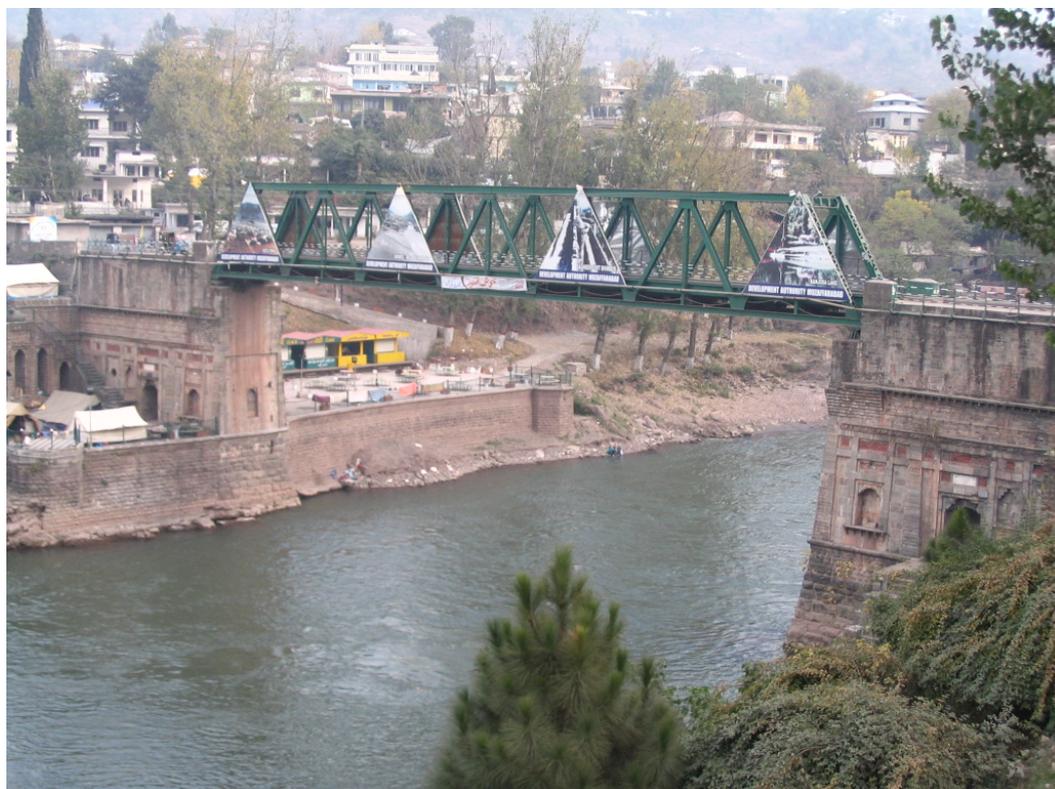
Figure 5.6: Undamaged pedestrian bridge across Jhelum River, Muzaffarabad. Bridge consists of steel truss single span simply supported on brick masonry gravity abutments

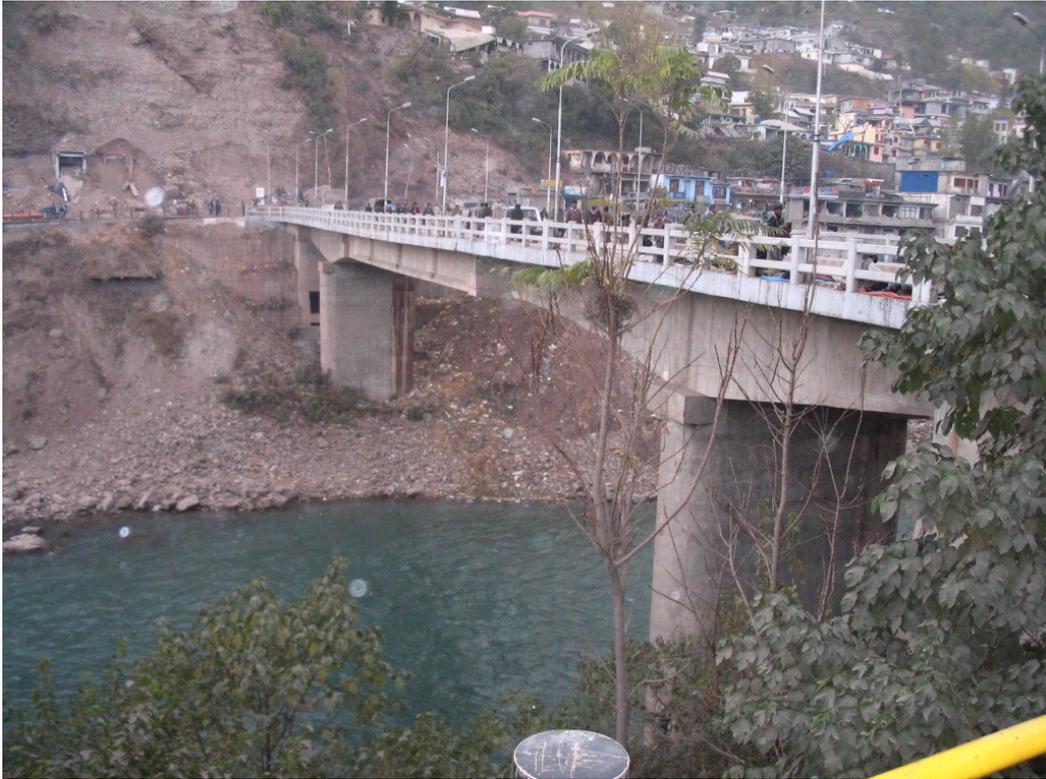
Figure 5.7: Undamaged vehicle bridge across Nelum River, Muzaffarabad. RC spans simply supported on RC piers and abutment

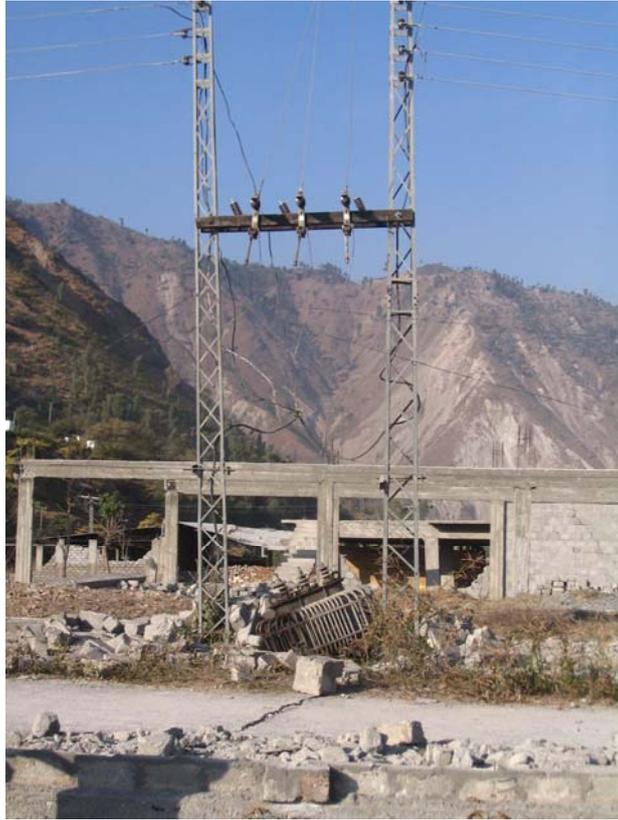
The electricity distribution systems ranging from the primary and secondary distribution networks to consumer substations suffered damage during the earthquake (ADB-WB, 2005). Figure 5.12 shows a local distribution transformer that has detached itself from the supporting frame. The transmission networks are vulnerable from landslides as shown in Figure 5.13 where a transmission tower is located on a scarp of a shallow depth landslide.

Figure 5.12: Transformer unit detached from the supporting structure, Muzaffarabad

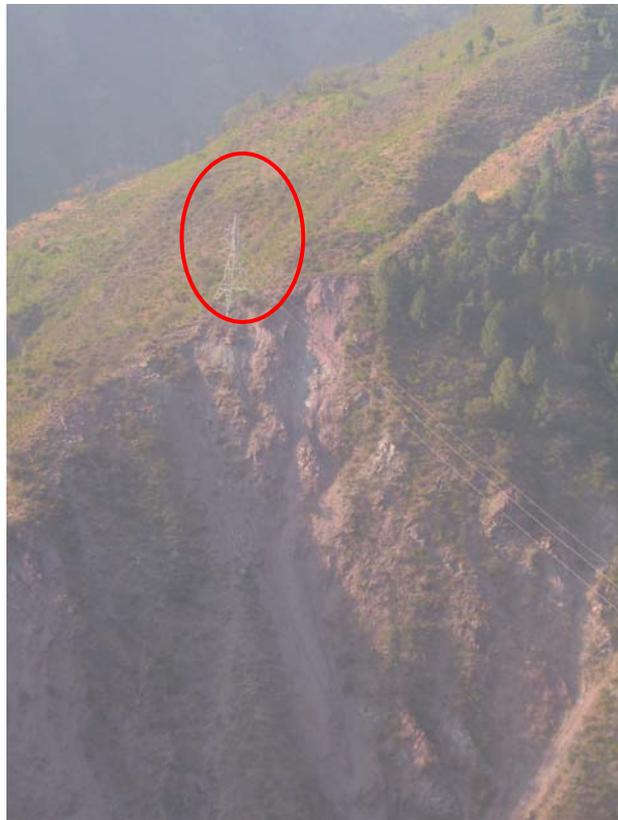
Figure 5.13: Potentially vulnerable transmission tower on the crest of a shallow depth landslide

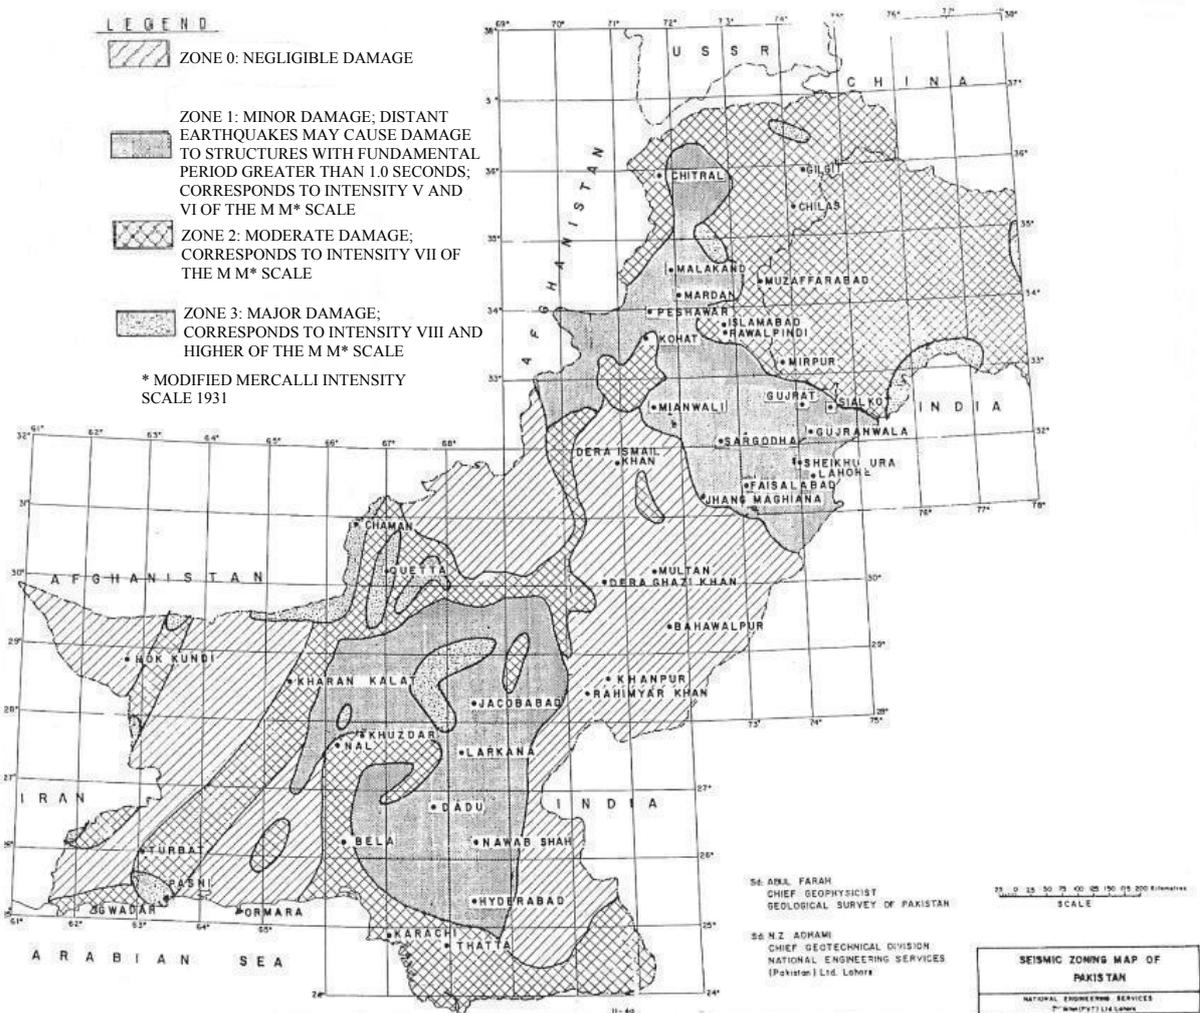
The seismic zoning map in the Pakistan Seismic Code is shown in Figure 6.1. The map divides Pakistan into four zones, (see Table 6.1), based on instrumental data collected from the Quetta Geophysical Centre between 1905 and 1979, and on values of felt intensity in each region during past earthquakes. Quoting the code: "the maps are based on a simple premise that the ground motion of a certain intensity experienced once in a certain area is likely to experience again in that area", and "the map does not take into account recurrence intervals of different magnitude earthquakes". These are serious assumptions which severely affect the usefulness of the code. In view of the large return periods associated with major earthquake events, 74 years of instrumental data and associated observed effects cannot be deemed a sufficient basis for defining a seismic zone map. The exclusion of historical events can lead to an under estimation of the design base shear for areas where the seismicity is characterised by large earthquakes of infrequent occurrence.

Figure 6.1: The Pakistan seismic zoning map (as per 1986 Pakistan Seismic Code)

From Figure 6.1 it can be seen that all the areas in Jammu Kashmir and North West Frontier Province that were affected by the October 8, 2005 earthquake lie in Seismic Zone 2. According to Table 6.1, these areas are likely to be subjected to moderate damage, corresponding to Intensity VII. In fact the affected areas i.e. Balakot, Muzaffarabad, etc were observed to have Intensities ranging from VIII to X, which greatly exceed that defined for Zone 2, and would place the epicentral region in Zone 3 (as defined in Table 6.1).

The statement made that in drawing the maps, “the recurrence intervals of different magnitude earthquakes were neglected”, means that a probabilistic seismic hazard analysis was not used in delineating the seismic zones. Hence, the zone factor (which represents the ground motion) in each location is associated with a different (and non-quantified) exceedence probability. This means that structures in different locations are being designed for different (and unknown) levels of risk. This is a serious problem for engineers using the Pakistan Seismic Code.

From this discussion it is clear that the Pakistan Seismic Zone map of 1986 in the Pakistan Seismic Code is inadequate for use in the seismic design of structures. The new map is an improvement but should be based on a probabilistic seismic hazard assessment rather than on past earthquake observations and their effects.

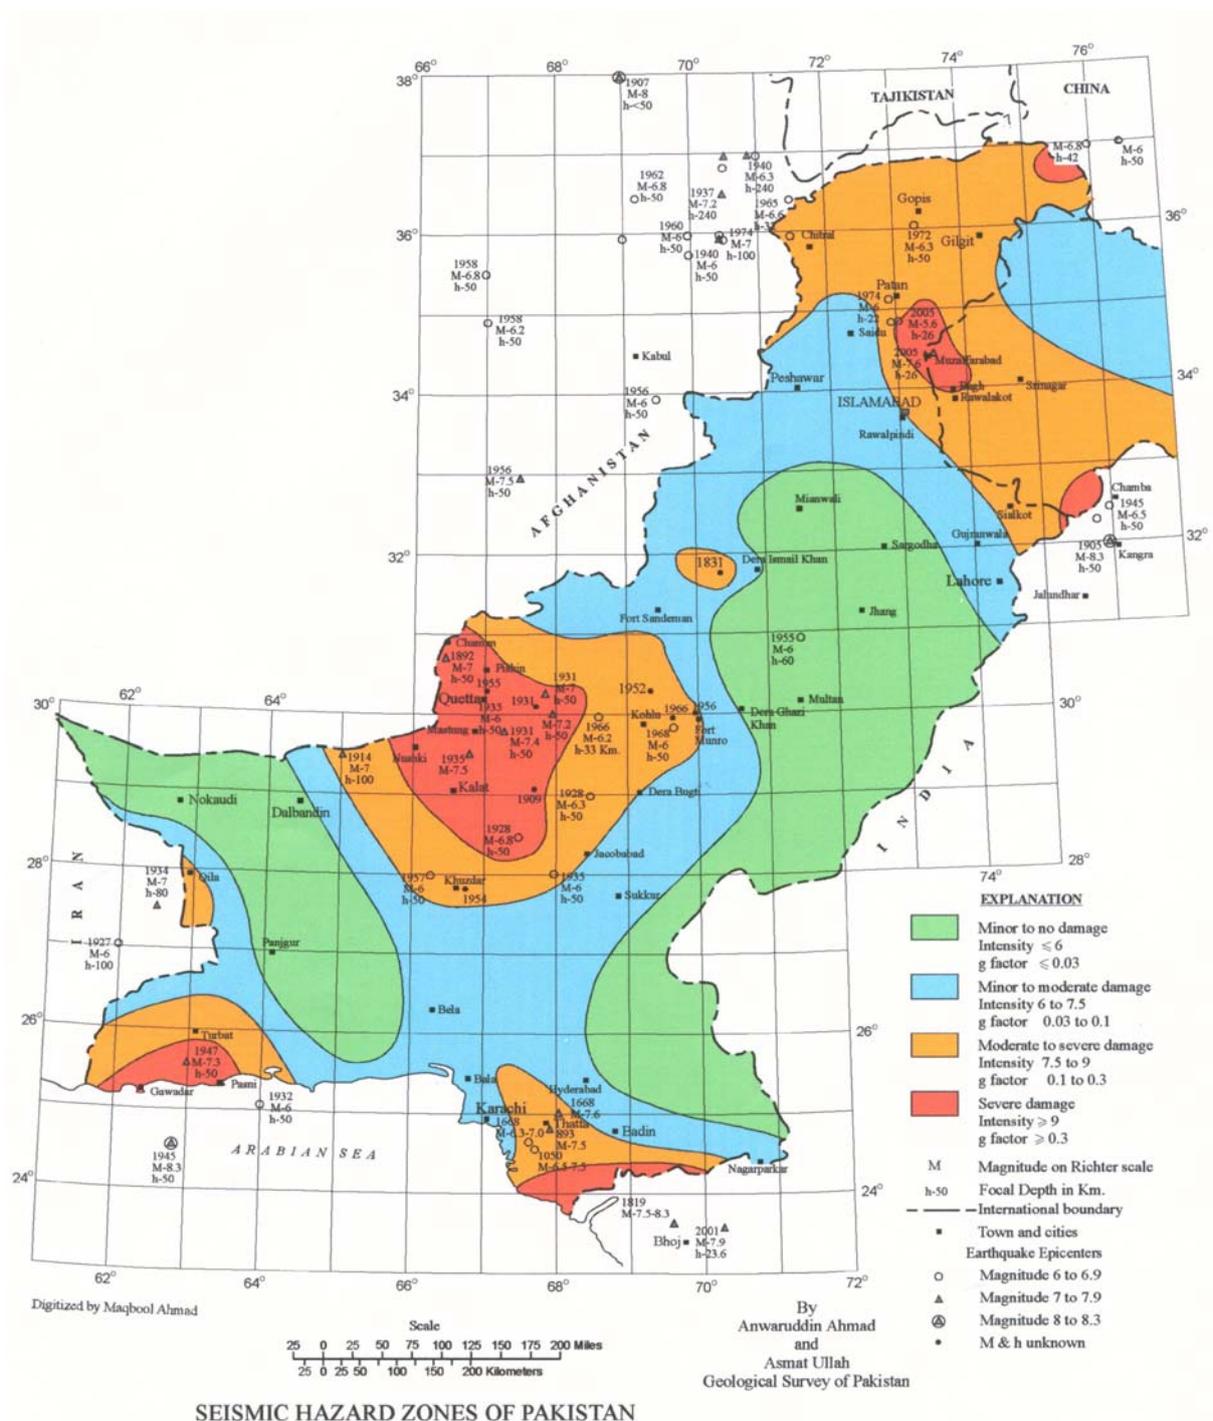
Figure 6.2: The revised Pakistan seismic zoning map, published by the Geological Survey of Pakistan following the October 8, 2005 Kashmir earthquake.

Following the October 8, 2005 event a new version of the Pakistan seismic hazard map was released by the Geological Survey of Pakistan (see Figure 6.2). A significant change can be observed in the contours of the zones which arise from the inclusion of historical records (large events dating back to the 17th century are recorded on the map). One obvious difference is that the area around Muzaffarabad has been assigned to the highest zone. Furthermore, all zones have been upgraded and Seismic Zone 0 has been eliminated, even though the descriptions of the zones in terms of intensity are virtually unchanged. In this map, ranges of PGA are presented for each seismic zone (see Figure 6.2 and Table 6.2). Although the new map may be an improvement on the old seismic zone map in terms of the additional earthquake data used, it also neglects the recurrence intervals of different magnitude earthquakes. The PGA values are therefore most likely extrapolated from strong ground motion, either recorded or derived from ground motion prediction equations, for large events in the past. Thus it poses the same problem to engineers of non-uniform and unknown seismic risk for their structure designs.

The values of PGA presented in the new version of the Pakistan zoning map are however seen to be significantly higher than those implied by the old code zone factors. This means that designs carried out following the 1986 code may be unsafe in view of the new “improved” hazard assessment. GSHAP assigns 500year return period PGA values to the Kashmir region in Pakistan ranging between 0.24g to 0.32g, with some areas in the NWFP being in the range 0.32g to 0.4g. These values tie in fairly well with the new seismic zoning map for Pakistan, but are three times larger than the PGA values assigned to the area by the old zoning map.

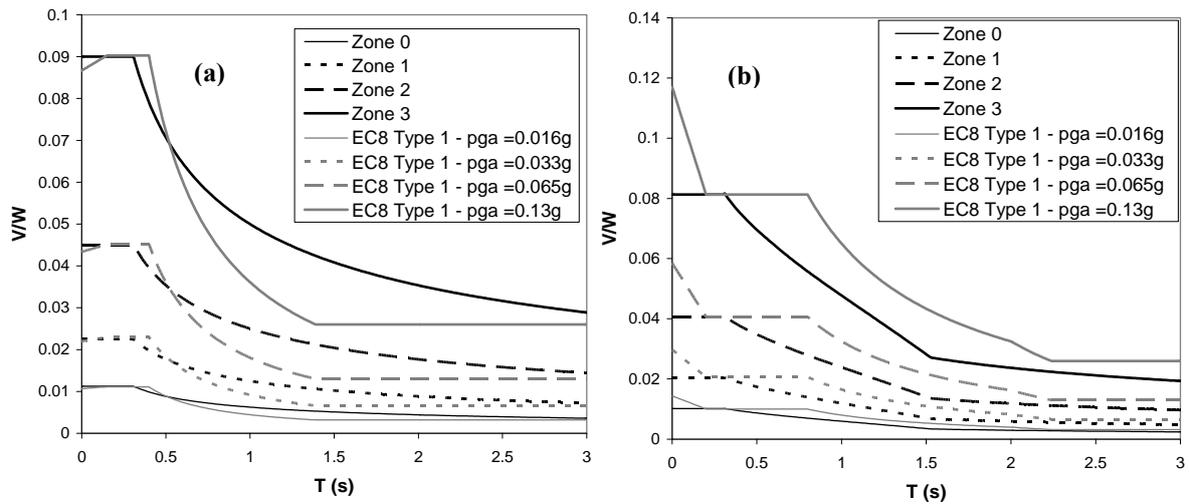
Figure 6.3: Examples of the plots of normalized base shear vs building fundamental period given by the Pakistan 1986 Seismic Code and Eurocode (EC) 8 used to find the PGA corresponding to each seismic zone: (a) Normal importance, non-ductile frame and rock-site conditions, (b) Normal importance, ductile frame and soil conditions

Figure 6.3 compares the plots of normalized base shear (representative of the spectral acceleration) versus structural period given by Eurocode 8 (EC8) and the 1986 Pakistan Seismic Code for the same PGA values, for soil and rock site conditions. It is observed that for soil site conditions EC8 assigns a greater base shear than the Pakistan Seismic Code for structures with fundamental periods between 0.6s to 2.0s. The opposite is true in the case of the rock site, although the difference is not as large in this case. This would seem to suggest that the 1986 Pakistan Seismic code under-predicts the seismic actions on flexible structures. A similar trend is seen in the comparison between the Pakistan code and UBC 1997 below.

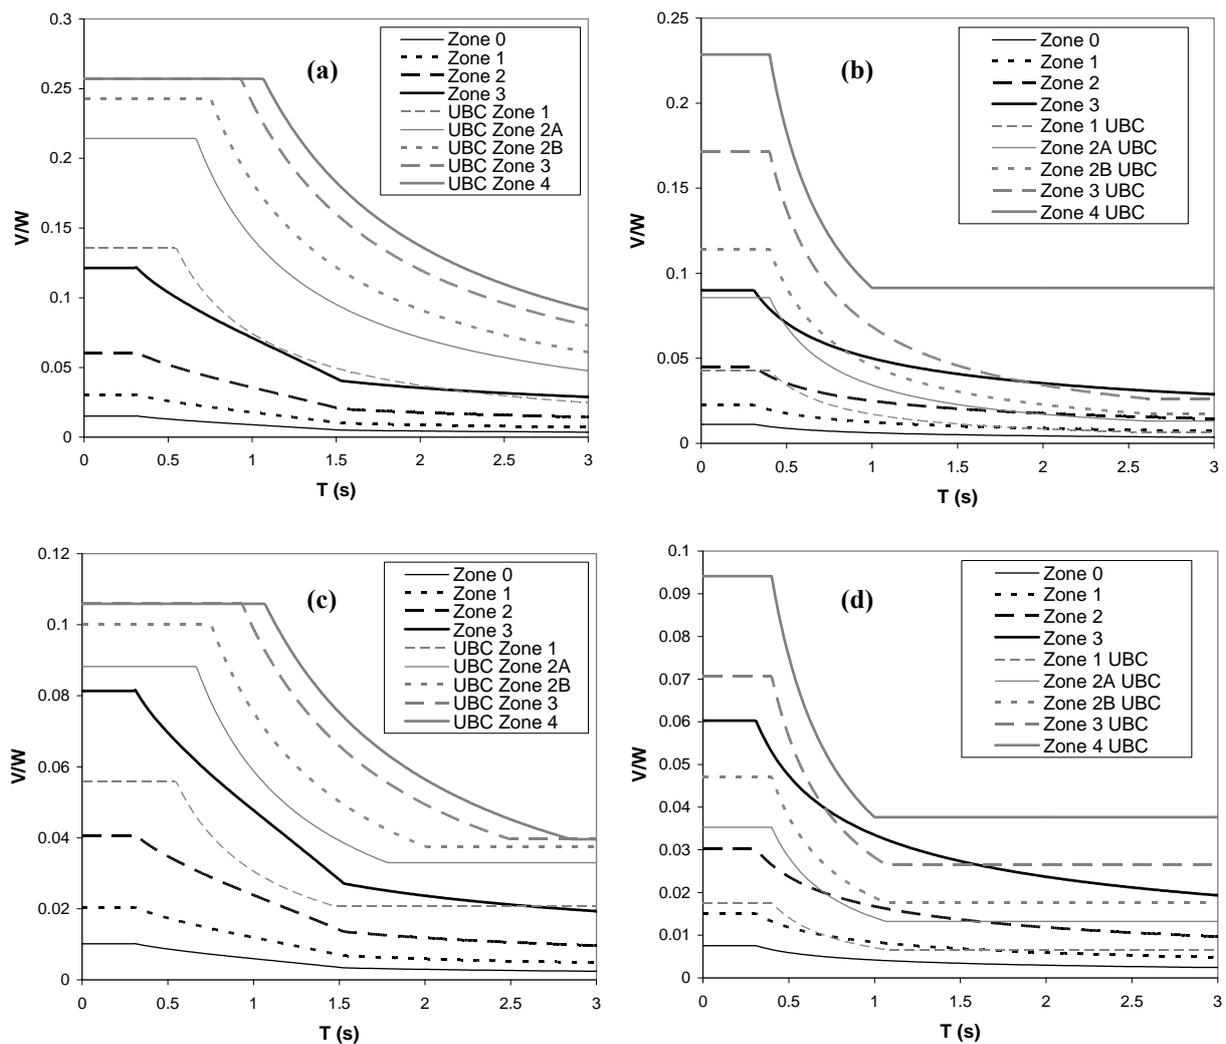
Figure 6.4: Examples of the plots of normalized base shear vs building fundamental period given by the Pakistan 1986 Seismic code and UBC 1997: (a) Normal importance, non-ductile MRF and soft-soil site conditions, (b) Normal importance, non-ductile MRF and rock site conditions, (c) Normal importance, ductile MRF and soft-soil site conditions, (d) Normal importance, ductile MRF and rock site conditions

Figure 6.4 compares the plots of normalized base shear versus structural period obtained from UBC1997 and the 1986 Pakistan Seismic Code for ductile and non-ductile reinforced concrete moment resisting frames for both soft soil and rock site conditions. From the plots it is clear that the base shear prescribed by the 1986 Pakistan seismic code for the design of buildings in its highest zone, is often less than that prescribed by UBC 1997 for its second lowest seismic zone (Zone 2A). The base shear given for Zone 2 in the Pakistan seismic code, which applies to the Kashmir Region, is in most cases seen to be less than that for Zone 1 in UBC 1997. The difference in magnitude of the prescriptions for base shear is further illustrated in Table 6.3. These observations strongly contradict the UBC 1997 recommendation that Pakistan be assessed as if it is in UBC Zone 4.
